**RE: Municipal Water Licence N3L3-0570  
CLASS B - MUNICIPAL**

**RE: Municipal Water Licence G99L3-003 and N3L3-0570  
CLASS B - MUNICIPAL**

## MUNICIPAL WATER LICENCE INSPECTION FORM

<b>LICENCE #:</b>	G99L3-003 and N3L3-0570	<b>EXPIRY DATE:</b>	November 20, 2014
<b>LICENCEE:</b>	Hamlet of Aklavik	<b>PREVIOUS INSPECTION:</b>	September 2, 2010
<b>COMPANY REP:</b>	Evelyn Storr	<b>INSPECTION DATE:</b>	August 26, 2011

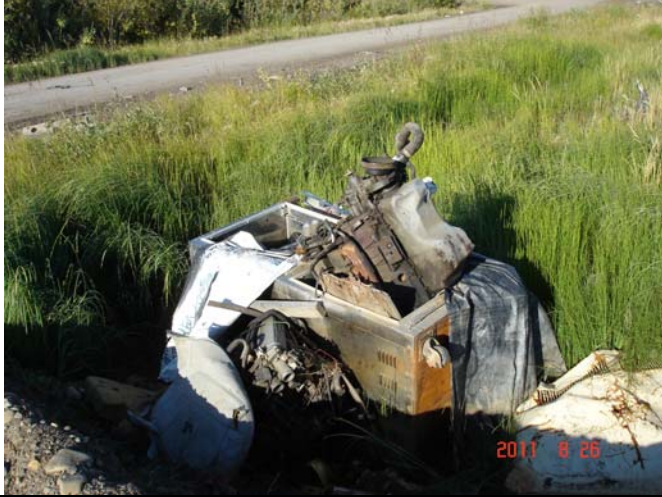
**Figure 1**

4. Access road built in between the flooded cell and the bulk waste area. Engines noted beside the access road (see Figure 1). Ensure they are emptied of all their fluids. The presence of vehicles, parts etc. are a contamination issue when they have not been cleaned out of their fluids properly. It would be appropriate for Solid Waste Disposal Facility (SWDF) maintenance that the Hamlet staff looks after the disposal of vehicles, parts etc to ensure they are empty for disposal.

Engines noted beside the access road built in between the flooded cell and the bulk waste area. Ensure they are emptied of all their fluids. The presence of vehicles, parts etc. are a contamination issue when they have not been cleaned out of their fluids properly.

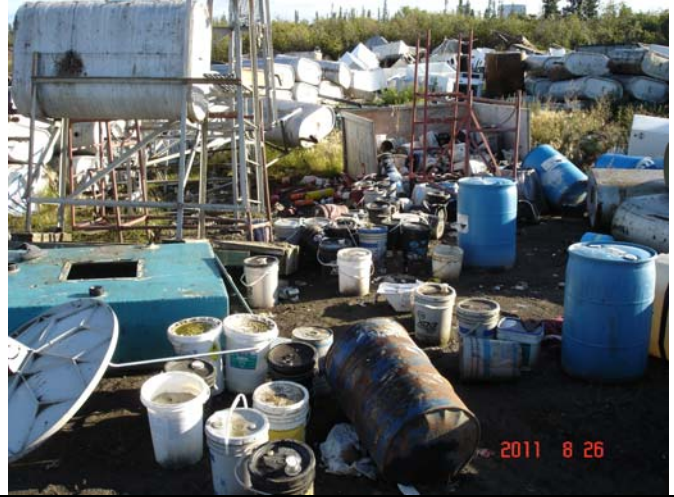
**Figure 2**

8. Ensure hazardous waste is stored in an area at the SWDF with a berm constructed around it to provide better containment (see Figure 2) as per Part D: Conditions Applying to Waste Disposal, Item 9, in Water Licence N3L3-0570. Hazardous waste(waste oil, batteries, barrels, etc.) should be temporarily stored and then disposed at approved and designated facilities. In the past spilled oil was noticed around the SWDF. When there has been spillage, make sure the soil and used oil is cleaned up, contained and properly disposed of. Ensure that the hazardous waste storage area is organized and materials stored properly. This will ultimately keep the area clean and encourage the public to segregate waste properly.

Ensure that the hazardous waste storage area is organized and materials stored properly. Ensure hazardous waste is stored in an area at the SWDF with a berm constructed around it to provide better containment.

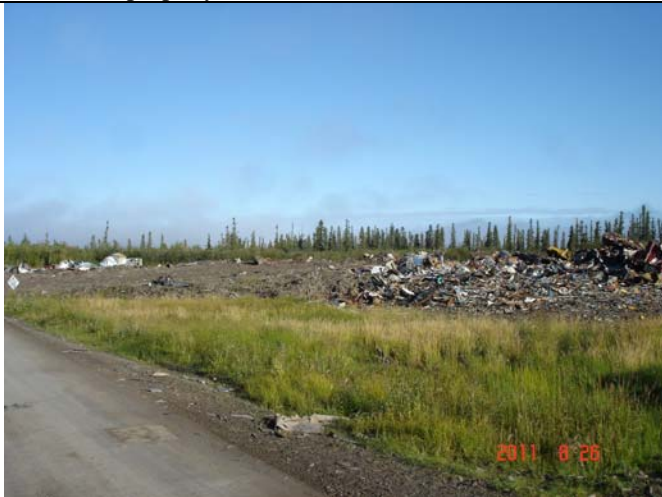
**Figure 3**

- A lot of work was done by the Hamlet to improve the Solid Waste Disposal Facility (SWDF). Fill has been placed over part of the bulk waste area, additionally it is now more spread out and has more crushed metal waste including vehicles (see Figure 3). Previously as of the last Inspection in September 2, 2010 an effort was made by the Hamlet to separate vehicles, crush them and put them in a designated cell. Waste vehicle cell filled with water, clear evidence of hydrocarbon contamination from vehicles and 2 new additions to waste vehicle cell area. Water samples were taken to find concentrations in water in amongst waste vehicle cell. Samples came back with below detection or low levels of oil present.

Fill has been placed over part of the bulk waste area, additionally it is now more spread out and has more crushed metal waste including vehicles.

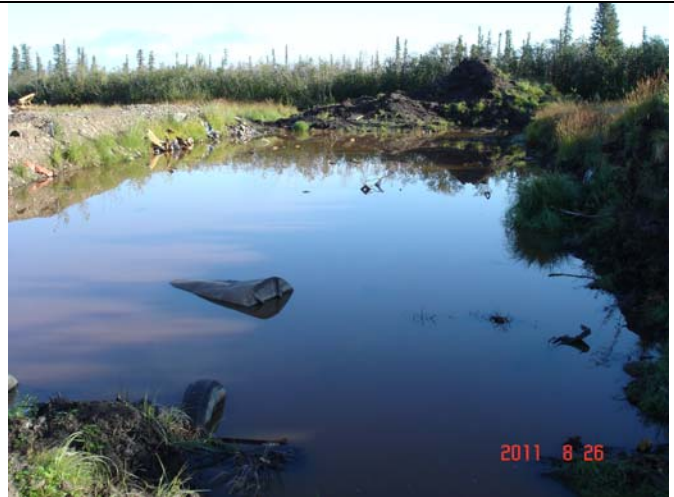
**Figure 4**

It was determined that the waste vehicles needed to be removed from the water and surface oil cleaned up as this is furthering contamination of the area. This was mentioned to the SAO during our site visit to the Solid Waste Disposal Facilities (SWDF) during the Inspection. Vehicles need to be above the water and it was discussed about them being on a gravel pad.

Vehicles etc have now been pulled from the flooded cell (see Figure 4). There is no longer a sheen/oil present in cell. There is an excavated ditch now connected to drain it.

Vehicles etc have now been pulled from the flooded cell. There is no longer a sheen/oil present in cell.

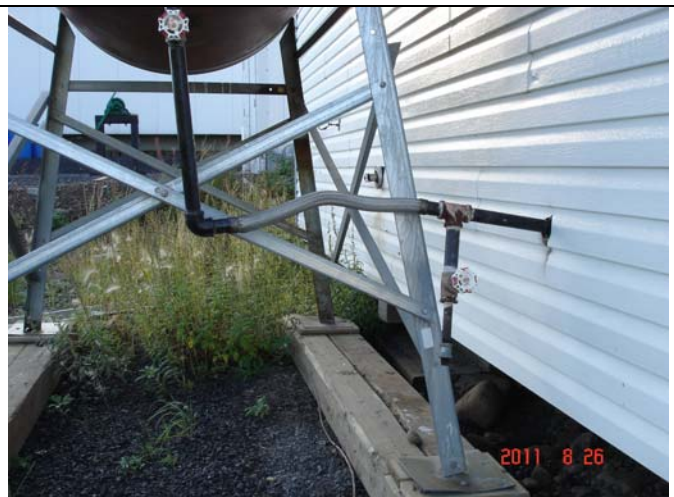
**Figure 6**

2. Chemical storage building has issues with the flex pipe from fuel tank piping to storage building. The flex pipe is twisted and pipe from the building is not straight which is causing issues (see Figure 6). This should be repaired and monitored to prevent a spill.

Chemical storage building has issues with the flex pipe from fuel tank piping to storage building. The flex pipe is twisted and pipe from the building is not straight which is causing issues. This should be repaired to be pro-active and monitored to prevent a spill.
