**RE: SEPTEMBER 15, 2005 INSPECTION OF WATER LICENCE N3L3-0570  
HAMLET OF AKLAVIK**

## MUNICIPAL WATER LICENCE INSPECTION REPORT

<b>DATE:</b>	September 15, 2005	<b>COMPANY REP:</b>	None available
<b>LICENSEE:</b>	Hamlet of Aklavik	<b>LICENCE #:</b>	N3L3-0570

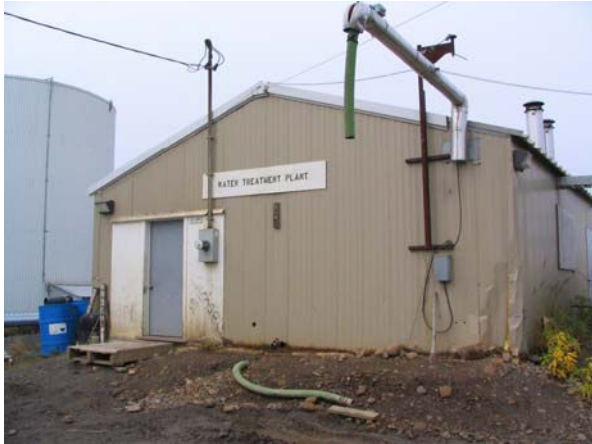
**Figure 1. Water Supply.** Water Intake and Treatment Facility.

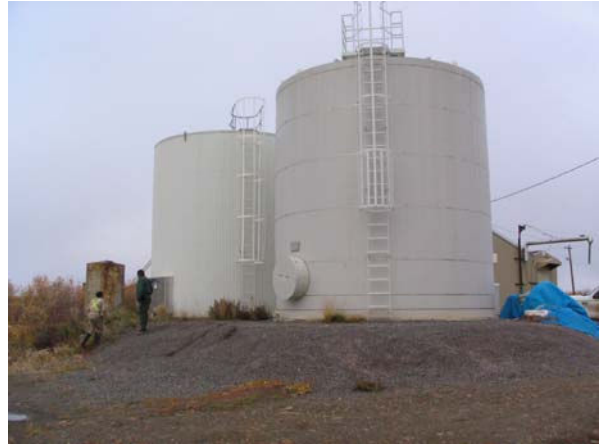
**Figure 2. Water Supply.** Raw and treated water storage tanks.

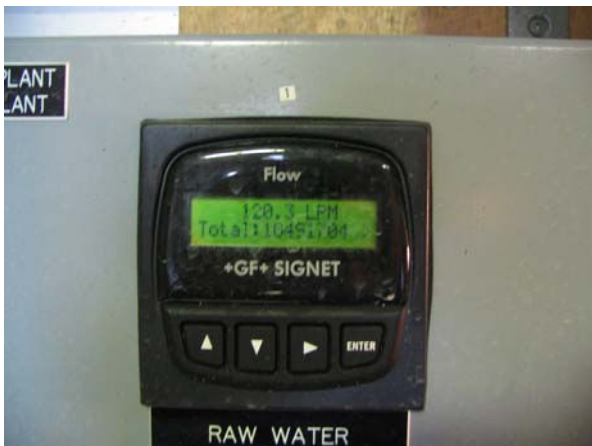
**Figure 3. Water Supply.** Water intake meter.

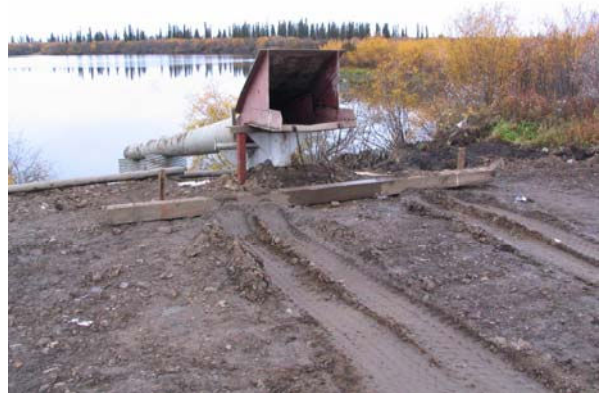
**Figure 4. Waste Disposal.** Sewage Lagoon raw sewage discharge culvert.

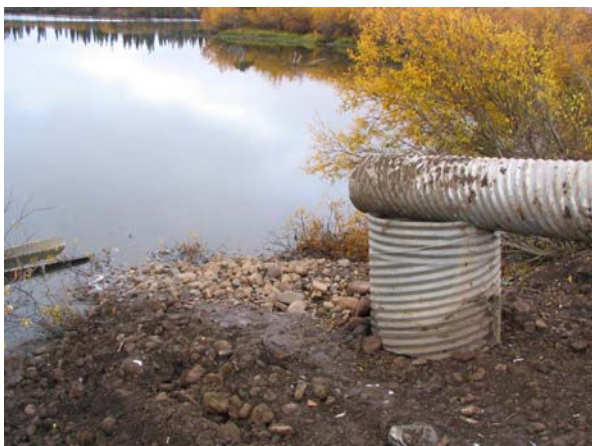
**Figure 5. Waste Disposal.** Sewage Lagoon raw sewage discharge culvert.

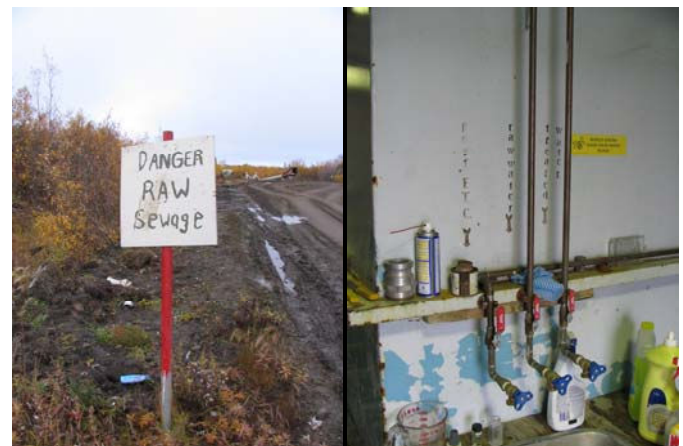
**Figure 6. Waste Disposal/Water Supply.** Sewage Lagoon signage (warning) and Raw water sampling station (no SNP).

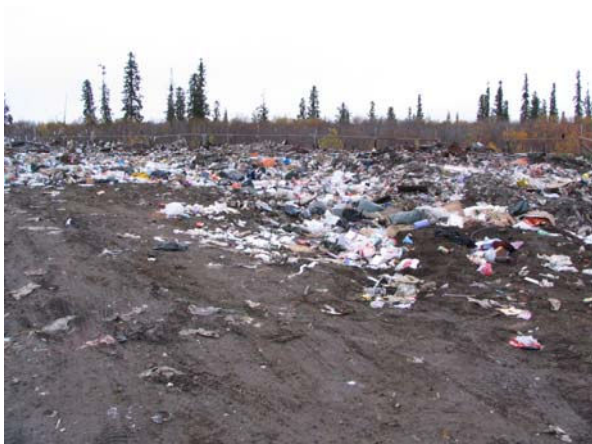
**Figure 7. Waste Disposal.** Solid Waste disposal Facility (SWDF) domestic garbage disposal area.

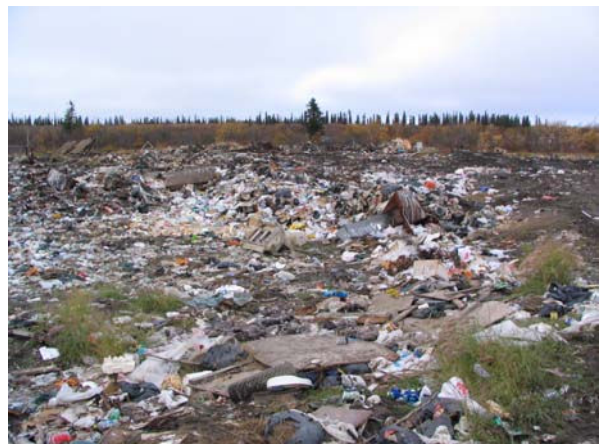
**Figure 8. Waste Disposal.** SWDF domestic garbage disposal area.

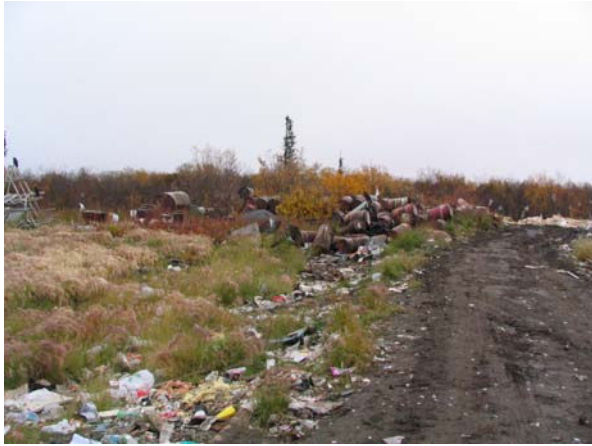
**Figure 9. Waste Disposal.** SWDF empty barrels.

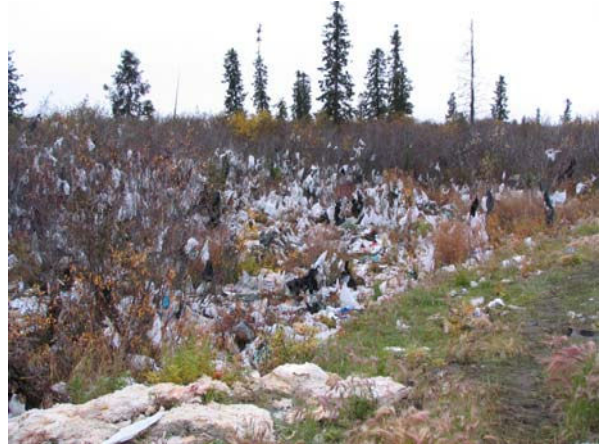
- Please see concern one (1) below under “SNP”.
- As indicated in previous Inspection Reports there is considerable wind blown debris (plastic bags) escaping to the northwest of the domestic garbage disposal area (figure 10).
- To further increase public guidance waste segregation signs should be posted for but not limited to domestic garbage, waste tires, waste appliances (washers/dryers, etc.), wood waste, snowmobiles, empty drums, honey bag pit, and hazardous wastes/waste oil.
- An appropriate area should be considered / constructed for hazardous wastes/waste oil and lead acid batteries. As with other communities these areas are becoming permanent storage areas. Effort should be taken to dispose of this material appropriately. Long term storage of this material is not recommended.
- Updated O&M plan not received. Please see records and reporting under “SNP” below.

**Figure 10. Waste Disposal.** SWDF. To the south of the domestic waste disposal area.

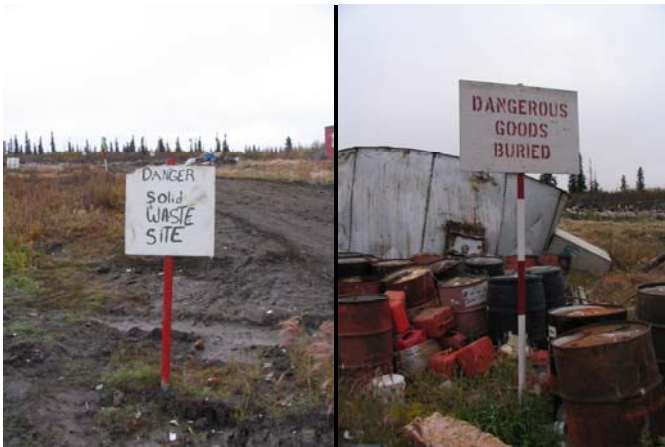
- As per concern 5 in the 2004 Inspection Report asbestos was buried to the north of the hazardous wastes/waste oil storage area and is the rationale for the “Dangerous Goods Buried” sign (figure 11).
- Facilities are posted and identified (figure 6, 11).
- In 2004 the SAO indicated that a screen was installed at the outflow of the Sewage Lagoon (Part B3).
- Part B6 bulky metal waste location identified (figure 13, 14). Currently this area is quite full.

**Figure 11. Waste Disposal.** SWDF signage (warning), and hazardous wastes/waste oil disposal area.

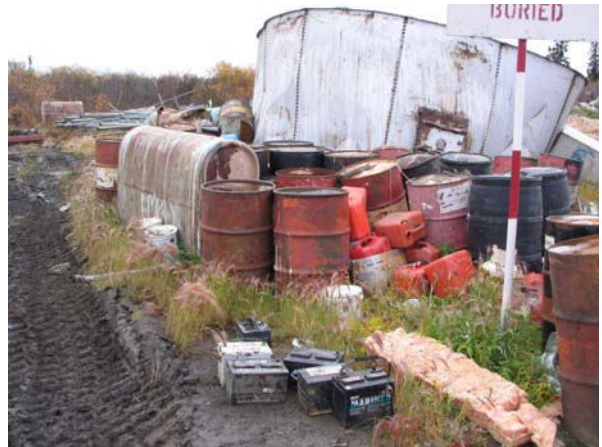
**Figure 12. Waste Disposal.** SWDF hazardous wastes/waste oil disposal area.

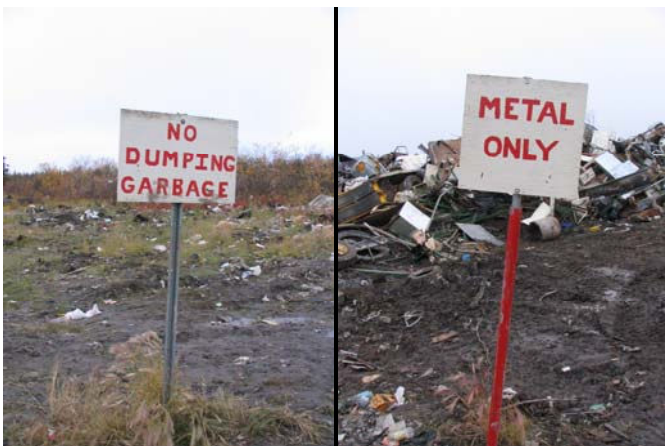
**Figure 13. Waste Disposal.** SWDF signage.

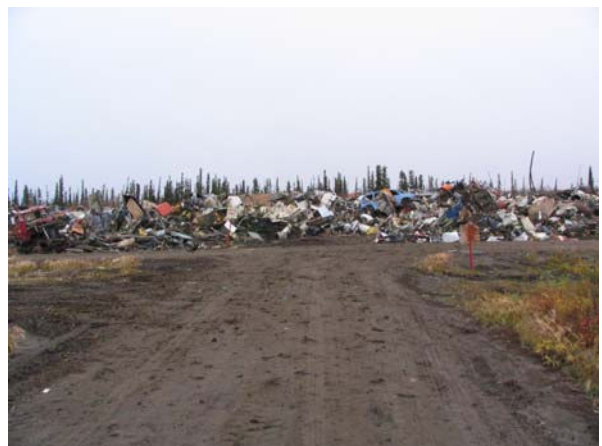
**Figure 14. Waste Disposal.** SWDF bulky wastes (metal) disposal area.

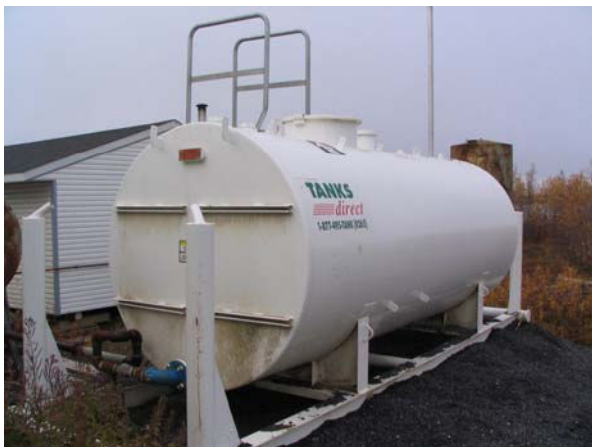
**Figure 15. Fuel Storage.** Water intake and Treatment Facility fuel storage.

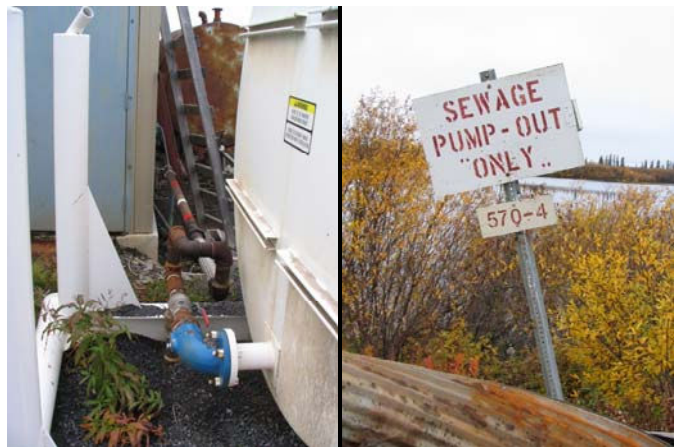
- Tank in excellent condition including transfer lines (figure 16).

**Figure 16. Fuel Storage/SNP.** Fuel storage transfer lines and SNP station 570-4 respectively.
