RE: Municipal Water Licence (G99L3-003 and N3L3-0570)

On September 2, 2010 an inspection was conducted of the Municipal Water Supply and Waste Disposal Facilities under the above mentioned Municipal Water Licences. Enclosed is a copy of the Municipal Water Licence Inspection Report.

WATER LICENCE INSPECTION FORM

| LICENCEE: | Hamlet of Aklavik | LICENCE #: | G99L3-003 and N3L3-0570 |

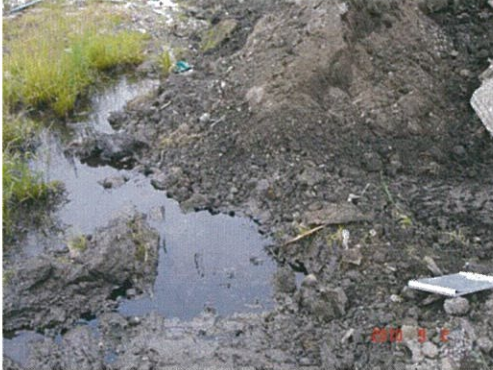
Figure 1

1. Spill of used oil next to waste metal area. Mentioned to Senior Administrative Officer (SAO) and Hamlet Foreman. This needs to be cleaned up, absorbents suggested to be used (see Figure 1).

Spill of used oil next to waste metal area and needed to be cleaned up.

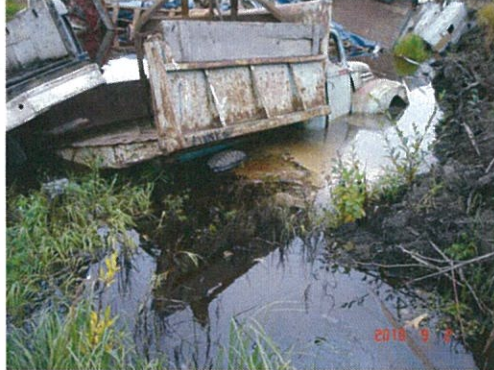
Figure 2

2. A lot of work was done by the Hamlet to improve the Solid Waste Disposal Facility (SWDF). Of the bulky metal waste area an effort was made to separate vehicles, crush them and put them in a designated cell. Waste vehicle cell filled with water, clear evidence of hydrocarbon contamination from vehicles and 2 new additions to waste vehicle cell area (see Figure 2). Water samples were taken to find concentrations in water in amongst waste vehicle cell. Waste vehicles need to be removed from water as this is furthering contamination of the area. This was mentioned to the SAO during our site visit to SWDF during the inspection. Vehicles need to be above the water and it was discussed about them being on a gravel pad.

Waste vehicle cell filled with water, evidence of hydrocarbon contamination from vehicles.

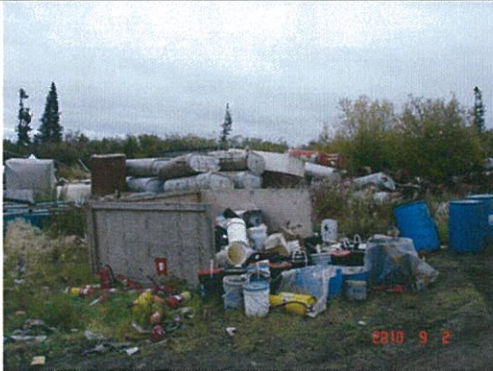
Figure 3

6. Hamlet needs to collect oil/glycol to send out for proper disposal.
7. Should be a berm around the waste oil storage to provide containment as the pails etc. are in various stages of being secure (see Figure 3). Berm around sewage bags needed to contain this material.

Berm needed around the waste oil storage for containment, the pails etc. are in various stages of being secure.

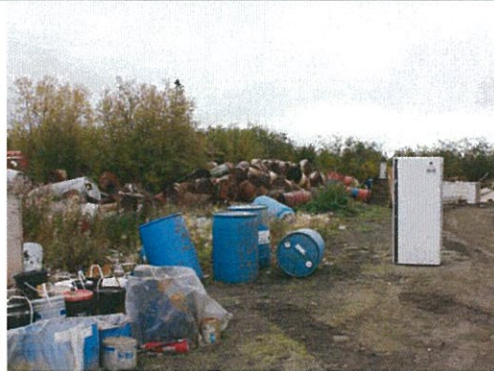
Figure 4

10. Ensure hazardous waste is stored in an area at the SWDF with a berm constructed around it to provide better containment as per Part D: Conditions Applying to Waste Disposal, Item 9, in Water Licence N3L3-0570 (see Figure 4). Hazardous waste (waste oil, batteries, barrels, etc.) should be temporarily stored and then disposed at approved and designated facilities. Spilled oil was noticed around the SWDF. When there has been spillage, make sure the soil and used oil is cleaned up, contained and properly disposed of. Ensure that the hazardous waste storage area is organized and materials stored properly. This will ultimately keep the area clean and encourage the public to segregate waste properly.

Ensure hazardous waste is stored in an area at the Solid Waste Disposal Facility with a berm constructed around it.

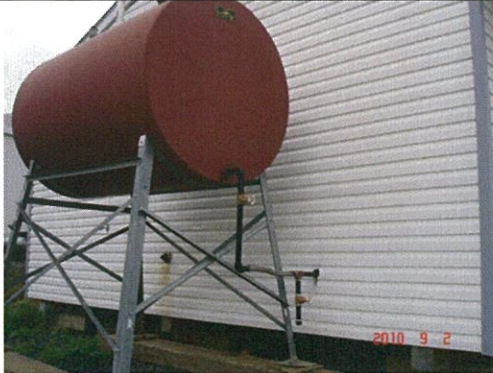
Figure 5

Flex pipe for the chemical storage building fuel tank is showing signs of movement. Continue to monitor.

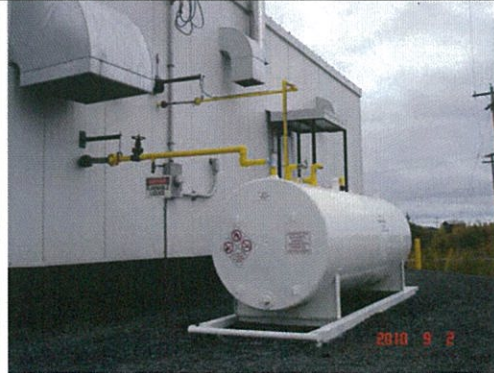
Figure 6

1. Flex pipe for the chemical storage building fuel tank is showing signs of movement. Continue to monitor for spill prevention (see Figure 5).
2. The new Water Treatment Plant's fuel tank has a set up for the pipeline that is a concern. The flex pipe appears to be supported with pipe hangers attached to the main building but on the fuel tank's side of the flex pipe. It is questionable if this is appropriate because it does not appear that either the main building or the fuel tank are now fully independent of one another (see Figure 6).

WTP Pipe hangers from main building attached to fuel tank's side of flex pipe, both not fully independent of one another.
