2008 Hamlet of Tuktoyaktuk Annual Water Licence Report

Prepared by AECOM for the Hamlet of Tuktoyaktuk

October 28, 2009

WATER LICENCE INSPECTION FORM

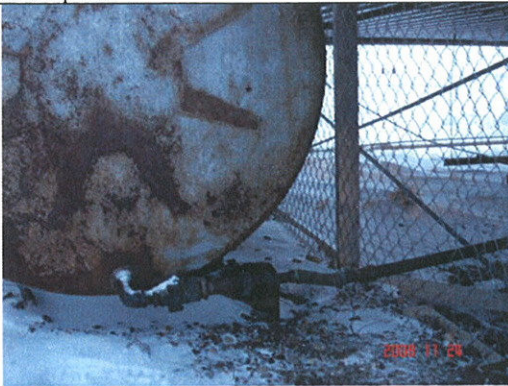
Figure 1

Owner:	Hamlet of Tuktoyaktuk	Operator:	Hamlet of Tuktoyaktuk	Condition of tanks:	Fair, has rusty connection points ¹
Berms & Liners	N/A	Water within Berm:	N/A	Evidence of Leaks:	None detected during inspection
Drainage Pipes	N/A			Pump Station and Catchment Berm	N/A
Pipeline Condition	Poor, corroded, hose flex connector mis-aligned ¹			Not Applicable:	N/A

Fuel Tank has rusted connection points, the flex connector is mis-aligned and piping could leak. The piping system needs to be repaired.

1. Fuel tank and hose flex connector is out of alignment. The pipeline connection to the tank needs to be repaired. Further movement of the tank and pipeline connection can cause a spill. Fuel tank has rust/corrosion at the connection points and should be replaced. Recommend moving the pipeline so it draws from the top of the tank so as to prevent future spills. (see Figure 1)

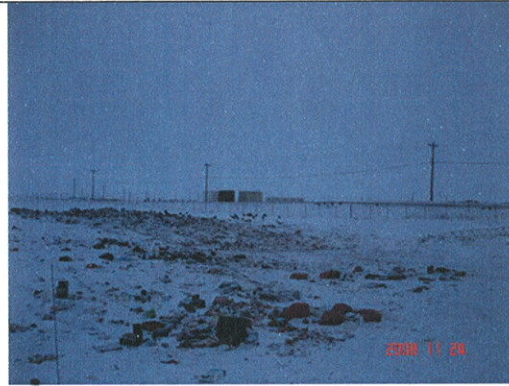
Figure 2

Additional cover material is needed to cover solid waste and this will assist with controlling windblown debris.

4. Very little cover material to cover solid waste. This is required to ensure proper maintenance of the SWDF. This would also assist with controlling windblown debris. (see Figure 2)
