**Indian and Northern
Affairs Canada**

RE: Municipal Water Licence (N7L3-0714)

Enclosure: Water Licence Inspection Report (3 pages)
Municipal Solid Wastes Suitable for Open Burning Document

DATE:	August 2, 2007	COMPANY REP:	Peter Nogosak
LICENCEE:	Incorporated Hamlet of Tuktoyaktuk	LICENCE #:	N7L3-0714

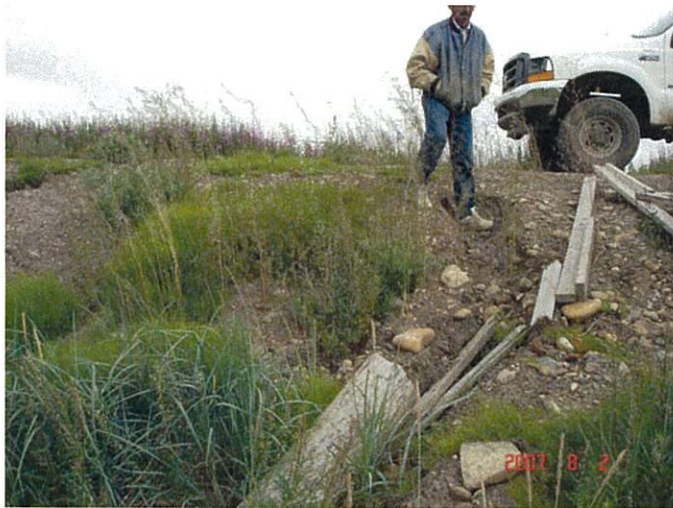
Inspection Images:
Figure 1

2. There was visible erosion on the southside of the Sewage Lagoon and will need to be dealt with before greater erosion and damage to the dyke occurs. (see figure 1)

Erosion present on dyke on the south side of the Sewage Lagoon.

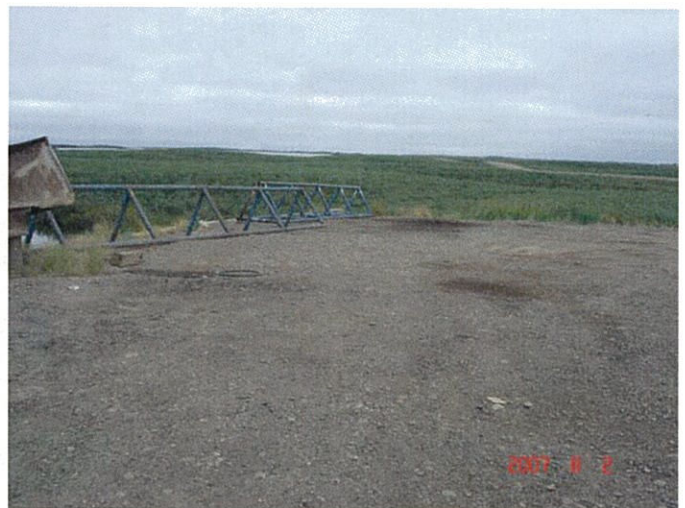
Figure 2

3. There was oil staining present at the sewage dump off in addition to the dyke surrounding the Sewage Lagoon. There is potential for this to contaminate water in the area. This contaminated soil needs to be removed and sent to a proper disposal facility. Leaks from vehicles need to be repaired to prevent further problems. (see figure 2)

Heavy staining present on Sewage Lagoon turnaround by offload chutes.

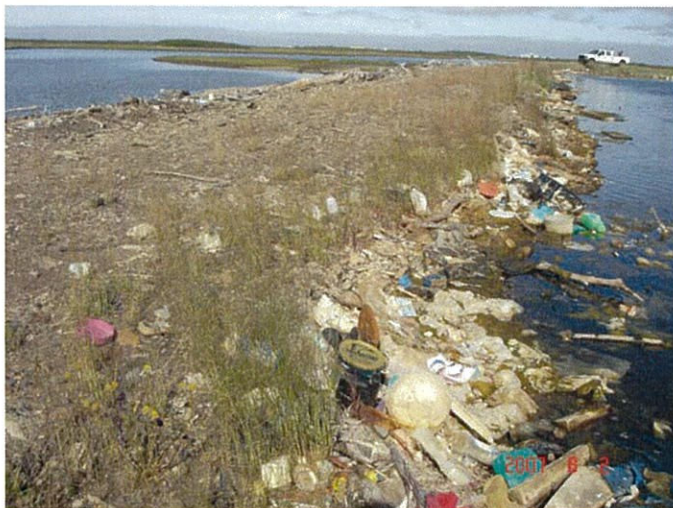
Figure 3

4. There is less than 0.5 metres of freeboard maintained at the Solid Waste Lagoon. The dyke needs to be built up to ensure there is a proper freeboard. A freeboard limit of 0.5 metres shall be maintained at all times at all dykes and earthfill structures.(see figure 3)

Less than 0.5 metres of freeboard maintained at the Solid Waste Lagoon.

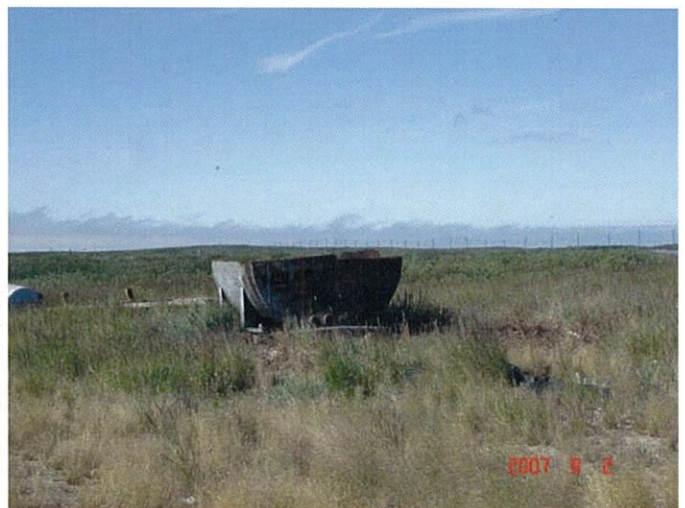
Figure 4

5. There was a burn bin located on the north side of the Solid Waste Disposal Facilities. Burning of non-segregated Municipal Solid Waste(MSW) remains an unacceptable option for the management of MSW. Municipal Solid Wastes that are conditionally suitable for open burning are paper products, paperboard packaging and untreated wood wastes according to the document from the GNWT Department of Environment and Natural Resources titled 'Municipal Solid Wastes Suitable for Open Burning' (Please see enclosed document). (see figure 4)

Burn bin located on the north side of the Solid Waste Disposal Facilities.
