**RE: Municipal Water Licence (N7L3-0714)**

An inspection was conducted of the Municipal Water Supply Facility, specifically the intake facility on March 19, 2010. Enclosed is a copy of the Water Licence Inspection Report.

WATER LICENCE INSPECTION FORM

DATE:	March 19, 2010	COMPANY REP:	Debbie Raddi
LICENCEE:	Incorporated Hamlet of Tuktoyaktuk	LICENCE #:	N7L3-0714

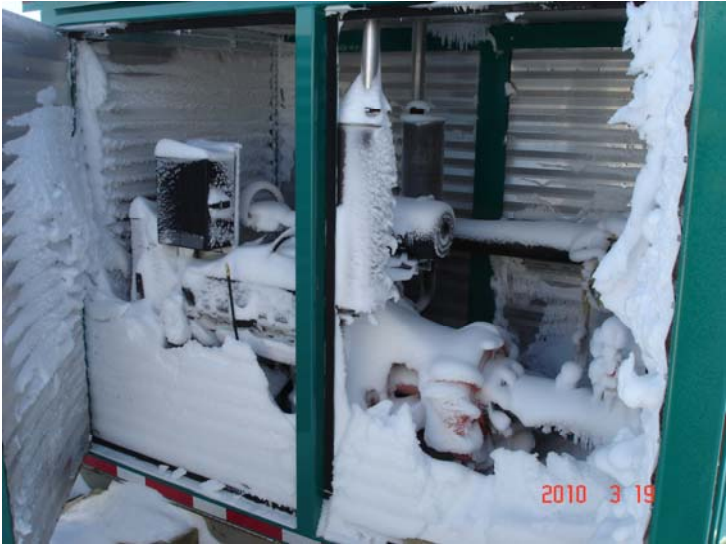
Figure 1

1. Snow was blown in amongst the motor/pump enclosure at the intake facility (see Figure 1). To protect equipment and prevent future maintenance issues a protective cover or equivalent would be recommended for the enclosure.

Snow in equipment enclosure at intake facility.

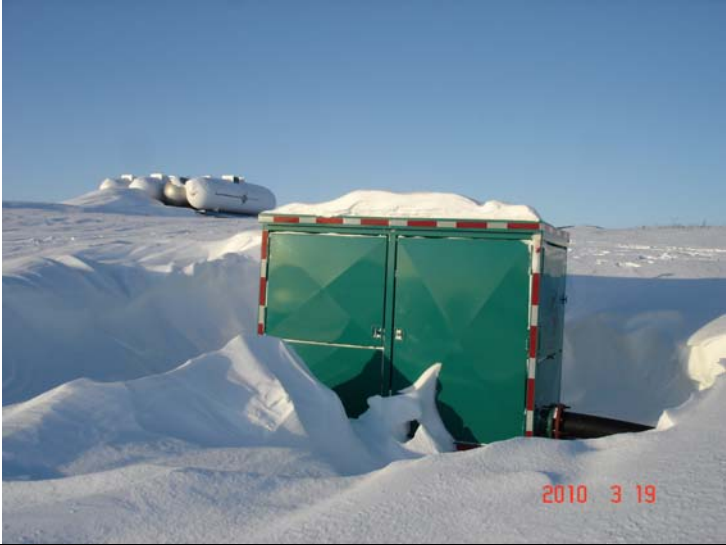
Figure 2

Intake facility and propane tanks at Kudlak Lake.

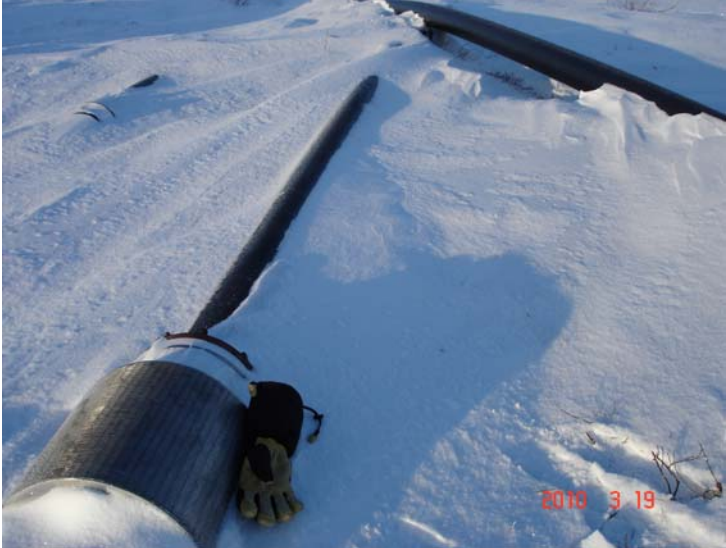
Figure 3

Fishscreen and piping at intake facility.
