MUNICIPAL WATER USE INSPECTION FORM

DATE:	October 2, 2003	COMPANY REP:	Paul Nogasak (foreman)
LICENSEE:	Hamlet of Tuktoyaktuk	LICENCE #:	N7L3-0714

List of Figures for Municipal Water Licence Inspection Report

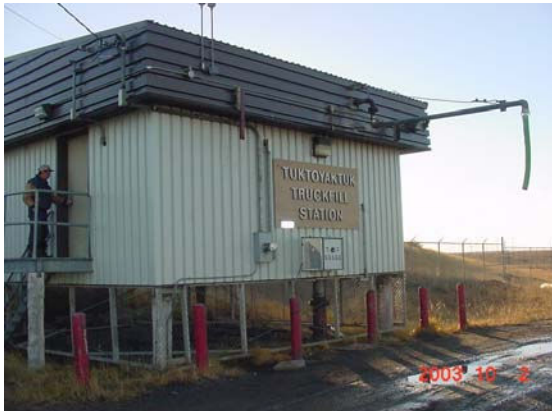
Figure 1. Water Supply. Water treatment plant and transfer station

- Treatment Facility (Tuk. Truckfill Station) (figure 1) diesel fuel storage container (figure 2) has no double containment and has corroded transfer line (figure 3). In addition the transfer line is not protected. Careful inspection of the line and use of a double contained container should be considered. There is potential for a fuel spill. If fuel spill does occur fuel will travel south east and enter a pond approximately 25 m away. Currently this pond does not serve any particular use.
- Old 200 L drum (figure 2) should be removed and disposed of at an appropriate area.

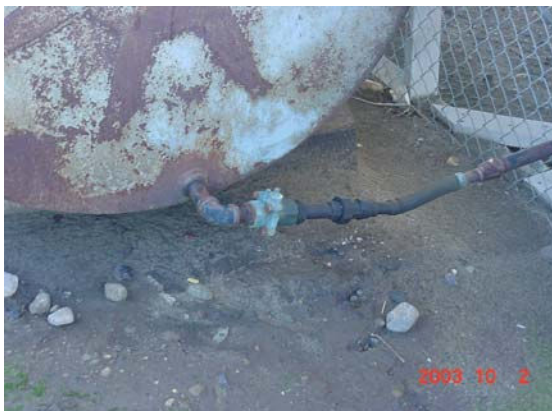
Figure 3. Water Supply. Fuel storage at water treatment plant. Corroded/exposed pipe.

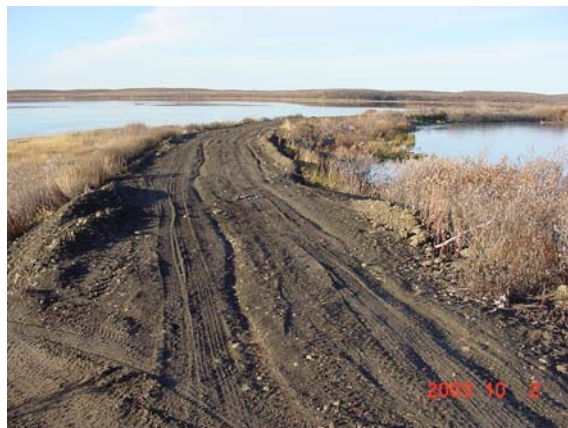
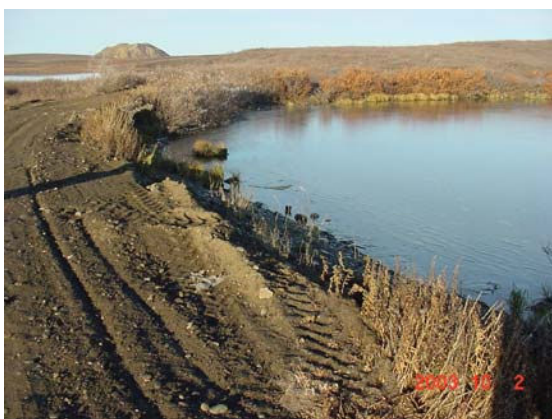
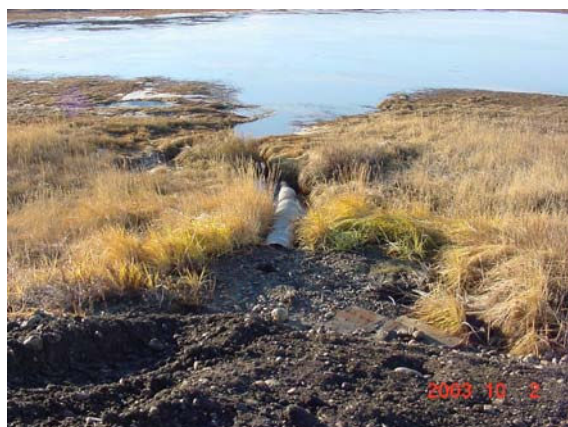
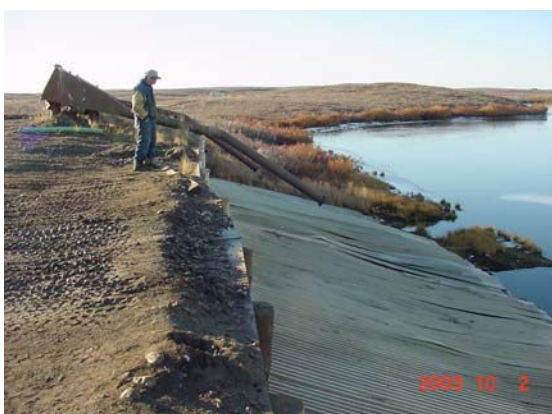
- Discharge of the Sewage Lagoon (figures 4-7) was requested on August 26, 2003. Approval of the discharge was rejected due to high pH levels that could potentially harm aquatic ecosystems (above pH 9). As per our letter dated October 22, 2003 fall emergency decant was authorized to maintain structural integrity of the containment berm (Figure 4,5) and thus Sewage Lagoon. All other parameters were sampled on time and met license effluent quality standards. After review of previous year’s analytical results this trend was not seen. In the future, industrial discharges to this lagoon will be discouraged until the Hamlet can meet their License Discharge criteria. As a note the Hamlet was diligent and made every effort, through sampling and delaying discharge, to meet discharge criteria.

- Work was done to sewage lagoon containment berm this year (July). In general fill material was placed on berm to fix erosion that had occurred in previous years. Berm is now in good condition.

- Sewage Lagoon was a nice green color at the time. There was ~0.75” of ice on the surface.
- No signs posed indicating sewage lagoon and SNP station 0714-2.

Figure 4. Waste Disposal. Sewage lagoon (south west end) at containment berm.

Figure 5. Waste Disposal. Sewage lagoon (south west end) at containment berm.

Figure 6. Waste Disposal. Sewage lagoon (south west end) discharge location.

Figure 7. Waste Disposal. Sewage lagoon intake structure.

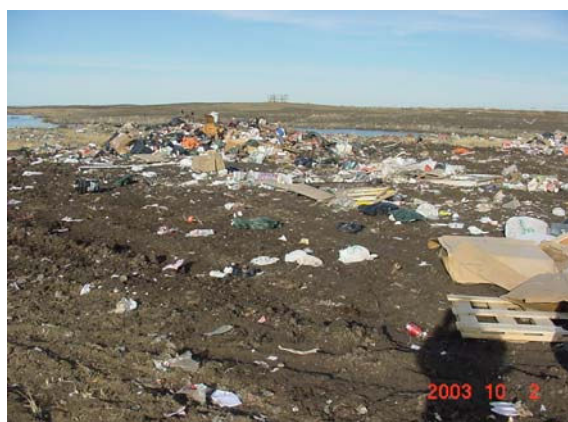
Figure 8. Waste Disposal. Landfill domestic garbage disposal area.

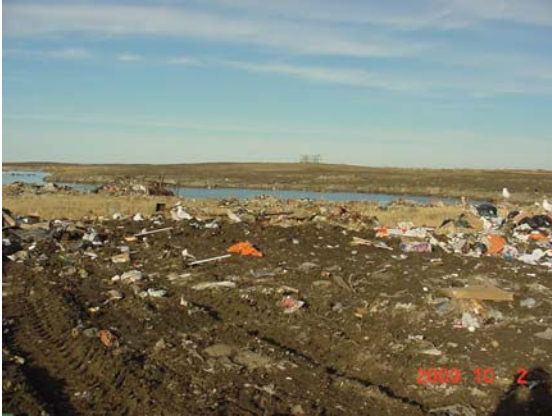
Figure 9. Waste Disposal. Landfill general north view.

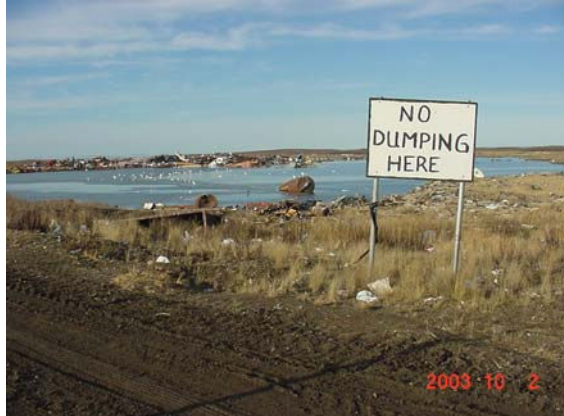
Figure 10. Waste Disposal. Landfill north view with metal waste (bulk) storage area in distance.

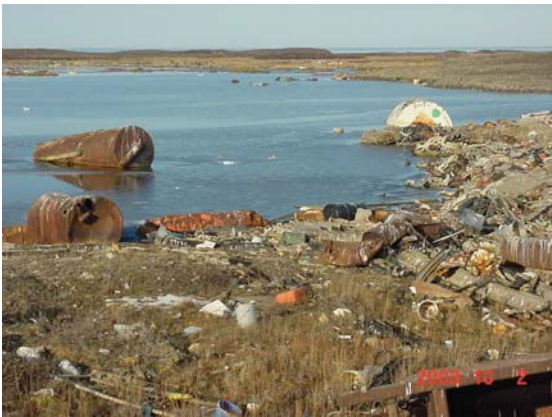
Figure 11. Waste Disposal. Landfill north view.

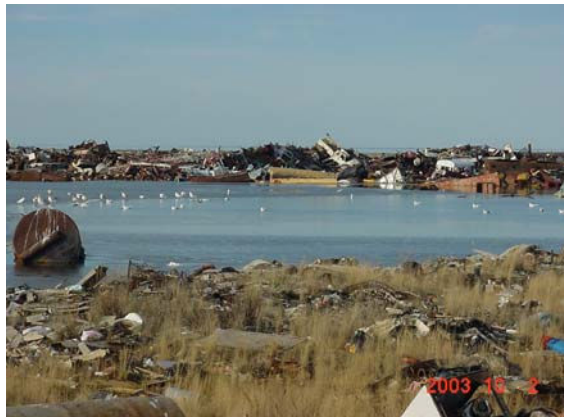
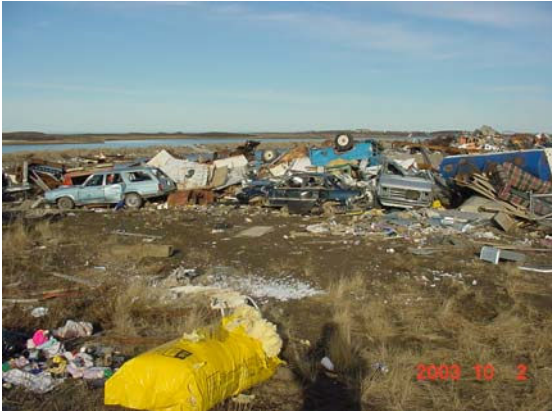
- Currently there is no disposal area for old lead acid batteries. This issue should be addressed.
- Oil and fluids in old vehicles disposed of at the metal waste storage area (figure 12, 13) are not drained and removed. It is a matter of time before this material escapes causing contamination of ground and/or surface water.

Figure 12. Waste Disposal. Landfill north west view with metal waste storage area in background.

Figure 13. Waste Disposal. Landfill east view with metal wastes storage area in background.

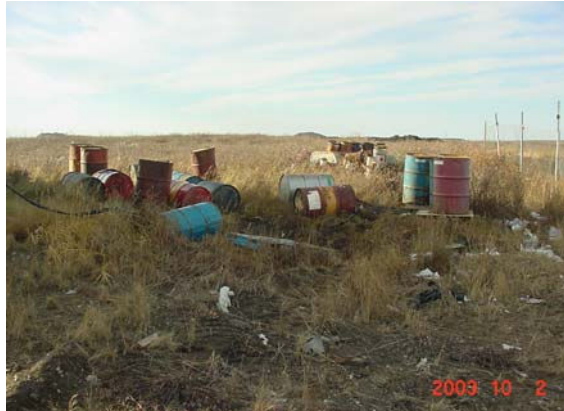
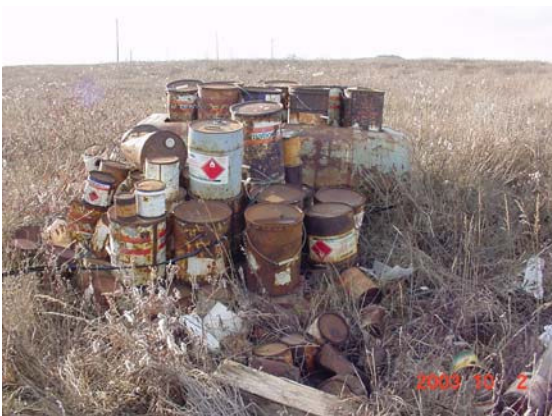
- Fence around the SWDS needs repair. There are various areas that show damage.
- Like many communities the waste oil and hazardous materials area (Figure 14, 15) are becoming permanent storage areas. It is recommended that every effort be made to dispose of these materials at a certified disposal facility. Long term/permanent storage of this material is not recommended. It is only a matter of time before spills occur and this becomes a liability. It is understood that there is a plan to dispose of this material at Grubens. However, there is no timeline. Plans should be made to address this issue and should be addressed in the O&M Plan.

- Hazardous waste storage area (figure 14, 15) needs to be designed appropriately.

Figure 14. Waste Disposal. Landfill waste oil and hazardous wastes area.

Figure 15. Waste Disposal. Landfill waste oil and hazardous wastes area.

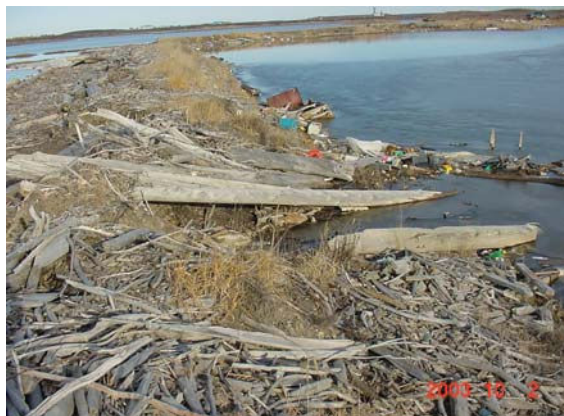
8. Solid waste Disposal Site (SWDS) North West containment berm (figure 16) needs repair. This is an area of potential failure. As indicated during the inspection there are plans to fix the berm at this location.
9. O&M plan was submitted in September 2001. Upon consultation with the board this plan has not been accepted because of outstanding information required by the Hamlet.

Figure 16. Waste Disposal. Landfill north west containment berm.
