RE: Municipal Water Licence (N7L3-0714)

WATER LICENCE INSPECTION FORM

DATE:	September 3, 2010	COMPANY REP:	Bill Buckle
LICENCEE:	Incorporated Hamlet of Tuktoyaktuk	LICENCE #:	N7L3-0714

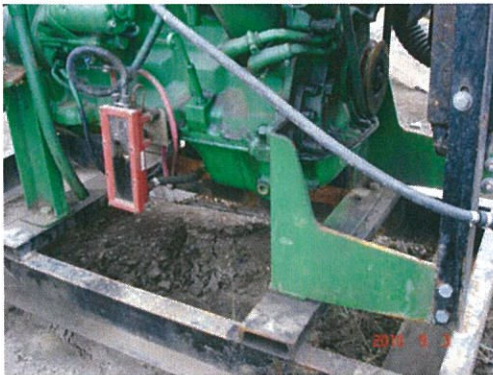
Figure 1

4. Fuel and oil leaks were present on and by the pump for the sewage decant and need to be prevented/cleaned up (see Figure 1). Ensure a spill kit and drip pads are present for the operation of the pump (and its associated fuel tank) used for the sewage lagoon and Solid Waste Disposal Facility (SWDF) lagoon decants. Drips and spills are possible sources of contamination to nearby water bodies and need to be prevented.

Fuel and oil leaks were present on and by the pump for the sewage decant and need to be prevented/cleaned up.

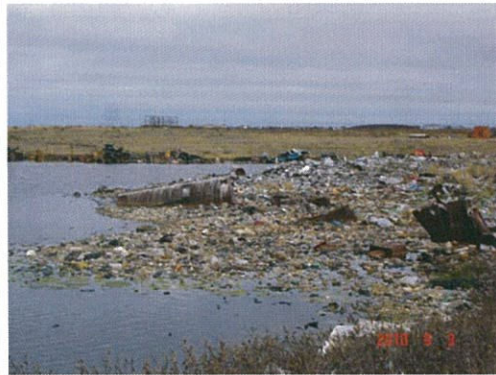
Figure 2

7. There was a large amount of waste all over the SWDF lagoon that needs to be cleaned up and properly segregated as well. There was a lot of garbage present in the water, containers floating including used oil containers which need to be removed and properly disposed of (see Figure 2). In one instance there was an ATV and a Caterpillar excavator piece of equipment located in the lagoon for the SWDF (see Figure 3). This kind of material and garbage amongst the water is unacceptable and needs to be removed.

There was a lot of garbage present in the water, containers floating including used oil containers which need to be removed and properly disposed of.

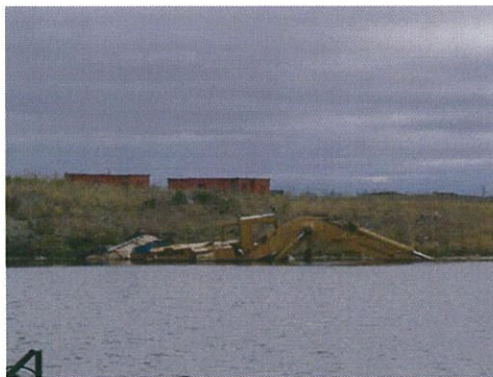
Figure 3

A Caterpillar excavator piece of equipment located in the lagoon for the SWDF. This kind of material and garbage in amongst the water is unacceptable and needs to be removed.

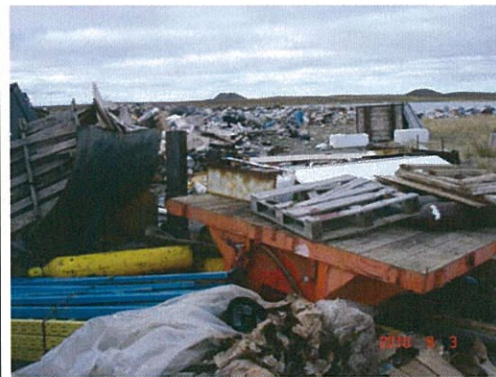
Figure 4

9. Propane and welding tanks present which present a hazard and need to be disposed of properly (see Figure 4).
10. There are presently no tire stop blocks installed at the sewage discharge chutes to prevent trucks from hitting the chutes, backing up too far, or just ensuring consistent discharge of sewage. This is highly recommended as it will protect infrastructure and allow for a clean discharge area.

Propane and welding tanks present which present a hazard and need to be disposed of properly.
