Hamlet of Tuktoyaktuk

Tuktoyaktuk Landfill

Condition Assessment Report – Fall 2004

Prepared 2005 07 29

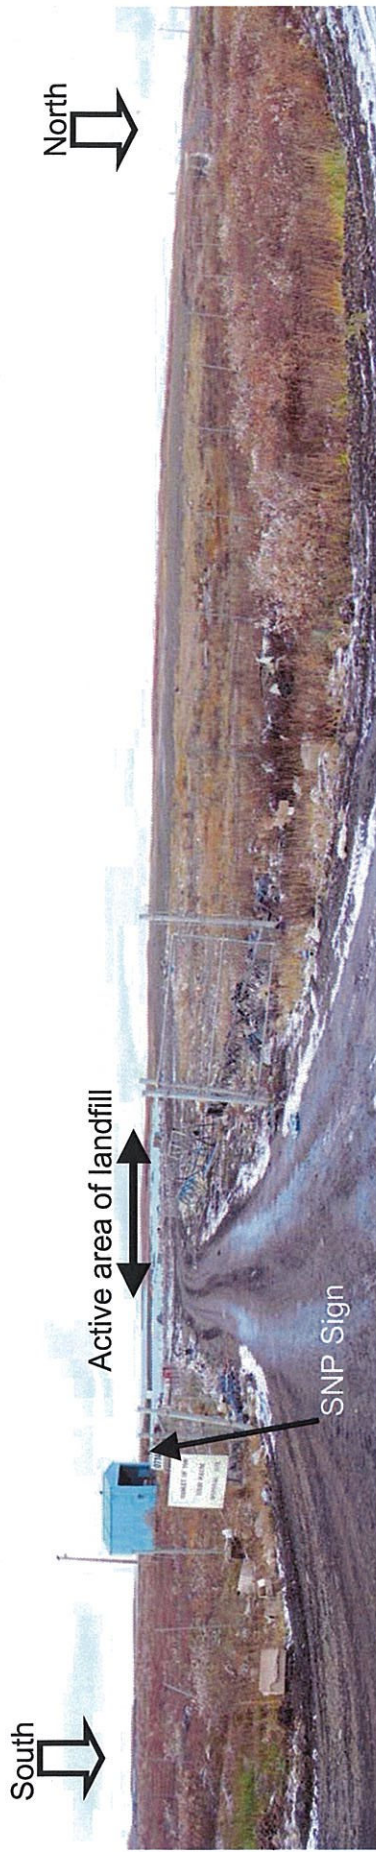
Entrance to Municipal Solid Waste (MSW) Area

The landfill site is accessed from one entrance along the adjacent road at the southeast corner; the road provides access to the MSW area (See Figure 3, Landfill Site September 15, 2004)). This access does not have a gate to limit community access at any time. The access road is in reasonably good condition.

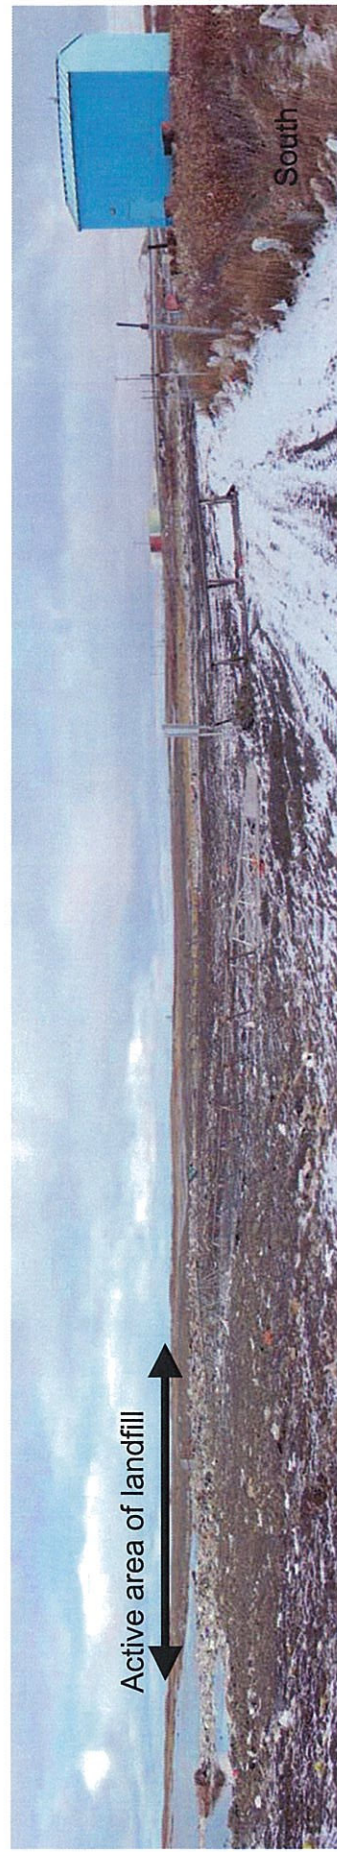
Active Municipal Solid Waste (MSW) Area

The waste disposal area of the landfill site is organized into the MSW area to the southeast (See Figure 3, Landfill Site September 15, 2004). The MSW area occupies an area approximately 70 metres wide and 30 metres deep; the active area of the MSW area is the entire 70 metre width. The area is managed without burning, and with limited compaction, and limited cover. The MSW area has no organized areas for household hazardous waste storage, although some hazardous is stored adjacent to the site.

The MSW area could be better managed with regard to dumping control, and the operating area. The landfill area has very limited signage to define the operating areas and operating limitations. MSW is deposited out into the on-site drainage retention pond, which is not an ideal practice; normally waste would be deposited into "cells" in the active landfill area.

The landfill area is influenced most significantly by the lack of organization, and management of the MSW area. This area requires organization for MSW disposal, and household hazardous waste storage. The MSW area requires management (signs and barricades) to limit the MSW disposal area into a more manageable (smaller) area. Discrete cells should be constructed in the MSW area to better manage the waste disposal and limit the deposition of waste into the on-site drainage retention pond.

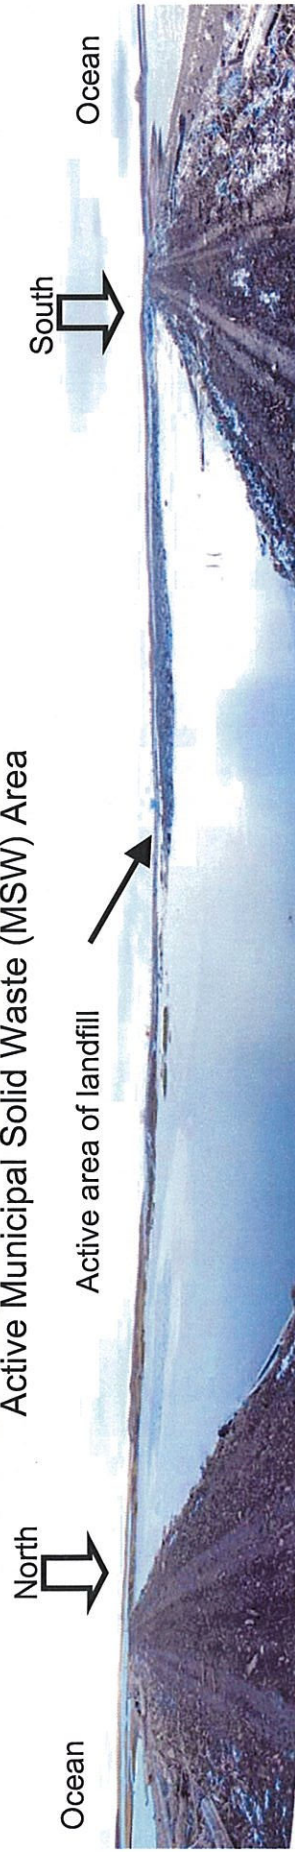
Perimeter berm

The landfill area employs a perimeter berm approximately 250 metres in length to manage or control on-site drainage (See Figure 3, Landfill Site September 15, 2004). The berm was reconstructed in 2004 to repair the ongoing erosion from wave action. The berm does not have any discharge control structure, therefore the drainage accumulates from the site. The perimeter berm also prevents ingress of the ocean, which in the past has caused debris to float away with the tides.
