**RE: PROGRESS ON INFORMATION CONCERNING WATER LICENCE RENEWAL  
FOR THE HAMLET OF TUKTOYAKTUK (N7L3-0714:**

# ***Hamlet of Tuktoyaktuk Water Licence Renewal Background Report***

*Project No. 69130*

**Figure 1. Facility Locations**

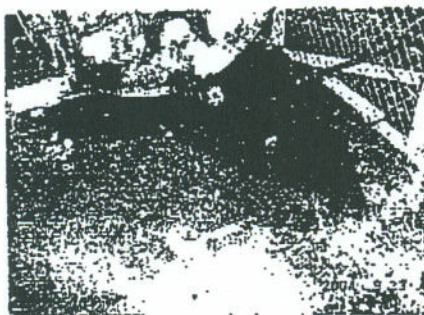
- Small fuel spill at water treatment plant (figure 1). Fuel tank and distribution/conveyance lines badly corroded (figure 1,2). This was addressed in the 2003 Inspection Report.
- Fuel spill 04-Pumping Station at Kudlak Lake pumping station (Figure 3). Clean up efforts are currently in progress (figure 4).

Figure 1. Water Supply. Fuel storage at water treatment plant.

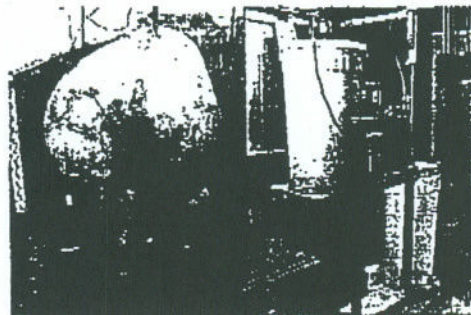
Figure 2. Water Supply. Fuel storage at water treatment plant and chlorination system.

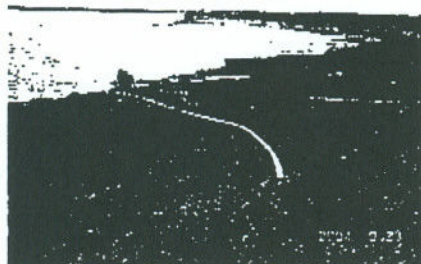
Figure 3. Water Supply. Water intake pumping station at Kudlak Lake

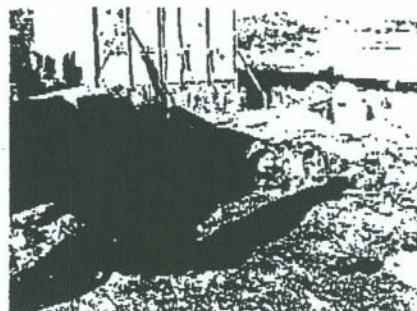
Figure 4. Water Supply. Sea Can Fuel Storage Container at Figure 3 and spill 04-572 clean up efforts.

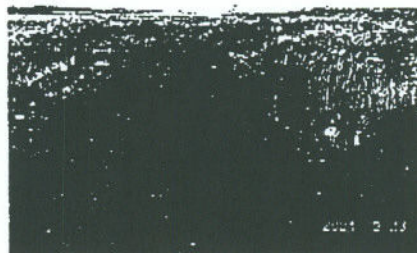
- Lagoon green color indicating aerobic conditions (figure 8).
- No leaks found at sewage Lagoon and SWDF containment berm (figure 6, 7 and 14, 15 respectively).
- In general considerable work has been done at the SWDF including the old bulk metal waste storage area. This material was crushed and buried. The hamlet is looking for a new bulk metals waste disposal area.
- Currently understood that the landfill does not accept hazardous wastes (used oil, batteries, etc). Currently used oil is disposed of at Grubens and is incinerated. Public does not drop off used oil at this facility.

Figure 6. Waste Disposal. Sewage Lagoon (south west end) containment berm.

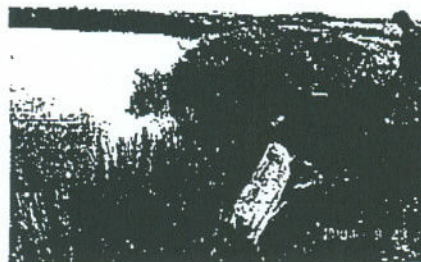
Figure 7. Waste Disposal. Proper location for SNP 0714-2 sign.

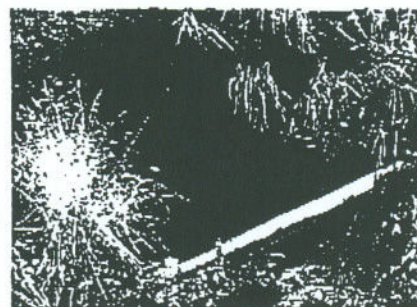
Figure 8. Waste Disposal. Sewage Lagoon SNP 0714-2 sampling area.

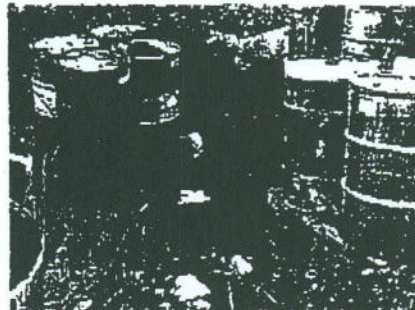
- As indicated last year the SWDF waste oil and hazardous materials area (Figure 12, 13) are becoming permanent storage areas. It is recommended that every effort be made to dispose of these materials at a certified disposal facility. Long term/permanent storage of this material is not recommended. It is only a matter of time before spills occur. It is understood that there is a plan to dispose of this material (waste oil) at Grubens.

Figure 12. Waste Disposal. SWDF waste oil and hazardous wastes area.

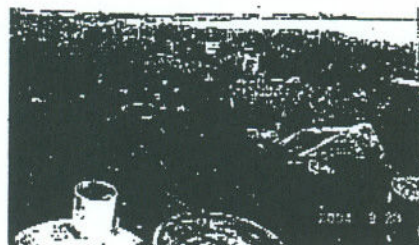
Figure 13. Waste Disposal. SWDF waste oil and hazardous wastes disposal area.

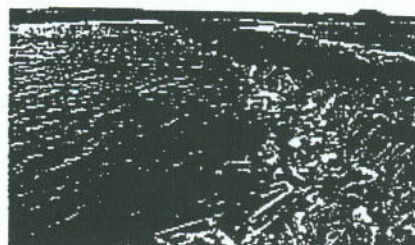
Figure 14. Waste Disposal. SWDF north west containment berm.

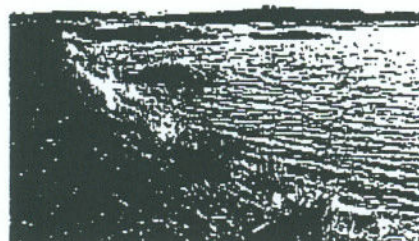
Figure 15. Waste Disposal. SWDF north west containment berm and proper location for SNP 0714-3 sign.

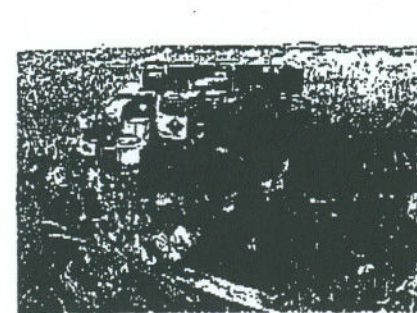
5. Fence around the SWDS needs repair. There are various areas that show damage.
6. Like many communities the waste oil and hazardous materials area (Figure 14, 15) are becoming permanent storage areas. It is recommended that every effort be made to dispose of these materials at a certified disposal facility. Long term/permanent storage of this material is not recommended. It is only a matter of time before spills occur and this becomes a liability. It is understood that there is a plan to dispose of this material at Grubens. However, there is no timeline. Plans should be made to address this issue and should be addressed in the O&M Plan.

7. Hazardous waste storage area (figure 14, 15) needs to be designed appropriately.

Figure 15. Waste Disposal. Landfill waste oil and hazardous wastes area.

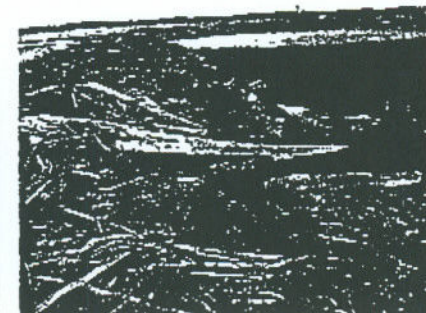
8. Solid waste Disposal Site (SWDS) North West containment berm (figure 16) needs repair. This is an area of potential failure. As indicated during the inspection there are plans to fix the berm at this location.
9. O&M plan was submitted in September 2001. Upon consultation with the board this plan has not been accepted because of outstanding information required by the Hamlet.

Figure 16. Waste Disposal. Landfill north west containment berm.

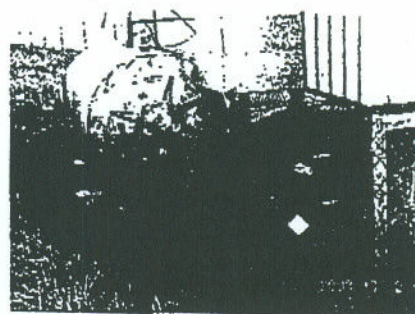
1. Treatment Facility (Tuk. Truckfill Station) (figure 1) diesel fuel storage container (figure 2) has no double containment and has corroded transfer line (figure 3). In addition the transfer line is not protected. Careful inspection of the line and use of a double contained container should be considered. There is potential for a fuel spill. If fuel spill does occur fuel will travel south east and enter a pond approximately 25 m away. Currently this pond does not serve any particular use.
2. Old 200 L drum (figure 2) should be removed and disposed of at an appropriate area.

**Figure 2. Water Supply. Fuel storage at water treatment plant.**

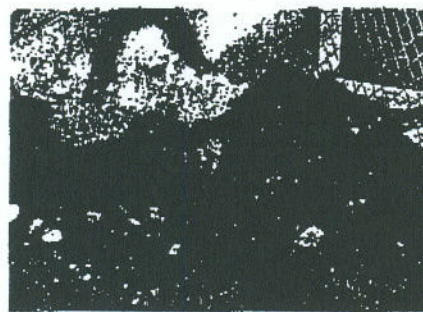
**Figure 3. Water Supply. Fuel storage at water treatment plant. Corroded/exposed pipe.**
