Hamlet of Tuktoyaktuk

Background Report for Water Licence Renewal

111351-03 (60118825)

November 2009

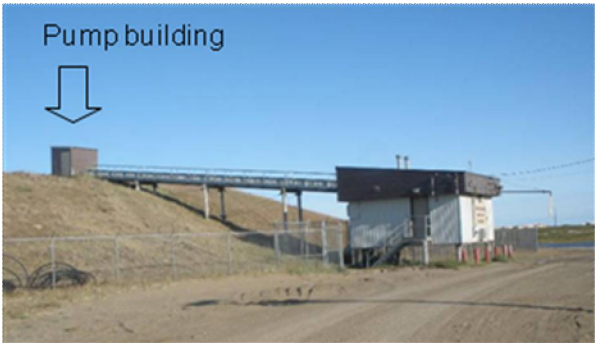
Water reservoir

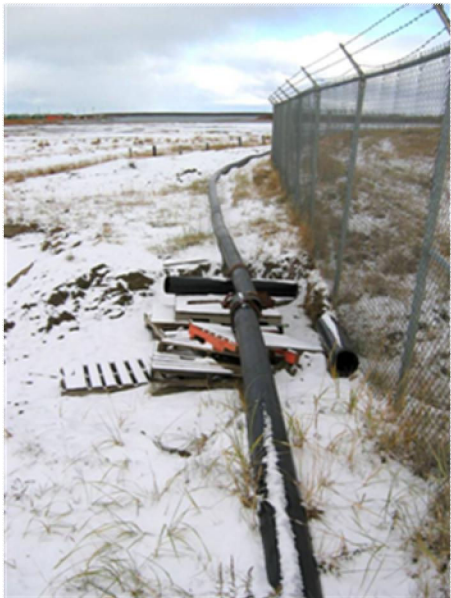
Truckfill Inlet Piping and Pumphouse
(without new building)

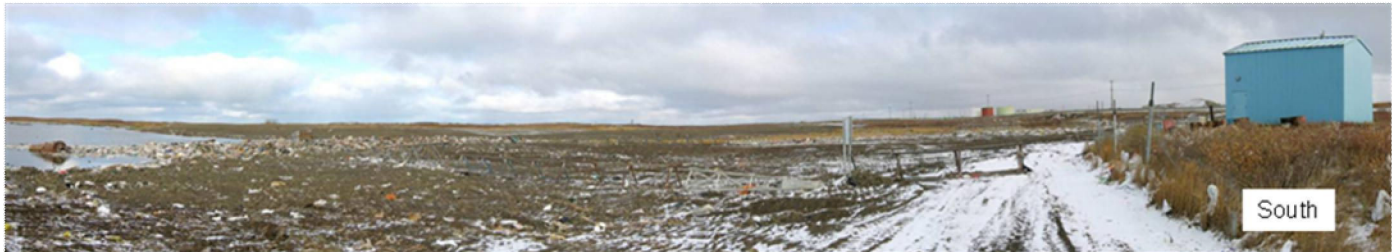
View 1: Entrance to Municipal Solid Waste (MSW) Area

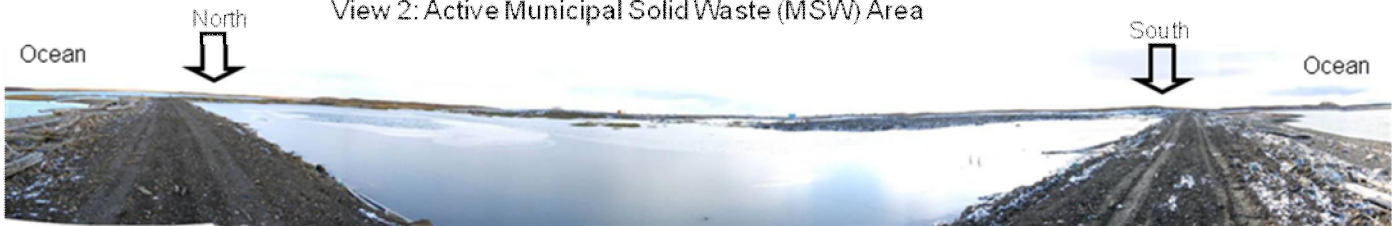
View 2: Active Municipal Solid Waste (MSW) Area

The municipal waste area occupies an area approximately 70 m wide and 50 m long. The landfill is operated with limited compaction and limited cover.

It has been suggested in the studies that the landfill site needs management improvements. The most significant of these improvements is that the municipal waste area requires management (signs and barricades) to limit the waste disposal area into a more manageable (smaller) area.

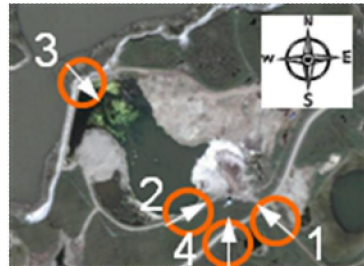
View 3: Perimeter berm

Most of the surface area of the Solid Waste Disposal facility is covered by a lagoon containing surface runoff from the landfill. The surface runoff lagoon is retained by a 250 m long gravel and clay berm on the eastern edge of the landfill site.

The berm does not have any discharge control structure, so drainage continually accumulates. The perimeter berm also prevents the ingress of the ocean.

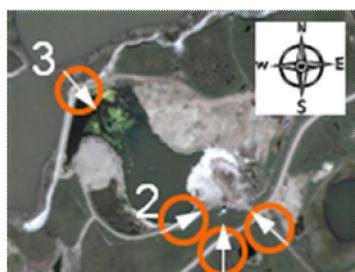
View 4: Active Municipal Solid Waste (MSW) Area in 2009
