# Hamlet of Tuktoyaktuk

# **Tuktoyaktuk Sewage Lagoon**

## **Condition Assessment Report – Fall 2004**

Prepared 2005 07 19

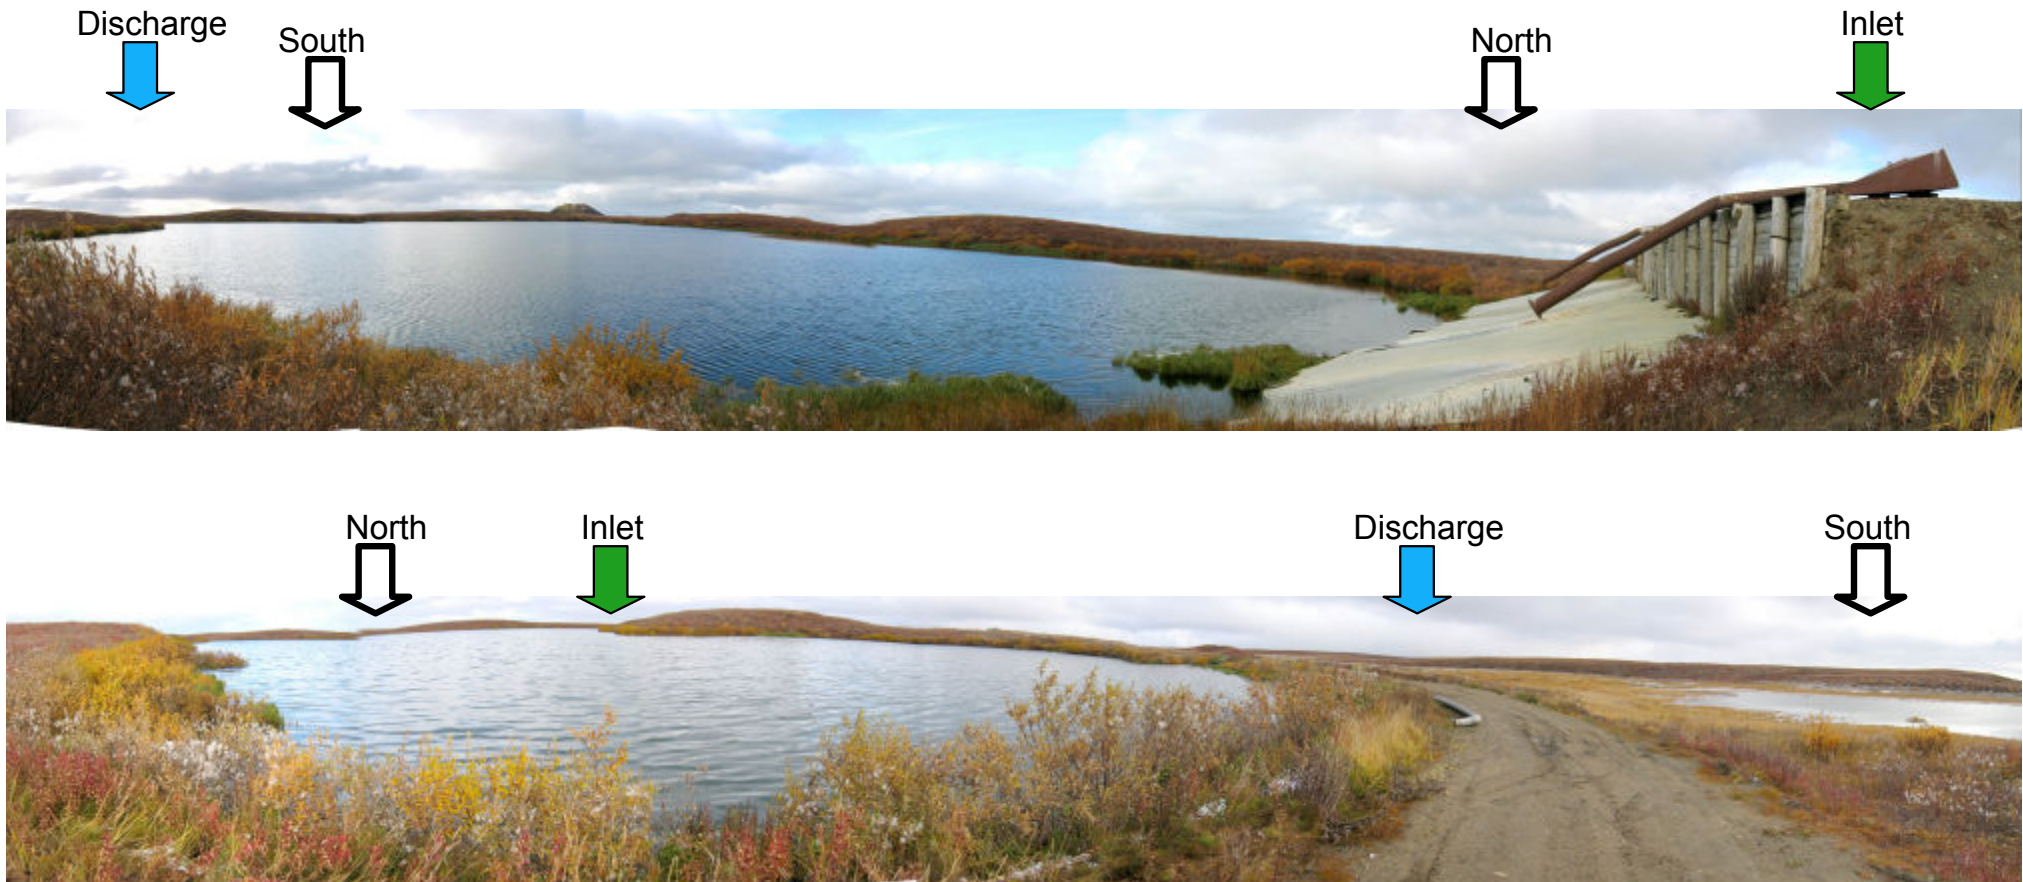
The truck discharge area into the lagoon consists of a 30 metre by 40 metre gravel area (approximate size) with two gravel ramps backing to a welded steel chute and pipe system for the vacuum trucks to discharge into (See Figure 3. Facility Photos – September 15, 2005 (Upper Photo)).

The steel chute is welded to steel piles, and the pipe system is welded to the chute, and resting on the timber retaining wall adjacent to the chute. The chute and pipe system appear to be in reasonably good condition.

The trucks discharge by elevating the vacuum tank at the front end of the truck and opening a valve at the back of the truck. The truck discharge area appears to be in reasonably good condition with sufficient operating area for the vehicles.

The sewage lagoon seasonal discharge point is located at a constructed berm area at the south edge of the lagoon (See Figure 3. Facility Photos – September 15, 2005 (Lower Photo)). The berm provides the retaining structure to maintain the water level in the lagoon. The lagoon is discharged into the adjacent ocean inlet in the fall of each year using a temporary pumping system set up on top of the berm (See Figure 4. Lagoon Discharge – October 2004).

The granular berm is well vegetated on the inside and outside faces of the lagoon, however there is some erosion on the outside face of the berm. This erosion appears to be the result of the seasonal discharge of the lagoon.

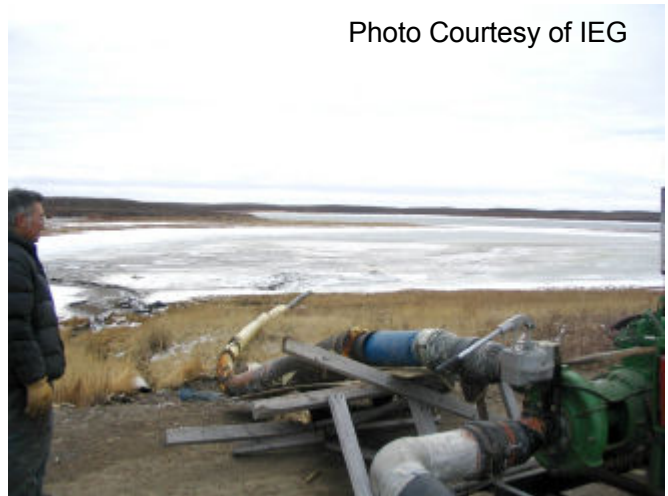
Outlet of pumped  
lagoon seasonal  
discharge into ocean.

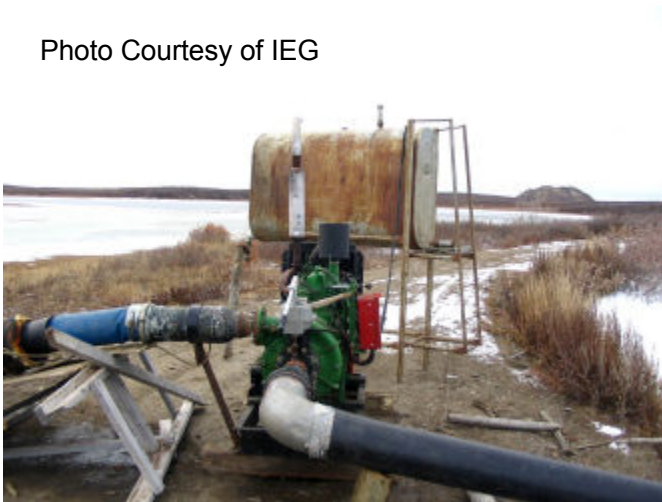
Pumping system for  
seasonal discharge into  
ocean.

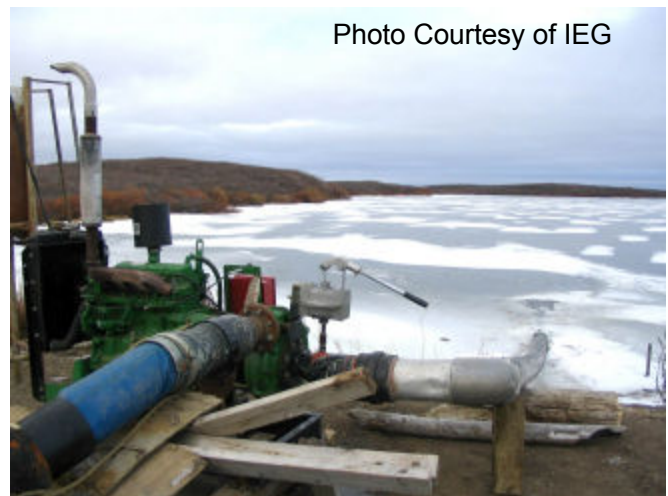
**Figure 4. Lagoon Discharge - October 2004**

Inlet of pumped  
lagoon seasonal  
discharge into ocean.
