**RE: Municipal Water Licence (N7L3-1531)**

WATER LICENCE INSPECTION FORM

DATE:	September 21, 2010	COMPANY REP:	Jackie Coulter
LICENCEE:	Hamlet of Sachs Harbour	LICENCE #:	N7L3-1531

WATER LICENCE INSPECTION REPORT Pg. 4

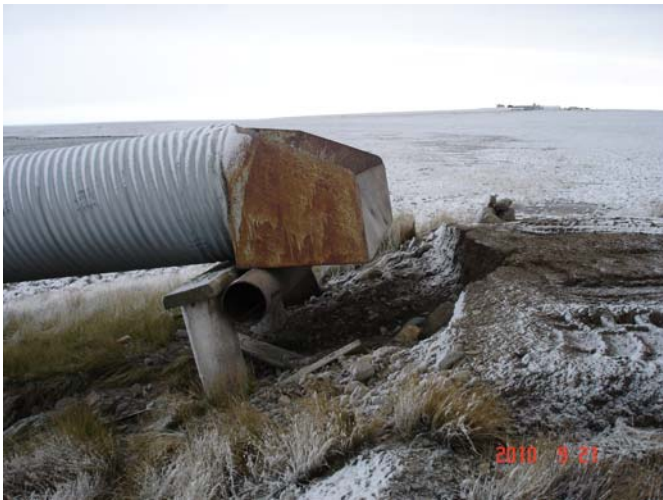
Figure 1

4. Erosion is occurring at the sewage discharge chute. New material had been added but erosion is evident. The distance from the truck to the start of the chute needs to be properly measured out and the truck tire stop/barricade installed/maintained (see Figure 1). This would prevent further erosion of material into the sewage lagoon which

Erosion is occurring at the sewage discharge chute. The distance from the truck to the start of the chute needs to be properly measured out and the truck tire stop/barricade installed/maintained. This would help prevent costs for the Hamlet to repair it and material to replace it

decreases efficiency and costs the Hamlet to repair it and material to replace it. Continued maintenance is needed to prevent further erosion and subsequent damage to the sewage discharge chute.

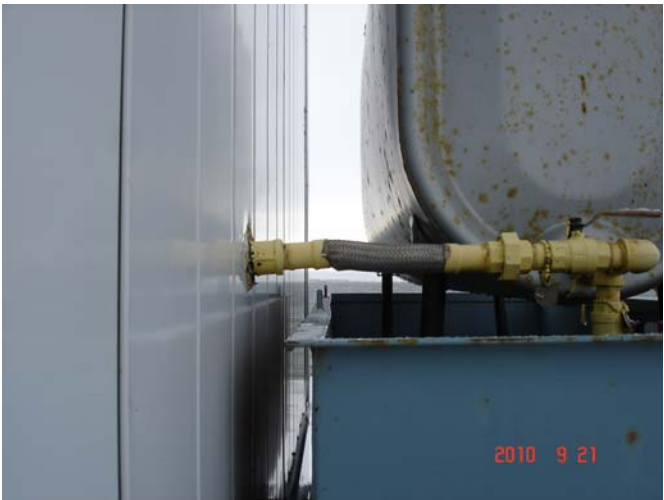
Figure 2

- Comments:
- Concerns:
1. Water Supply Facility (WSF) flex pipe for pipeline to the fuel tank is not entirely in the bermed area and needs to be routinely monitored (see Figure 2). This is a concern since if there is any failure; fuel might not go into the berm during a spill.
  2. Inside the generator room there is fuel present with spill pads in the drip tray under pipe coming from the fuel tank and this was present during previous inspections. There was also a strange wax or similar build up on the fuel pipeline elbow in the generator room before going into the Water Treatment room.

Flex pipe for pipeline to the fuel tank is not entirely in the bermed area and is a potential source of contamination. A spill might not end up in the bermed area. It is important to routinely monitor the piping.

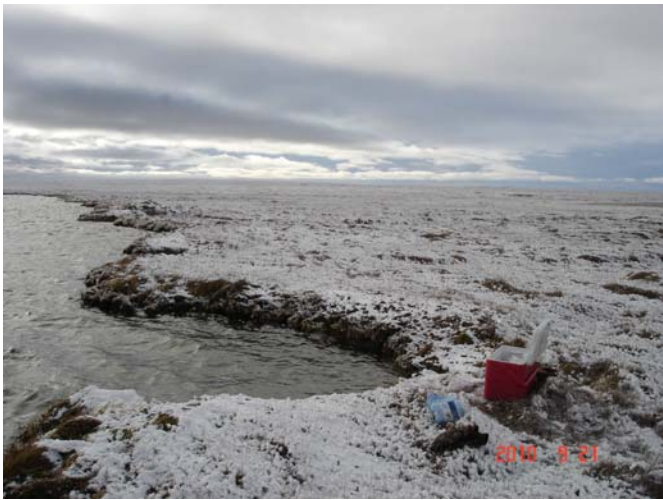
Figure 3

1. Sewage is deposited in the sewage lagoon at a rate estimated to be 7000L about 2-3 times a day, 3 times a week. The Sewage Disposal Facility (SDF) is a natural water body and is the lowest elevation in the immediate area and does not immediately appear to discharge. However there are indications from staff that it might discharge when there is excess water during the spring or exfiltration is possible through the active layer/ground water surrounding the sewage lagoon. The opposite side of the SDF from the sewage discharge chute would be where any discharge would occur as this is a low lying wetland area.

Samples were taken during inspection at SNP 1531-2 located on the other side of the sewage lagoon. The area does not appear to discharge unless high water as this seems to be the lowest elevation in the immediate area.

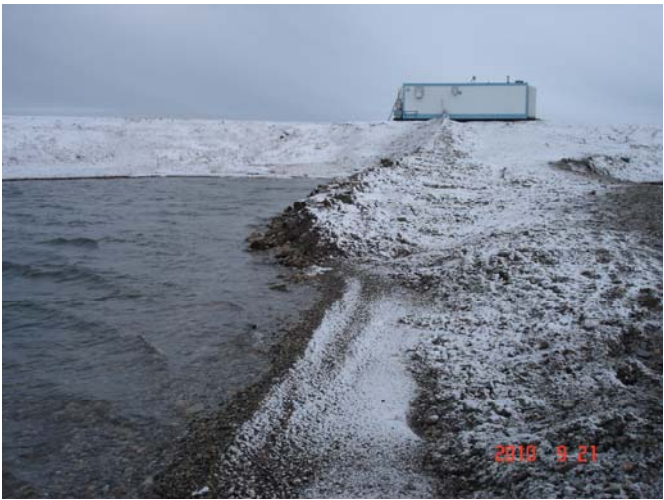
Figure 4

Samples Collected		Hamlet	No samples had been taken at the time of inspection. <sup>1</sup>	
		DIAND	Yes, samples were taken during inspection at SNP 1531-2 (see Figure 3) and in the corner of Water Lake on the southside of the intake line, below the WSF and the drainage from the hill/access road (see Figure 4).	
Signs Posted:	SNP	N/A – map or drawing has not been submitted.		Warning
		Signage needed for Sewage Disposal Facilities, Water Supply Facilities and the Solid Waste Disposal Facilities. <sup>3</sup>		
Record & Reporting		Water consumption records have been provided for 2004-2008, but not as Annual Reports. Annual report for 2009 has not been sent in.		
Geotechnical Inspection		N/A

Other sampling area located in the corner of Water Lake on the southside of the intake line, below the WSF and the drainage from the hill/access road.
