**RE: Municipal Water Licence N7L3-1531
CLASS B - MUNICIPAL**

MUNICIPAL WATER LICENCE INSPECTION FORM

LICENCE #:	N7L3-1531	EXPIRY DATE:	November 20, 2012
LICENCEE:	Hamlet of Sachs Harbour	PREVIOUS INSPECTION:	September 21, 2010
COMPANY REP:	Adella Carpenter	INSPECTION DATE:	September 6, 2011

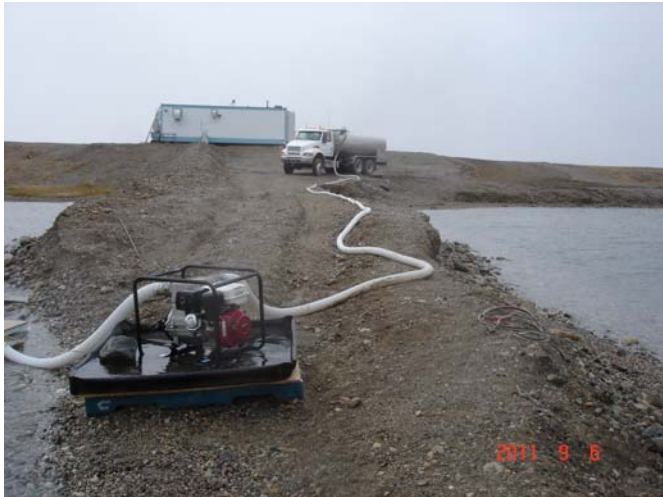
- During the inspection it was noticed that the drip tray was full of water (see Figure 1). There were no indications of contamination so the water was emptied and the pump repositioned so any future water leaks would occur outside the drip tray. The hoses should be well connected and ensure there are no leaks from all fittings (if any spraying water it should be repaired). Please note that any leaks of water going into the drip tray remove containment volume and is a source of contamination. Pumping operations should be as dry as possible when in close proximity to the water. To be proactive the water pump should be filled away from the waters edge. Any spills or leaks will more than likely go right into the Water Supply.

Figure 1
The Hamlet is drawing water directly by pumps and the water truck from Water Lake then batch chlorinating. Please note that given that the water pump is in close proximity to the water it is critical to avoid any spillage of fuel/oil or potential leaks from the pump. During the inspection the drip tray was full of water so ensure the pump/hoses are water tight.

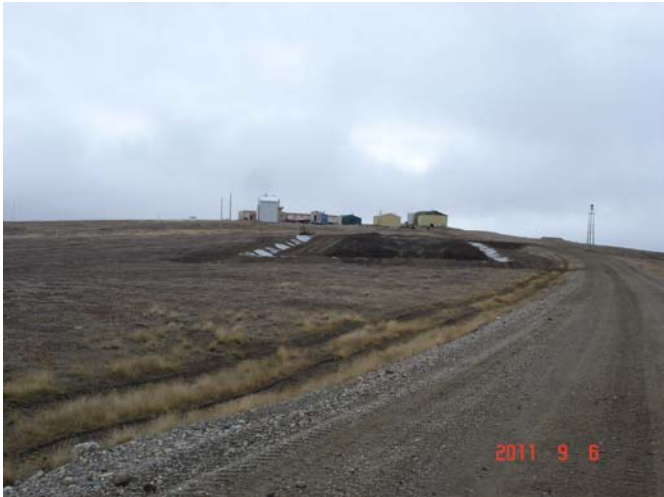
5. While the current GNWT- Public Works remediation project in the community is good for the area in that it is removing hydrocarbon contaminated soil from the old POL tank farm spill on the beach in front of the Hamlet there are still considerable risks involved that need to be monitored to ensure the protection of the water supply. The landfarm – containment cell is located just north of the old Environment Canada Meteorological Station (aka Icicle Inn) along the gravel road bordering Water Lake and it will be important to monitor for blowing soil /dusting and any other sources of contamination (see Figure 2). Spilled material by any trucks or equipment should be cleaned up and any future grading needs to be to the side of the road opposite the drainage for the water supply. It is important to monitor the containment cell throughout the winter and ensure the exposed soil is secure against any erosion.

Figure 2
POL tank farm spill remediation project has a landfarm that needs to be monitored to protect the water supply nearby. It is located just north of the old Environment Canada Meteorological Station (aka Icicle Inn) along the gravel road bordering Water Lake and it will be important to monitor for blowing soil /dusting and any other sources of contamination.

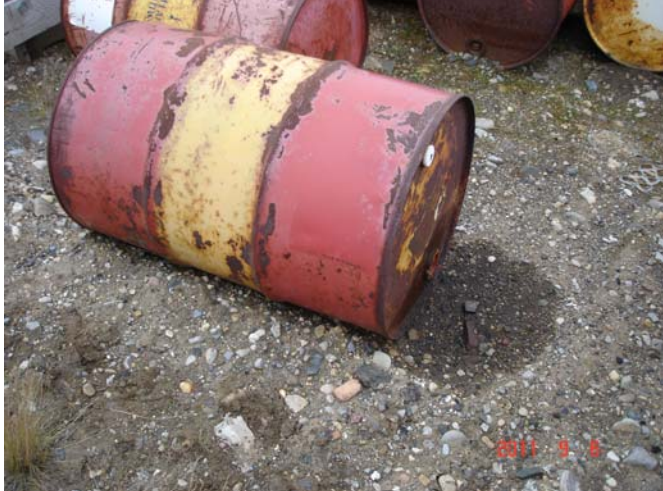
1. There was a drum at the Solid Waste Disposal Facility(SWDF) that appeared to be leaking out of its bung opening (bung was in place) so it needed to be tipped up but the other end had a bullet hole so the contents should be transferred to another secure drum (see Figure 3). Gradually this whole drum will leak out – 205L worth. Since this particular drum might spill its entire contents it should be cleaned up immediately. Drums at the SWDF should be checked regularly to ensure they are secure and clean up any spills.

Figure 3
There was a drum that appeared to be leaking out of its bung opening so the contents should be transferred to another secure drum. Gradually this whole drum will leak out – 205L worth. Since this particular drum might spill its entire contents it should be cleaned up immediately.

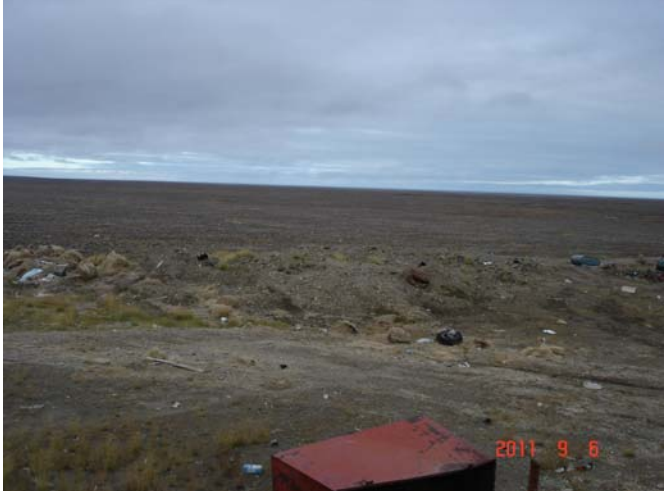
2. Contaminated soil from an old POL tank farm spill on the beach in front of the Hamlet was excavated by Biogenie S.R.D.C. Inc and deposited at the SWDF (see Figure 4). It would be appropriate to remove this soil and transfer it to the GNWT- Public Works (PW) landfarm – containment cell by the old Environment Canada Meteorological Station (aka Icicle Inn) since it is apart of that original spill (see Figure 2) and should be considered as part of POL tank farm spill cleanup.

Otherwise for the POL contaminated soil piles at the SWDF there needs to be a berm to prevent migration of contaminants into water and should include a liner under the contaminated soil pile (see Figure 4). Since contaminated soil exists at the SWDF without proper containment, this is a violation of Part D: Conditions Applying to Waste Disposal, Section 8 of the Water Licence. The details surrounding this contaminated soil are unknown as little information has been provided to the Hamlet. Apparently some soil samples were taken, the results should be obtained, reviewed and the soil material properly managed. The presence of contaminated soil at the SWDF without proper containment is unacceptable and will lead to further contamination.

Figure 4
Contaminated soil from an old POL tank farm spill on the beach in front of the Hamlet was excavated by Biogenie and deposited at the Solide Waste Disposal Facilities. This soil should be transferred to the GNWT- Public Works landfarm – containment cell since it is apart of that original spill.

In light of the current GNWT-PW remediation project occurring at the Hamlet it would appropriate to reuse the liner and/or any extra or left over materials to create a small containment cell – landfarm at the SWDF to allow containment and treatment of any contaminated soil/spills that are generated by the Hamlet in the future. Not to mention there already exists expertise and experience to build a containment cell for contaminated soil.

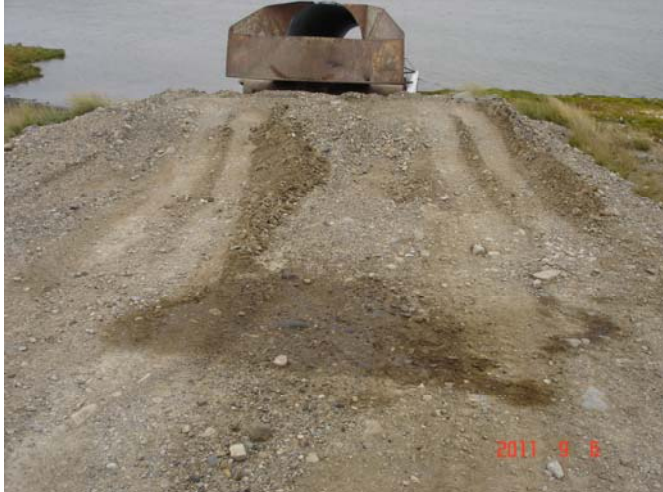
5. There is staining located in front of the discharge chute that indicates that the sewage truck is leaking oil (see Figure 5). Check the sewage truck and repair any leaking oil to limit contamination to the surrounding area and keep the sewage infrastructure clean.

Figure 5
There is staining located in front of the discharge chute that indicates that the sewage truck is leaking oil. Check the sewage truck and repair any leaking oil to limit contamination to the surrounding area.

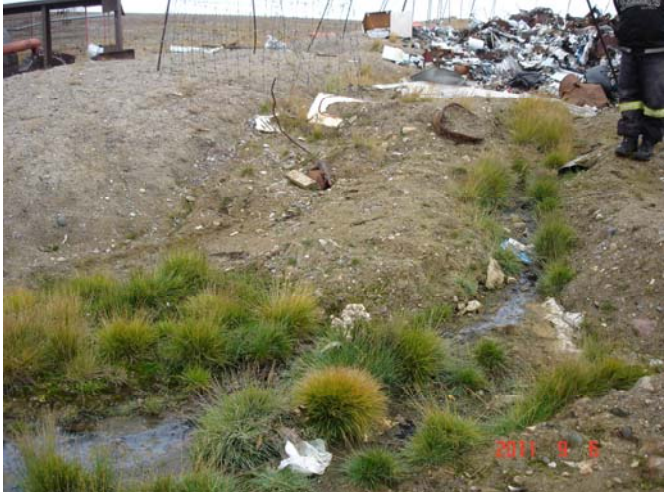
10. In the northeast corner of the current waste cell there was standing water and runoff coming from the waste cell through a culvert that ran through the cell berm (see Figure 6). The water was black and other strange colours with a surficial hydrocarbon like sheen present. This runoff needs to be sampled so as to monitor the site and possible contaminant issues for the Surveillance Network Program. Since no sampling has occurred this is a violation of Part B: General Conditions, Section 2, of the Water Licence.

Figure 6
In the northeast corner of the waste cell is standing water and runoff coming from the cell through a culvert located within the berm. This runoff needs to be sampled to monitor the site and any possible contaminant issues from the water.
