**File Number N3L8-1838**  
**Type of Operation CLASS B - MISCELLANEOUS**

## MISCELLANEOUS WASTE DISPOSAL INSPECTION REPORT

LICENCE #:	N3L8-1838	EXPIRY DATE:	December 31, 2019
LICENCEE:	Northwest Territories Power Corporation	PREVIOUS INSPECTION:	N/A
COMPANY REP:	Joshua Clark, Environmental Analyst	INSPECTION DATE:	August 25, 2016

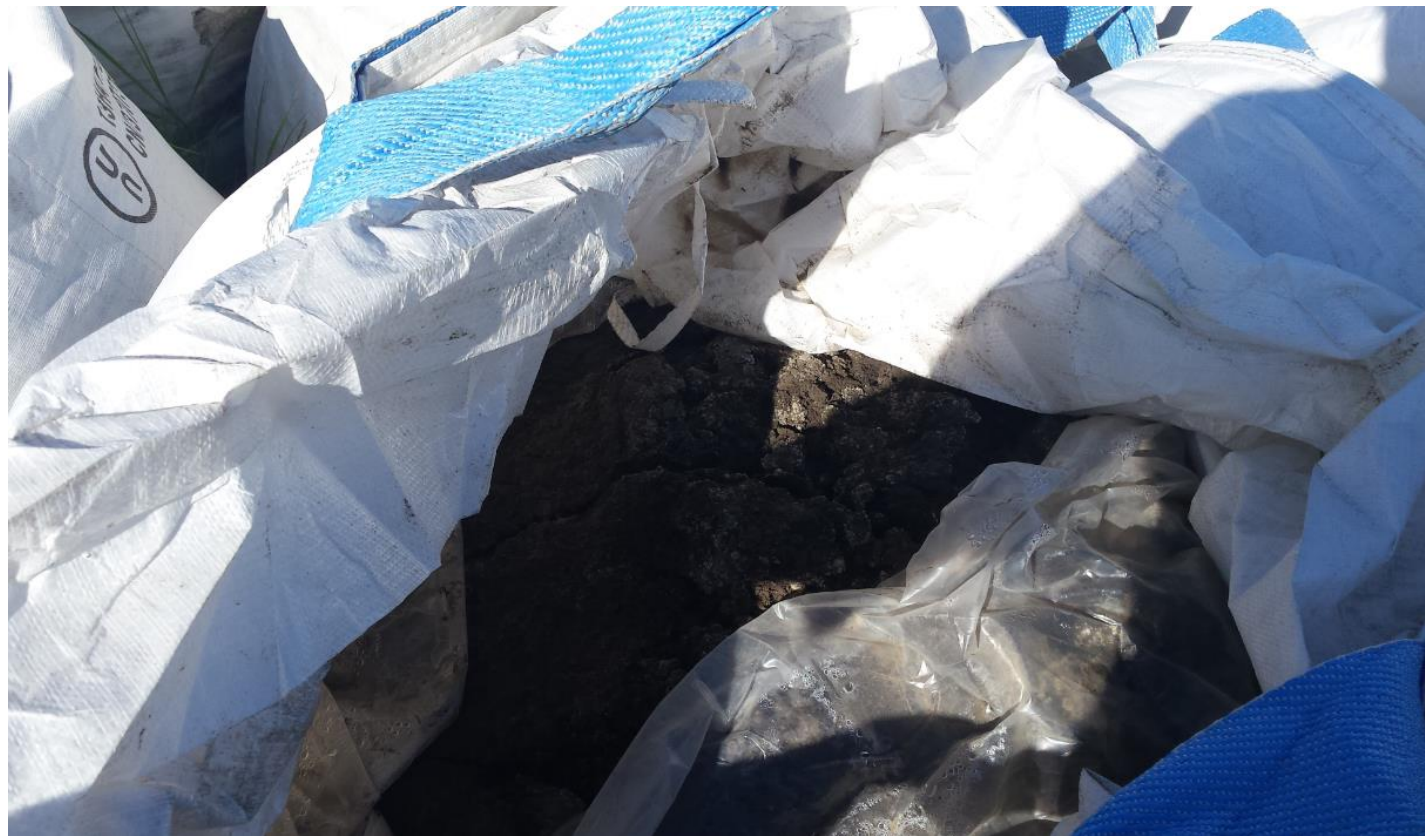
Figure 3

- <sup>1</sup>There were a few dozen bulk bags of contaminated soil and wood stored at the northwest corner of the site (Figure 2). At the time of the inspection, there was a noticeable smell of hydrocarbons in the air inside and outside of the site. The smell likely originated from open bulk bags not being properly sealed and tied off (Figure 3). The majority of the bags on site were in this state and will have to be properly contained as soon as possible before further rainfall and eventual freeze-up. In their current state, the bags are not properly containing all contaminated wastes and as such this creates nuisance for nearby residents, and presents a considerable risk for hydrocarbons and other contaminants to migrate outside of the containers into the surrounding environment. No sheen or discoloration of nearby waters could be observed at the time of the inspection so it appeared that the contaminants had not yet migrated.

Majority of bulk bags were generally not sealed/tied off properly.

- Ensure that the bulk bags of contaminated materials are properly sealed and tied off as soon as possible, **and notify the Inspector as soon as this is completed.**
- Ensure that all chemicals/hazardous wastes stored on site are labeled and well understood.
- Ensure that the site is inspected regularly to monitor for any spills, leaks or seepage from the hazardous wastes stored on site, especially during major rainfall events and spring melt.
- Ensure that run-off and standing water are contained within the site at all times.

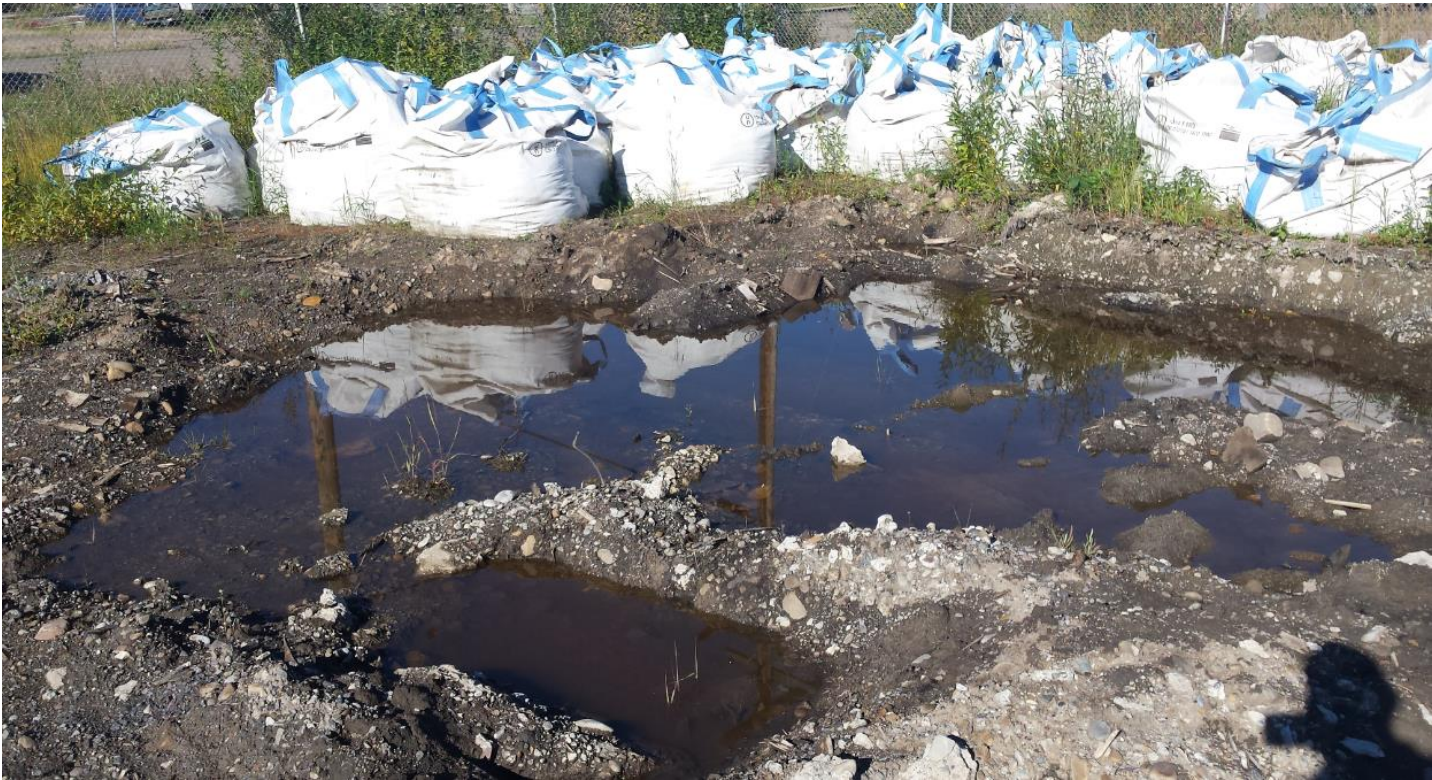
Figure 4

- There was standing water pooling adjacent to the bulk bags and other areas of the site (Figure 4). This will need to be monitored to ensure that the water does not escape the site, especially following major rainfall events and spring thaw. A diversion berm should be considered if controlling water run-off becomes a challenge.

Standing water adjacent to bulk bags.

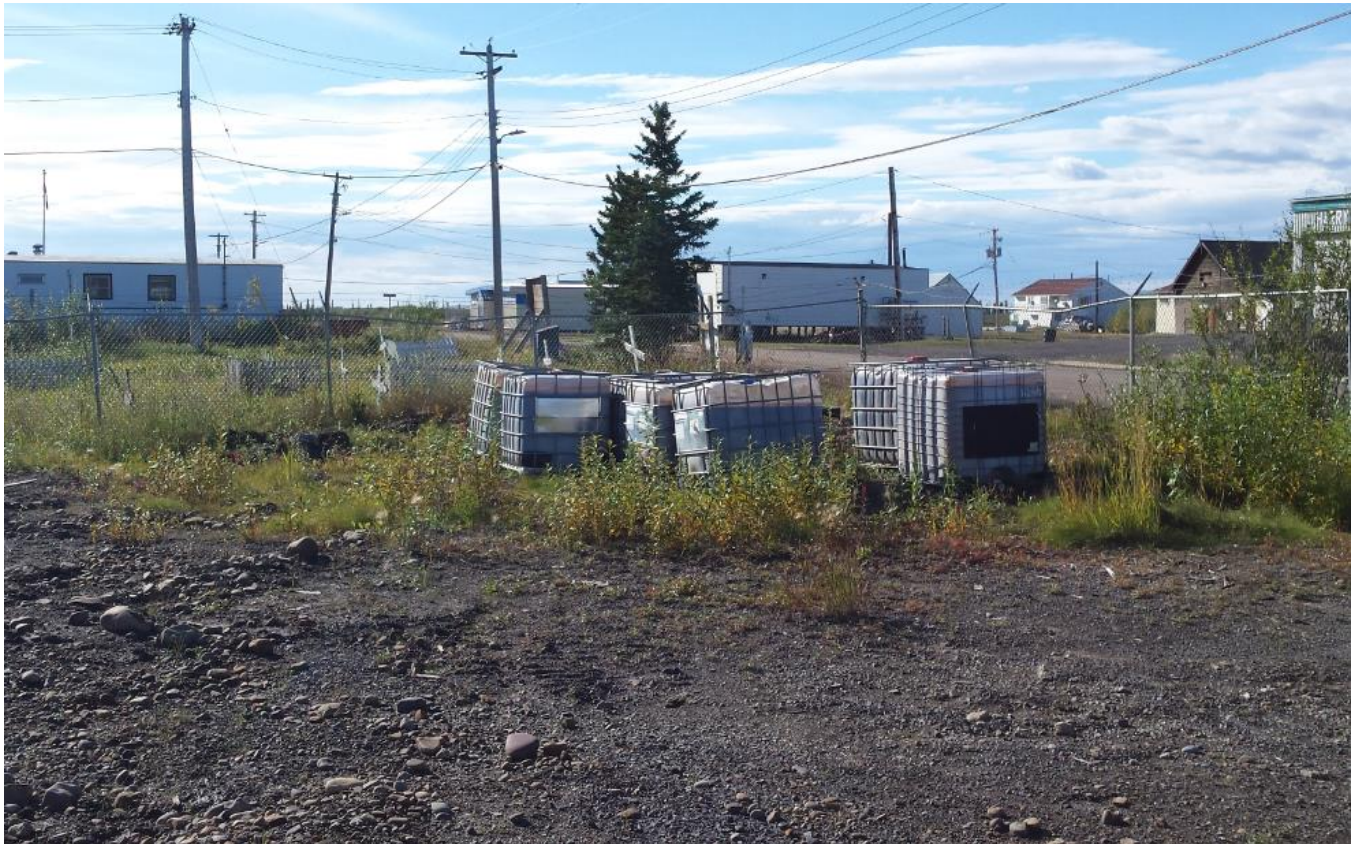
Figure 5

- There were 8 plastic bulk container totes stored at the southwest corner of the site (Figure 5). It was unclear what was in those plastic totes as the chemicals information was illegible at the time of the inspection. One top-lid was also taken off and had to be put back on the container at the

time of the inspection by the NTPC representative. Please ensure that the contents of these plastic totes are well understood and that all containers are properly labeled and sealed at all times.

Plastic totes located southwest corner of the site – MSDS/information sheets illegible.

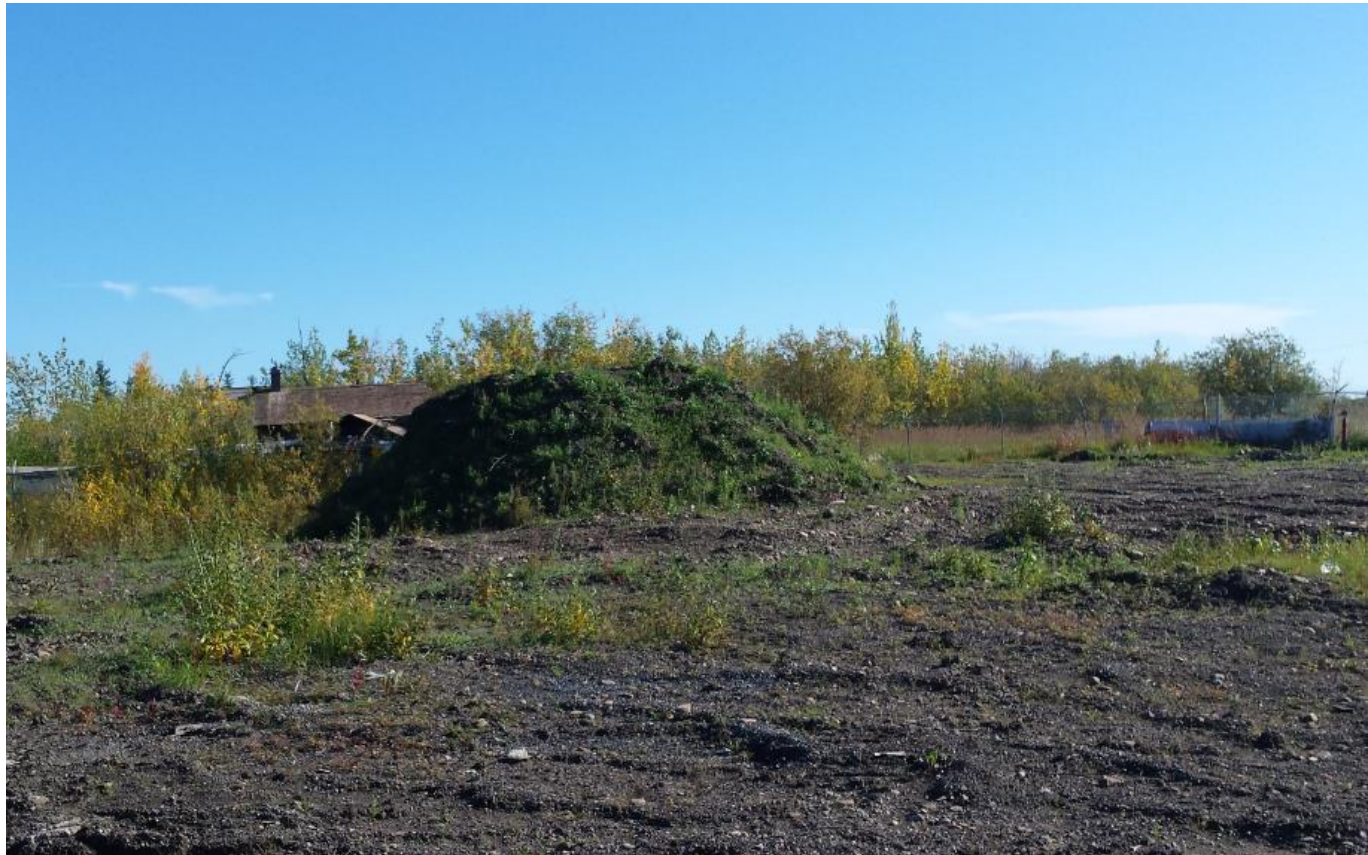
Figure 6

- There was one stockpile of soil towards the southeast corner of the site (Figure 6). It was unclear whether this soil was contaminated.
- No spill kit could be observed at the site at the time of the inspection however it is understood that spill kits are stored at the Aklavik Power Plant Facility as per the Spill Contingency Plan and that NTPC employees are well trained in spill response.

Stockpile at the southeast corner of the site.
