**RE: Municipal Water Licence N7L3-1619  
CLASS B - MUNICIPAL**

An inspection was conducted of the Municipal Water Supply and Waste Disposal Facilities on August 11, 2015. Enclosed is a copy of the Municipal Water Licence Inspection Report.

<b>LICENCE #:</b>	<b>N7L3-1619</b>	<b>EXPIRY DATE:</b>	<b>November 20, 2015</b>
<b>LICENCEE:</b>	<b>Hamlet of Paulatuk</b>	<b>PREVIOUS INSPECTION:</b>	<b>August 30, 2011</b>
<b>COMPANY REP:</b>	<b>Greg Morash SAO</b>	<b>INSPECTION DATE:</b>	<b>August 11, 2015</b>

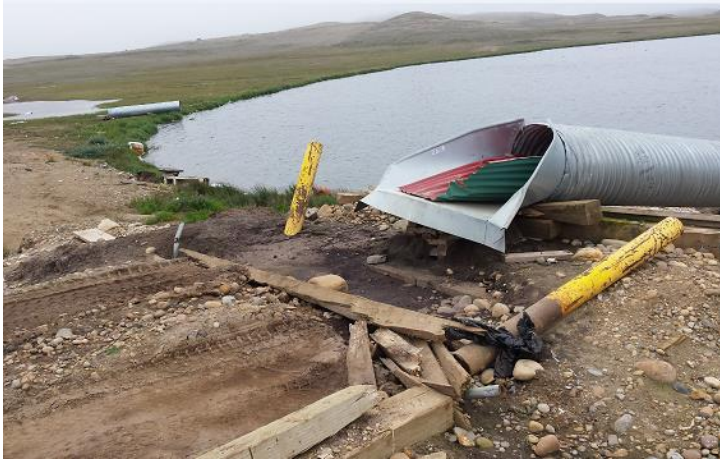
**Figure 1**

- Regular SNP sampling is not being conducted by the Hamlet as per SNP requirements.
- Truck pad by the sewage discharge chute appears to be in poor condition (see Figure 1). One of the 2 pilings is heavily damaged and the other is lying flat on the ground. Unclear if damage was caused by sewage truck, truck pad stability issues or both. Both pilings need to be set upright and secured into place. Consider relocating them further away from the discharge chute as to create sufficient room between the discharge chute and the sewage truck.

- There is very clear evidence of ongoing spillage at the site of discharge. This could lead to erosion and stability issues for the truck pad and the sewage discharge chute. Ensure that the sewage truck is not leaking any sewage/oil. Recommend backfilling heavily eroded/unstable areas in the short term and adding a catchment basin under the point of discharge to prevent any spillage on the truck pad. Longer term, recommend re-slopping the entire truck pad to ensure that there is sufficient drainage.

- Sewage discharge chute appears to be in poor condition. Previous wooden pad structured has been removed and current one appears to be unstable and potentially unsafe for workers. Ensure that the discharge chute is of proper length for the sewage truck and that it is secured in place. The Hamlet is to be commended for adding a secondary piece of metal to act as a further measure to prevent erosion of the culvert, as recommended in the last Inspection Report. However, some sewage is spilling directly on the pad. Recommend adding a containment basin or funnel-like structure to contain any sewage leaks from spilling on the ground.

Sewage discharge pad is in poor condition and needs to be addressed.

- o Consider using cover material to manage household wastes and control windblown debris and wildlife
  - o Address issues observed at the sewage discharge pad

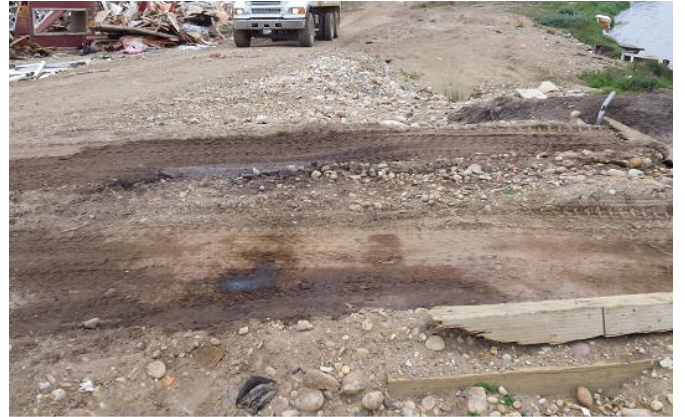
**Figure 2**

- There is evidence of an hydrocarbon or hydraulic spill on site (see Figure 2). Unclear if this is the same potential spill that was reported in the last Inspection Report. This needs to be sampled and sent for analysis, and remediated accordingly. Environment and Natural Resources (ENR) can provide assistance with this (equipment & process). Short term, recommend inspecting at sewage and waste disposal trucks for any sign of leakage.

Evidence of a hydrocarbon or hydraulic spill on the sewage discharge pad. This needs to be sampled and sent for analysis, and remediated accordingly.

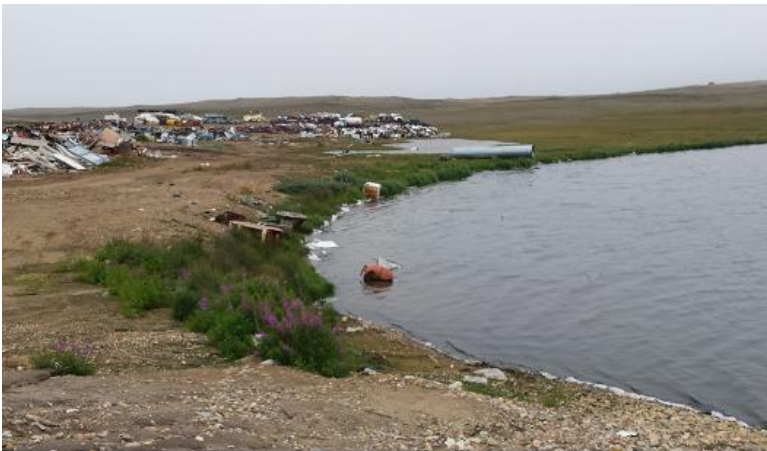
**Figure 3**

- Quality (colour/smell/turbidity) of the water seemed adequate. Some wastes could be observed along the shoreline of the sewage lake (See Figure 3). Recommend cleaning this up periodically to prevent any garbage from reaching the wetland downstream.

Wastes could be observed along the shoreline of the sewage lake. Recommend cleaning this up periodically to prevent any garbage from reaching the wetland downstream. Bulk wastes need to be taken out of the sewage lake.

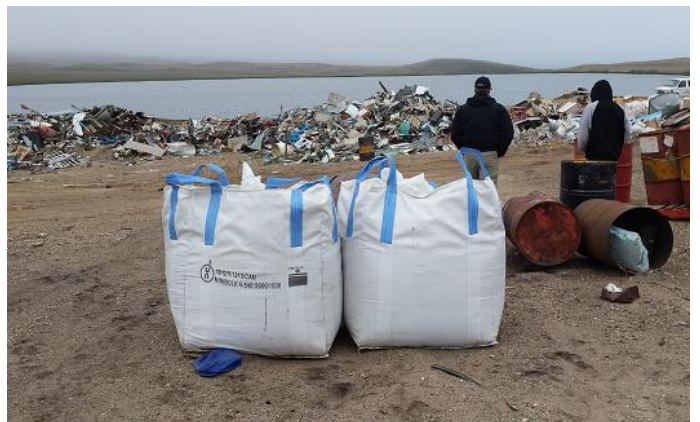
**Figure 4**

- It is the duty of the Hamlet to inform the Water Resource Officer when accepting contaminated soil/snow at the Solid Waste Disposal Facility (SWDF). 2 bags of suspected contaminated soil and of unknown origin were present (see Figure 4) and it was reported that contaminated snow was also brought on site. It also poses a threat to the surrounding environment, including the sewage lake which is downstream from the SWDF.

Bags of suspected contaminated soil of unknown origin – not reported to ENR.

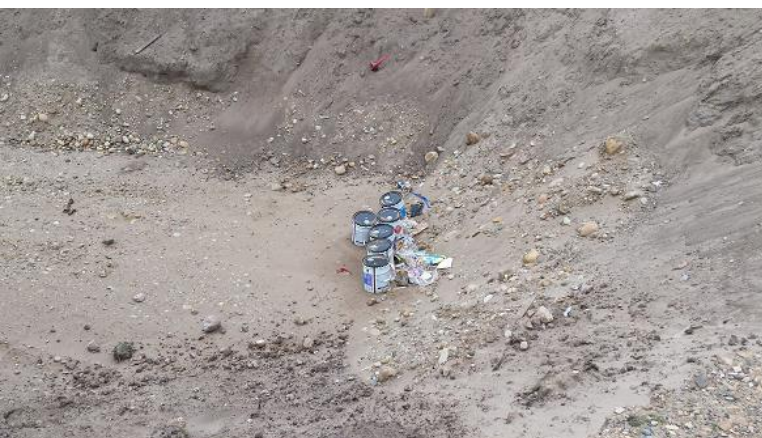
**Figure 5**

- The Hamlet is constructing a bermed cell to store hazardous wastes. It appears that the Hamlet or residents have already begun using this designated site although construction is not complete (see Figure 5). There were unused liner rolls observed beside the bermed area that have yet to be put into place. Recommend closing access to this cell and putting appropriate signage in place to inform residents so that no hazardous wastes are deposited there until construction is complete. Recommend adding a bin on site

Hazardous wastes being stored at incomplete designated storage area.

to store hazardous wastes in the meantime, or have residents drop-off hazardous wastes at the Hamlet garage for temporary storage.

- o Prioritize non-compliant items flagged in most recent inspection reports and correspondence with the Inuvialuit Water Board
  - o Ensure that the new hazardous waste storage area at the SWDF is completed and used properly by Hamlet staff and residents

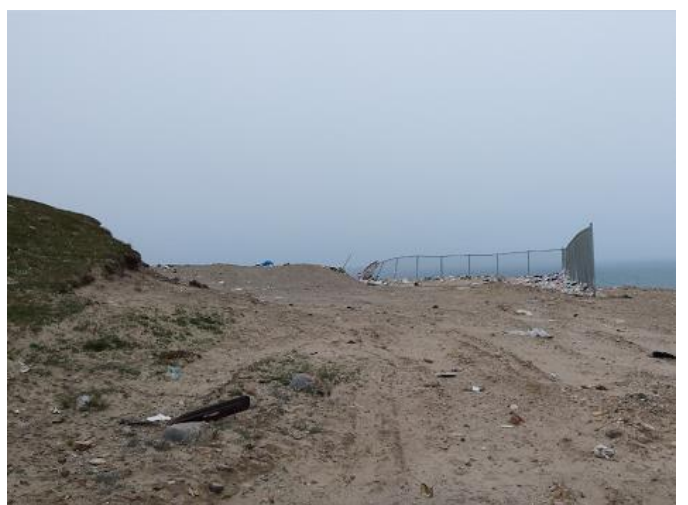
**Figure 6**

- It is evident that the Hamlet is continually dealing with windblown garbage issues. Some areas around the SWDF are fenced-off but most of them are failing due to the repeated strain caused by the cumulative weight of the household wastes (see Figure 6). Recommend periodically removing garbage piling up on fences to prevent damage. Recommend repairing or completely replacing and extending beyond what is currently fenced.

Failing fence behind solid waste disposal site due to strain caused by accumulation of windblown garbage.

- o Repair the fence around the SWDF and consider extending it to better contain windblown debris
- Please note that as of April 1, 2014, some information has changed under Item 6 of Water Licence N7L3-1531, under “General Procedures for the Administration of Licences Issued Under the Northwest Territories Waters Act in the Northwest Territories”. In the future, you may use the following contact information for the Analyst and the Inspector:
