**RE: Municipal Water Licence N7L3-1619  
CLASS B - MUNICIPAL**

An inspection was conducted of the Municipal Water Supply and Waste Disposal Facilities on August 30, 2011. Enclosed is a copy of the Municipal Water Licence Inspection Report.

## MUNICIPAL WATER LICENCE INSPECTION FORM

<b>LICENCE #:</b>	N7L3-1619	<b>EXPIRY DATE:</b>	November 20, 2015
<b>LICENCEE:</b>	Hamlet of Paulatuk	<b>PREVIOUS INSPECTION:</b>	September 14, 2010
<b>COMPANY REP:</b>	Debbie Gordon-Ruben	<b>INSPECTION DATE:</b>	August 30, 2011

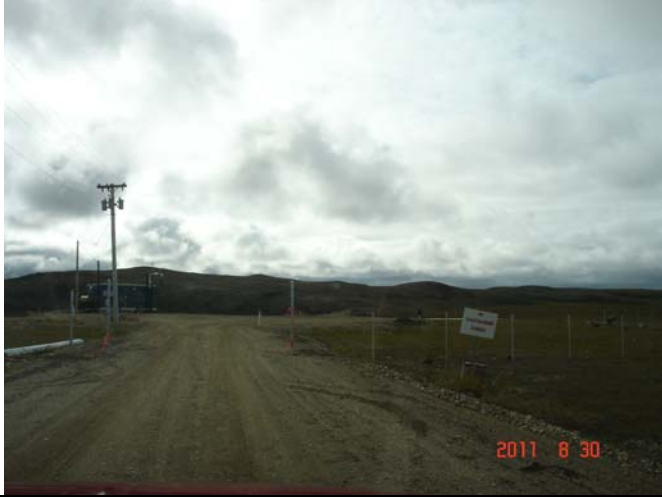
**Figure 1**

- New fence/gate is being installed around the WSF and its immediate area including the turnaround pad right up to the edge of New Water Lake (see Figure 1). The site looked clean and tidy. A new warning sign was installed in front of the fence which states "No Unauthorized Entry".

New fence/gate is being installed around the WSF and its immediate area including the turnaround pad right up to the edge of New Water Lake.

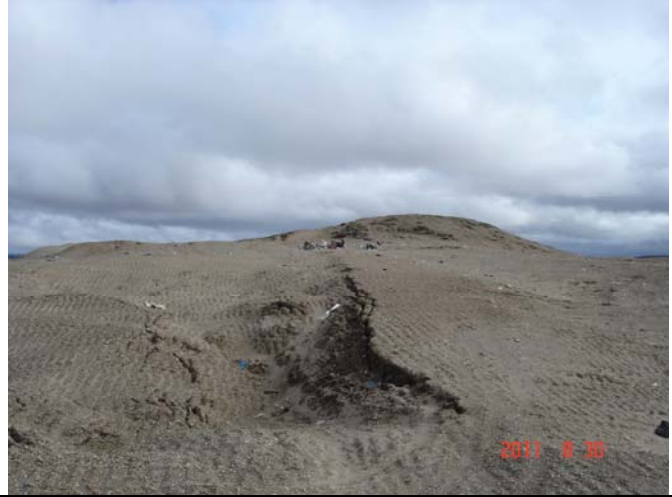
**Figure 2**

It was noted that there was subsidence/slumping with the cover material/cell cap for the previous waste cell (see Figure 2). Ensure more cover material is put on the cell adequately to fill it in and to ensure it matches the surrounding land as this will provide proper drainage with precipitation. Any subsidence will act as collecting point for precipitation and a conduit for water to enter the cell and flow through waste creating leachate/contamination issues.

It was noted that there was subsidence/slumping with the cover material/cell cap for the previous waste cell. Ensure more cover material is put on the cell adequately to fill it in and to ensure it matches the surrounding land as this will provide proper drainage with precipitation.

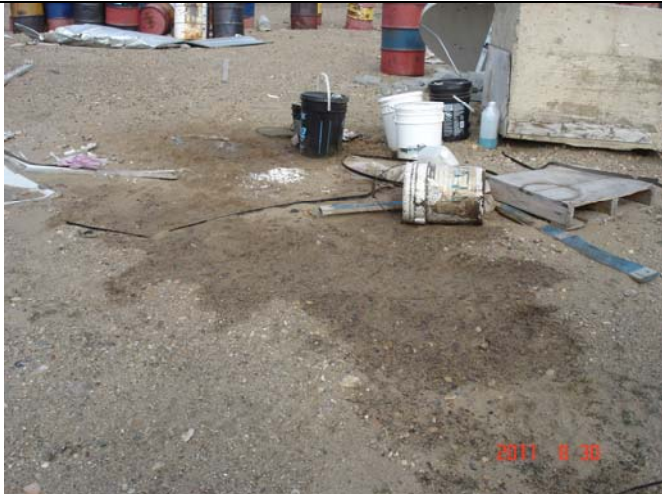
**Figure 3**

5. The Hamlet is to be congratulated for their work to see that drums are being gathered and segregated. Currently they are put into different areas one for waste/crushing, further segregation and recently acquired. Unfortunately there is a clear indication that many drums/containers are leaking. Spillage of drum/container contents is evident on the ground especially in the areas where there are many drums being stored and leaking appears to have been going on for some time (see Figure 3).

Unfortunately there is a clear indication that many drums/containers are leaking, as spillage of drum/container contents is evident on the ground. These spills from drums need to be called in as a spill to the 24 Hour Spill Report Line.

Leaking drums are not acceptable, barrels can be properly disposed of (as per GNWT-ENR guidelines) or stored. Ensure drums are secured, contained, properly segregated and fluids are unable to leak from containers (strong drum, bung in place, no holes, openings facing up). When there is suspected leaking bungs and openings they should not be in the bottom especially if a drum is on its side but rotated so they are facing up, however, the fluids must be transferred to secure and approved containers. There needs to be regular checks at the SWDF for leaks and subsequent repairs including containment of leaking containers/materials to prevent spills and further contamination of the environment. If contaminated soil is discovered it needs to be cleaned up and disposed of in the contaminated soil storage area. Please note that when any contaminated soil is deposited at the SWDF the Hamlet needs to notify the Inspector as per Part D: Conditions Applying to Waste Disposal, Item 7, of the Water Licence.

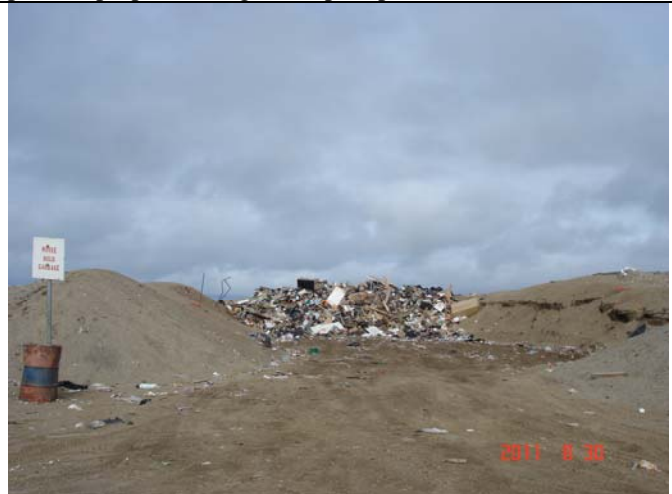
**Figure 4**

9. The Hamlet is to be commended for their efforts, as it was evident from looking at the household garbage –waste cell there had not been any recent burning of household/domestic garbage (see Figure 4). Upon looking at the current waste cell there was a significant amount of approved combustible waste such as cardboard and wood. A designated separate burning area for materials is recommended to allow the reduction of material, to conserve space and ensure proper control. The Hamlet should segregate waste suitable for open burning such as paper products, paperboard packaging and untreated wood wastes.

The Hamlet is to be commended for their efforts, as it was evident from looking at the household garbage –waste cell there had not been any recent burning of household/domestic garbage

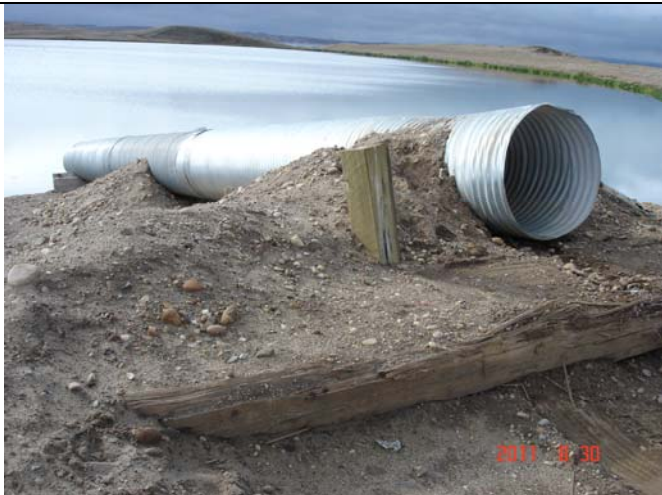
**Figure 5**

13. Sewage discharge chute has been lengthend and properly measured with the sewage truck (see Figure 5). Additionally the erosion areas on the front and the back have been filled in gravel material. To ensure no sewage bypass a tire stop is present. Sewage seems to be going into the chute but a little erosion is evident showing some by-passing is occurring. It was suggested putting a flat piece of metal (corrugated etc) to act as a futher measure to prevent erosion and catch any drips and angle them towards the chute. Continue to monitor as any materila that is eroded away is eventually deposited back into the sewage lagoon which decreases efficiency and costs the Hamlet to repair it and material to replace it.

Sewage discharge chute has been lengthened and properly measured with the sewage truck. Additionally the erosion areas on the front and the back have been filled in gravel material.

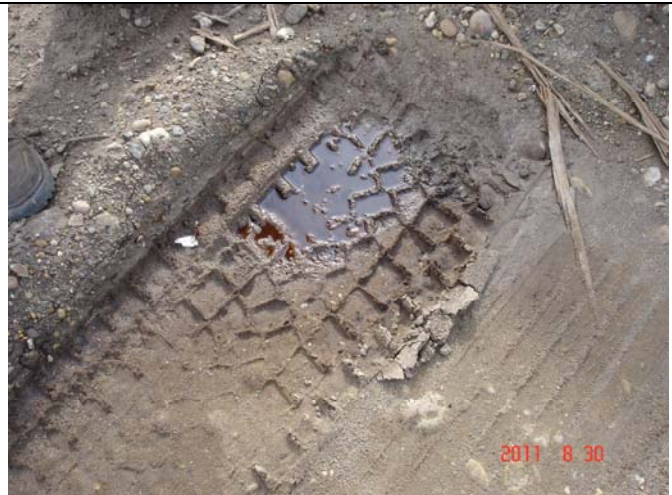
**Figure 6**

14. It appeared there was as spill of oil at the sewage discharge chute in the tire track (see Figure 6). This needs be confirmed, repairs completed to the whatever was leaking the oil and the spill cleaned up and properly disposed of.

It appeared there was as spill of oil at the sewage discharge chute in the tire track. This needs be confirmed, repairs completed to the whatever was leaking the oil and the spill cleaned up and properly disposed of.
