RE: Municipal Water Licence (N7L3-1619)

WATER LICENCE INSPECTION FORM

DATE:	November 4, 2009	COMPANY REP:	Debbie Gordon-Ruben
LICENCEE:	Hamlet of Paulatuk	LICENCE #:	N7L3-1619

WATER LICENCE INSPECTION REPORT Pg. 4 (Continued)

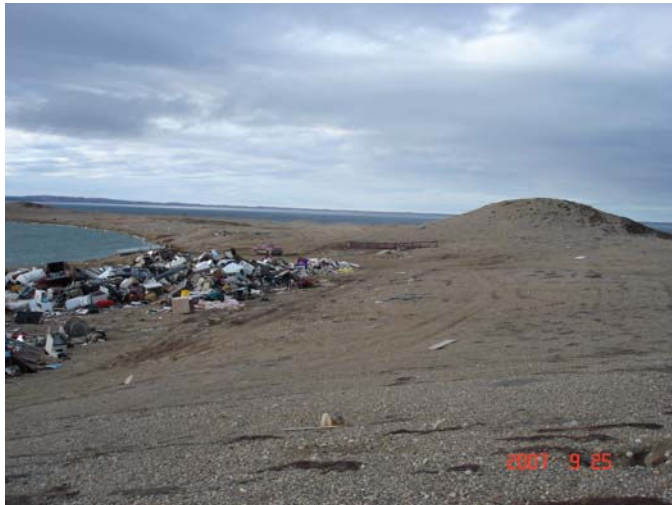
Figure 1

2. A lot of work has been done to move various barrels (some with fuel/oil etc) to a specific area (Figure 1 and 2). The current location is not bermed but the great effort is noted. It might be prudent for Hamlet Staff to build a berm around the few large groups of hazardous waste such as barrels, batteries etc. and contain them where they are as this material is located throughout the landfill. This would save on time and work involved to move all the material. In the containment/storage areas these materials need to be collected, prepared and shipped out for proper disposal at an approved facility. There is a clear indication that many containers are leaking. There needs to be regular checks for leaks and subsequent repairs/containment to prevent spills and further contamination of the environment.

Hill area before barrels were moved there. Inspection picture taken September 25, 2007.

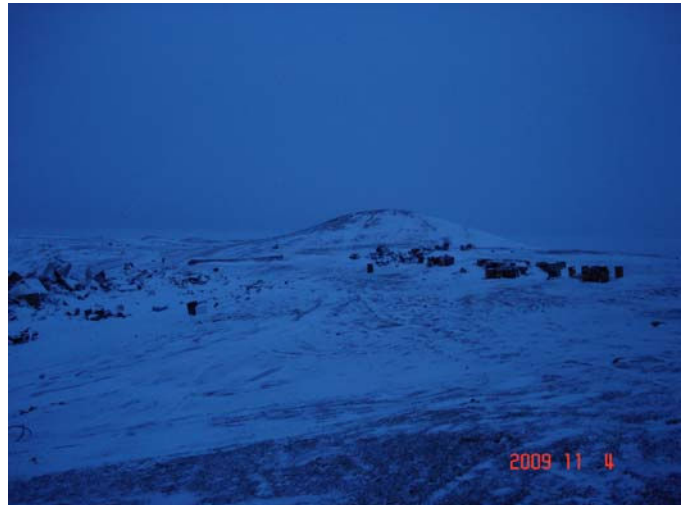
Figure 2

Hill area after barrels were moved there. Hazardous waste storage area needs bermed containment. Inspection picture taken November 4, 2009.

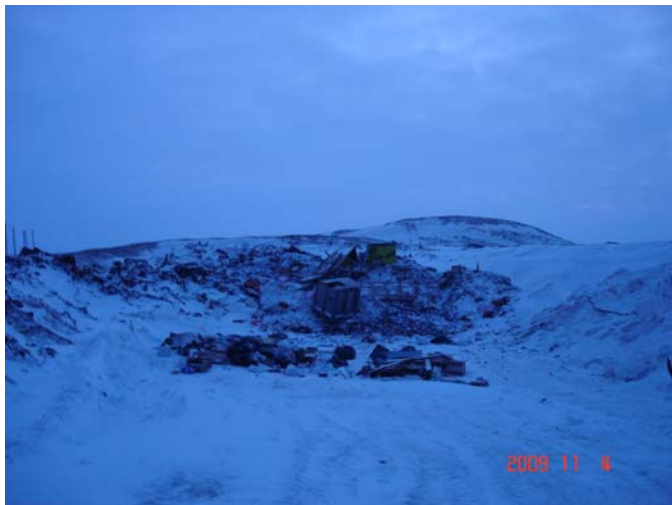
Figure 3

5. Burning of non-segregated Municipal Solid Waste (MSW) is still occurring (see Figure 3). This remains an unacceptable option for the management of MSW. Wastes that are conditionally suitable for open burning are paper products, paperboard packaging and untreated wood wastes according to the document from the GNWT Department of Environment and Natural Resources titled 'Municipal Solid Wastes Suitable for Open Burning'(Please see enclosed document). A designated burning area for these materials is recommended to ensure proper control.

Waste cell at Solid Waste Disposal Facility where unsegregated burning is occurring. Note burnable material is paper, untreated wood and cardboard.

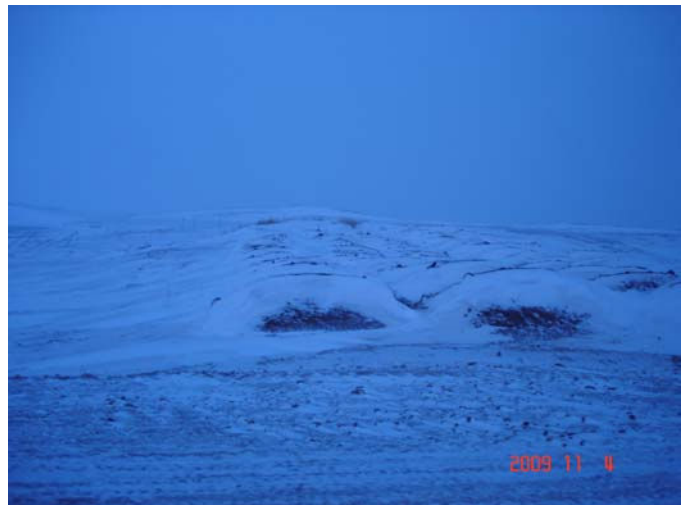
Figure 4

6. The presence of contaminated soil at the Solid Waste Disposal Facility (SWDF) without proper containment is unacceptable and could lead to further contamination (see Figure 4). There needs to be a geotextile/liner under the contaminated soil pile with a berm to minimize the potential for migration of contaminants into any waters. The Hamlet needs to provide proper containment for the contaminated soil.

Contaminated soil piles at Solid Waste Disposal Facility without any containment present.
