**RE: Municipal Water Licence (N7L3-1619)**

An inspection was conducted of the Municipal Water Supply and Waste Disposal Facilities on October 15, 2008. Enclosed is a copy of the Municipal Water Licence Inspection Report.

## WATER LICENCE INSPECTION REPORT

<b>DATE:</b>	October 15, 2008	<b>COMPANY REP:</b>	Debbie Gordon-Ruben
<b>LICENCEE:</b>	Hamlet of Paulatuk	<b>LICENCE #:</b>	N7L3-1619

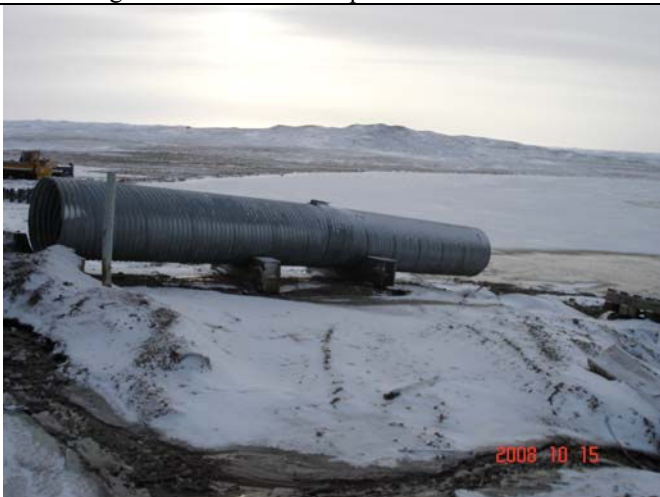
**Figure 1**

4. Sewage is bypassing the front of the sewage discharge chute and causing erosion all around the chute. The chute needs to: have a funnel at the front to prevent bypassing, a longer chute or move closer to the lagoon, have a turn around pad extended with truck tire stops(blocks or curb). (see Figure 1)

Sewage chute needs: a funnel for the front, to empty directly into the lagoon and truck tire stops.

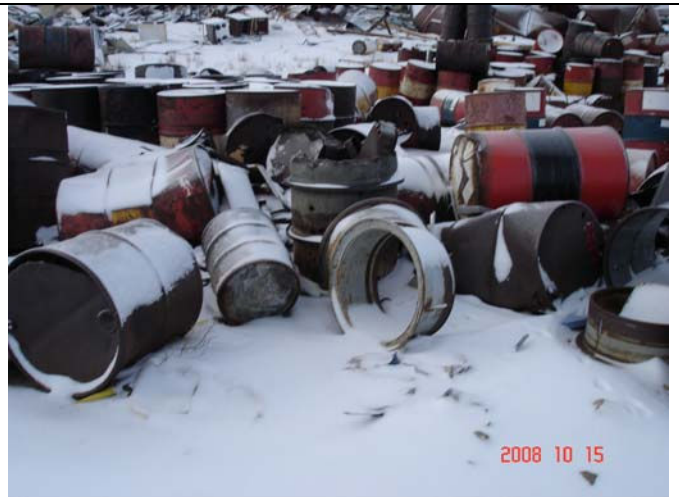
**Figure 2**

6. Barrels and contained materials need proper disposal. (see Figure 2)

Barrels and contained material need proper disposal.

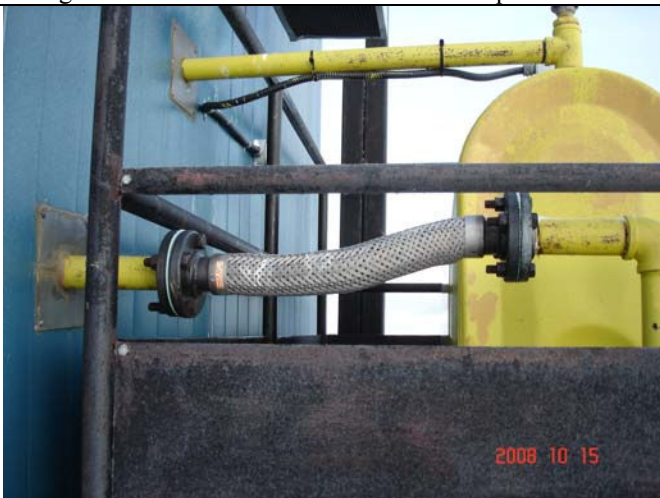
**Figure 3**

1. Flex connector is showing signs of being out of alignment. It is time to re-align the tank and fuel line fittings. If there is more movement of the pipe and connection there could be a spill into the Hamlet’s water supply. (see Figure 3)
2. Frozen water was present inside the berm for the fuel storage tank. The ice could rupture a bottom fitting for the fuel tank and cause a spill. The ice already decreases the containment capacity of the berm. (see Figure 4)

Flex connector is out of alignment. Tank and pipe need to be re-aligned. Further movement could cause a spill.

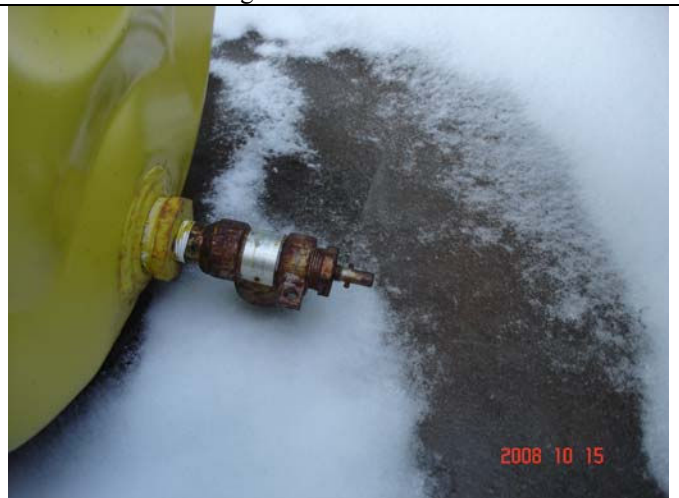
**Figure 4**

Frozen ice in bottom of berm threatens to break fitting on the base of the Fuel Storage Tank at Water Treatment Plant.

- Recommend regular snow removal or a roof/enclosure constructed over fuel storage tank to prevent further water inside bermed area.
