RE: Municipal Water Licence (N7L3-1619)

WATER LICENCE INSPECTION REPORT

| DATE: | September 25-26, 2007 | COMPANY REP: | Gilbert Ruben – Truckfill Operator Aaron Ruben – Water Treatment Plant Operator |
| LICENCEE: | Hamlet of Paulatuk | LICENCE #: | N7L3-1619 |

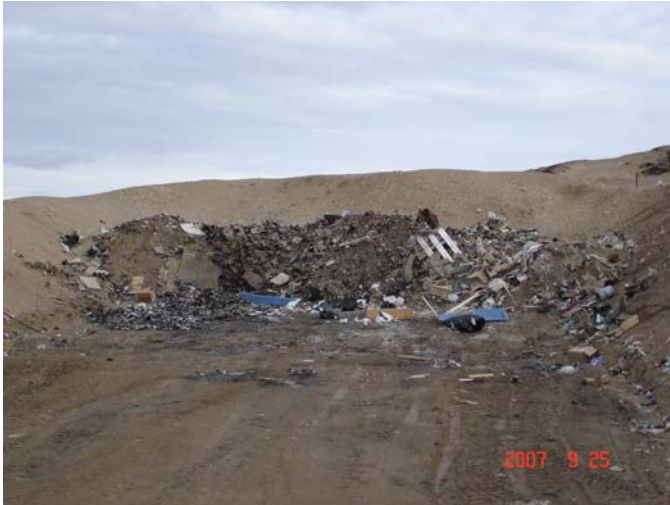
Figure 1

1. Burning of non-segregated Municipal Solid Waste (MSW) is occurring. Burning of non-segregated MSW remains an unacceptable option for the management of MSW. Wastes that are conditionally suitable for open burning are paper products, paperboard packaging and untreated wood wastes according to the document from the GNWT Department of Environment and Natural Resources titled 'Municipal Solid Wastes Suitable for Open Burning' (Please see enclosed document and Figure 1).

Burning of un-segregated domestic solid waste.

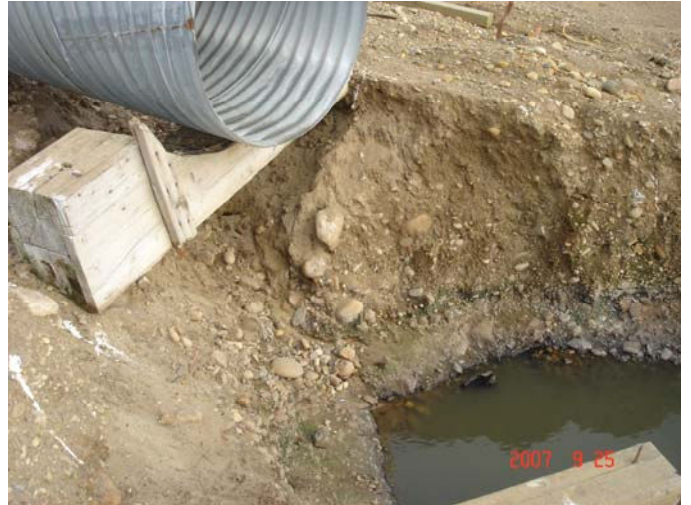
Figure 2

2. Sewage is bypassing the front of the sewage discharge chute and causing erosion all around the chute. The chute needs to be upgraded to prevent sewage from bypassing the front of the chute and to withstand erosion (Figure 2).

Erosion present at the end of the sewage unloading chute.

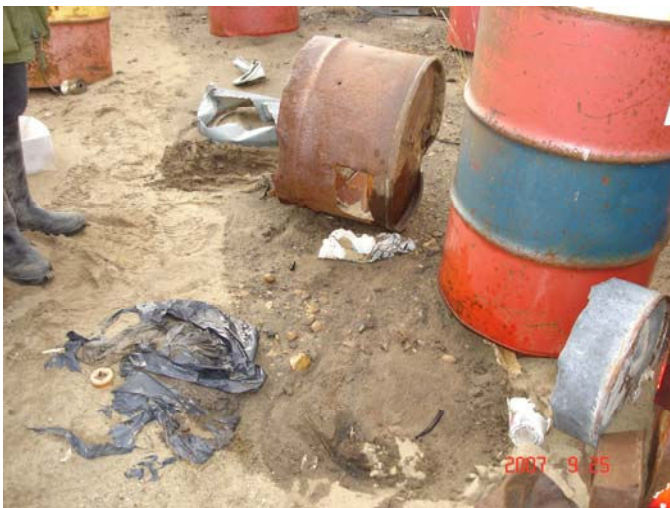
Figure 3

3. At the time of inspection someone had recently overturned a drum and dumped the contents at the Solid Waste Disposal Facility(SWDF) in amongst the drum storage area. There was a presence of hydrocarbon odour and it was clear the liquid had run down along the sandy soil area. This kind of situation should be reported to the Spill Line and the spill area should be cleaned up and properly disposed of. Spills of oil and other materials were evident among the drum storage area (Figure 3).

Evidence of drum's contents spilled at drum storage area.

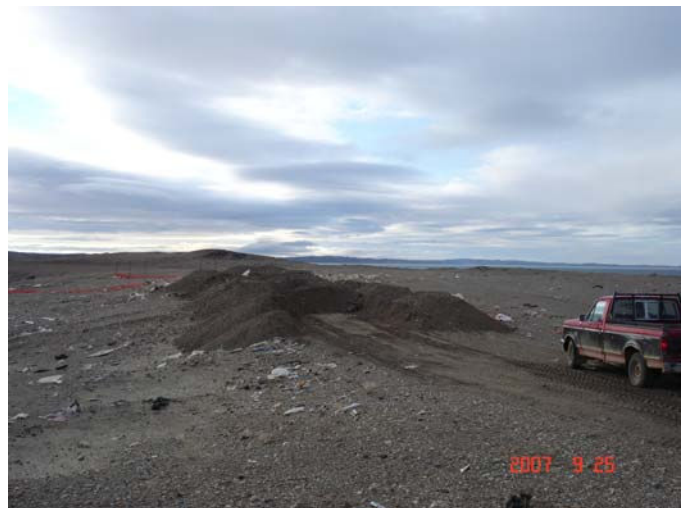
Figure 4

5. Discharge quality is unknown. Hamlet has not been sampling on a regular basis as per Surveillance Network Program requirements.
6. At the time of inspection contaminated soil was at the SWDF. The presence of contaminated soil occurred as a modification to the SWDF and the Operation and Maintenance Plan without notification of the Northwest Territories Water Board. The presence of contaminated soil at the SWDF without proper containment is unacceptable and could lead to further contamination. The Hamlet needs to comply with the Water Licence Part E: Conditions Applying to Modifications. Contaminated soil needs proper containment as per Water Licence Part G: Conditions Applying to Construction (Figure 4).

Contaminated soil pile area at Solid Waste Disposal Facility.
