**RE: INDUSTRIAL Water Use N7L1-1769
CLASS B – INDUSTRIAL
Mallik 3L-38
Unnamed Channel - Mackenzie River**

INDUSTRIAL WATER USE INSPECTION REPORT

LICENCE #:	N7L1-1769, Mallik 3L-38	EXPIRY DATE:	September 30, 2002
LICENCEE:	JAPEX Canada Limited	PREVIOUS INSPECTION:	October 2, 2012
COMPANY REP:	Yukio Kishigami	INSPECTION DATE:	August 26, 2013

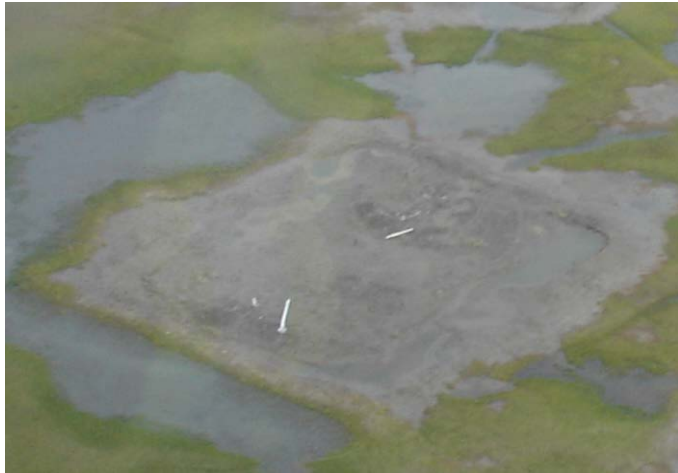
Figure 1

Well Waste Comments:
- Subsidence on sumps similar to before no noticeable changes.
- Ponding occurring in subsided areas.

Close up aerial view of 2002 drill sump.

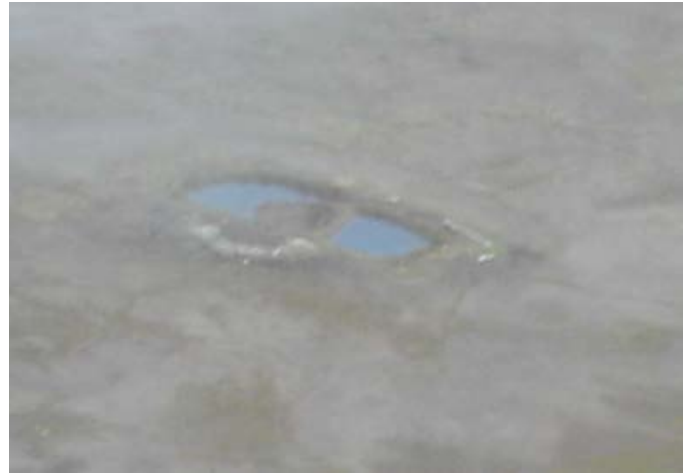
Figure 2

- Large cracks present on 2002 camp sump.

Close up aerial view of 2002 camp sump.

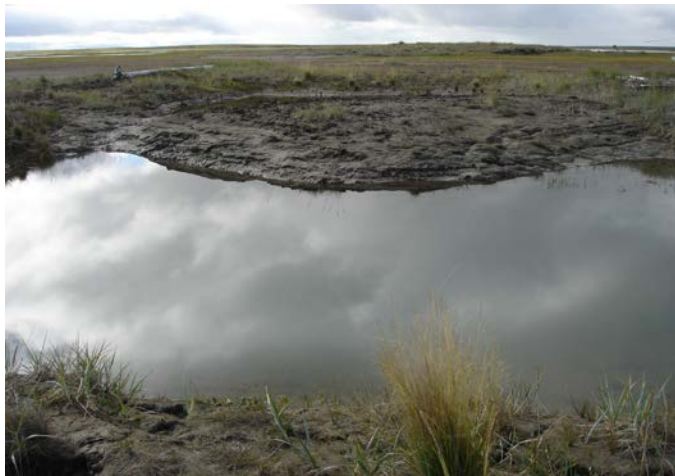
Figure 3

Subsidence and ponding at northend of camp sump.

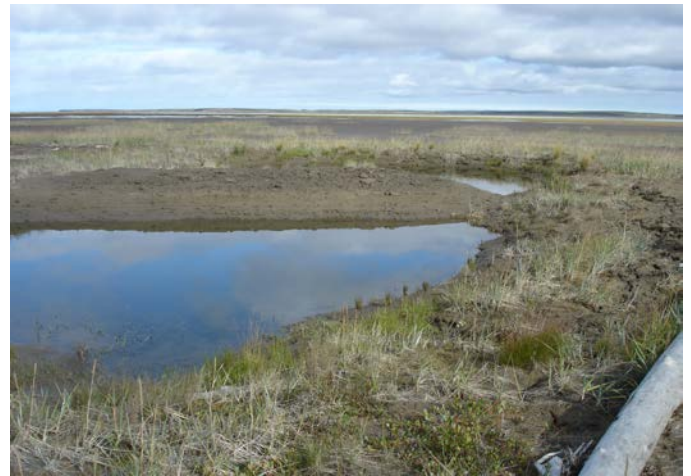
Figure 4

Subsidence and ponding at southend of camp sump.

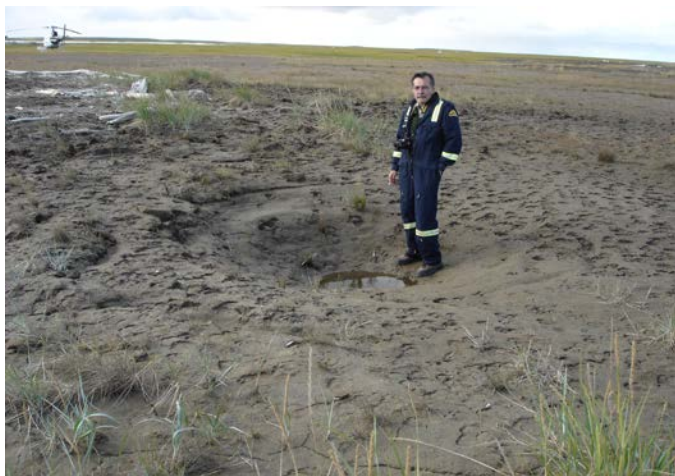
Figure 5

Sinkhole off northwest corner of camp sump.

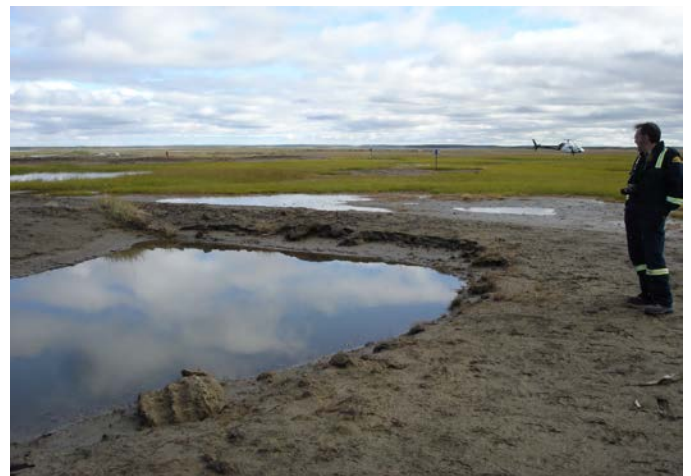
Figure 6

Subsidence at south end of drill sump.
