### INDUSTRIAL WATER LICENCE INSPECTION REPORT

DATE: July 24, 2003

LICENSEE: Shell Canada Ltd.

LICENCE #: N7L1-1770 / West Channel

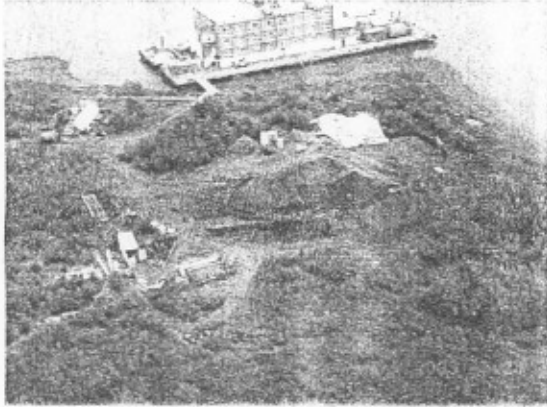
**Figure 1.** Aerial View of Shell Canada Ltd. West Channel Remediation Project.

At this time there was no water use from the Mackenzie River. Furthermore, there were no facilities (pumps etc.) installed to extract water from the river. For an aerial view of the site please refer to Figure 1 attached. As discussed below, under general comments, the bioremediation project was fully decommissioned. As a result no water from the Mackenzie River was required.

-All sewage is contained on Grubens barge facility (~80 person capacity)(Figure 1). At the time of inspection there were approximately 10 people staying at the facility. It is understood that no discharge of sewage to the Mackenzie River is occurring. Sewage is stored and then transported back the Inuvik and/or Aklavik for proper disposal.  
 -No Spills and/or unauthorized discharge of waste indicated by staff.

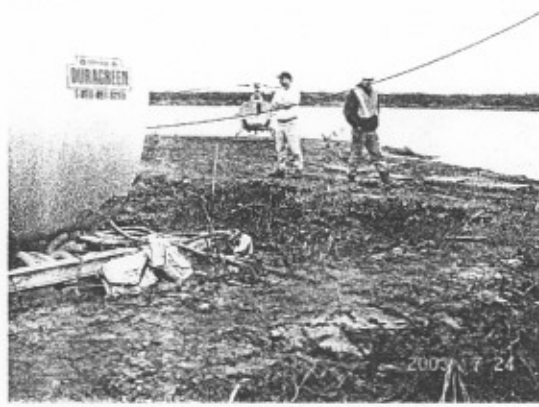
**Figure 2.** Southeast corner of containment berm.

-In general the area was neat and tidy and operations were acceptable.  
 -At the time of inspection the fuel storage area was poorly bermed and would not contain fuel (diesel) if a major leak occurred (Figure 2). At the time of inspection fuel storage consisted of a 12000 gallon dual contained DuraGreen tank and contained ~7000 gallons. This volume is a concern considering the close proximity of this facility to the Mackenzie River (~30m) (Figure 2). A verbal direction was given to representatives to address the concerns. Specifically, the concerns were inadequate berm height, and incomplete berm around the Northwest corner of the containment area (Figure 3). Lack of a complete berm at the Northwest corner is a concern because the general topography of the area sloped in this direction. The above concerns were also discussed with Mike Muller of IEG. It was agreed that the above issue would be addressed.

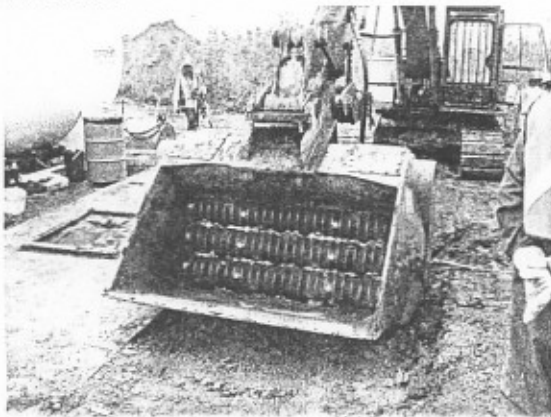
**Figure 3.** Alu bucket located to the northwest of the fuel storage tank. Please note the absence of a containment berm in this area.

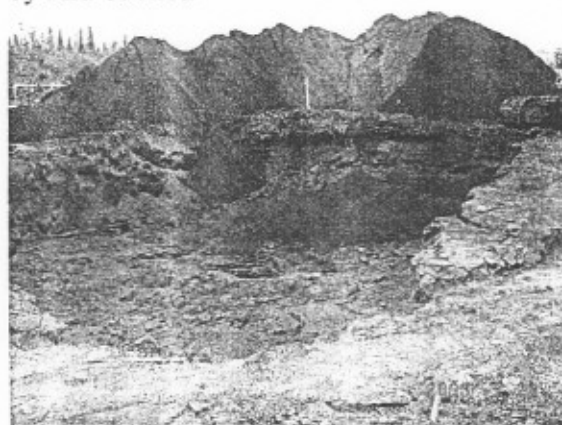
**Figure 4.** Excavated contaminated area showing aerated soil in background. The soil is to be placed back in excavated area by Alu bucket.
