Re: Devon Itiginkpac F-29 Sump Assessment

ITGINKPAK F-29 SUMP REMEDIATION PLAN

**KIGGIAK-EBA CONSULTING LTD.
CALGARY, ALBERTA**

OCTOBER 2006

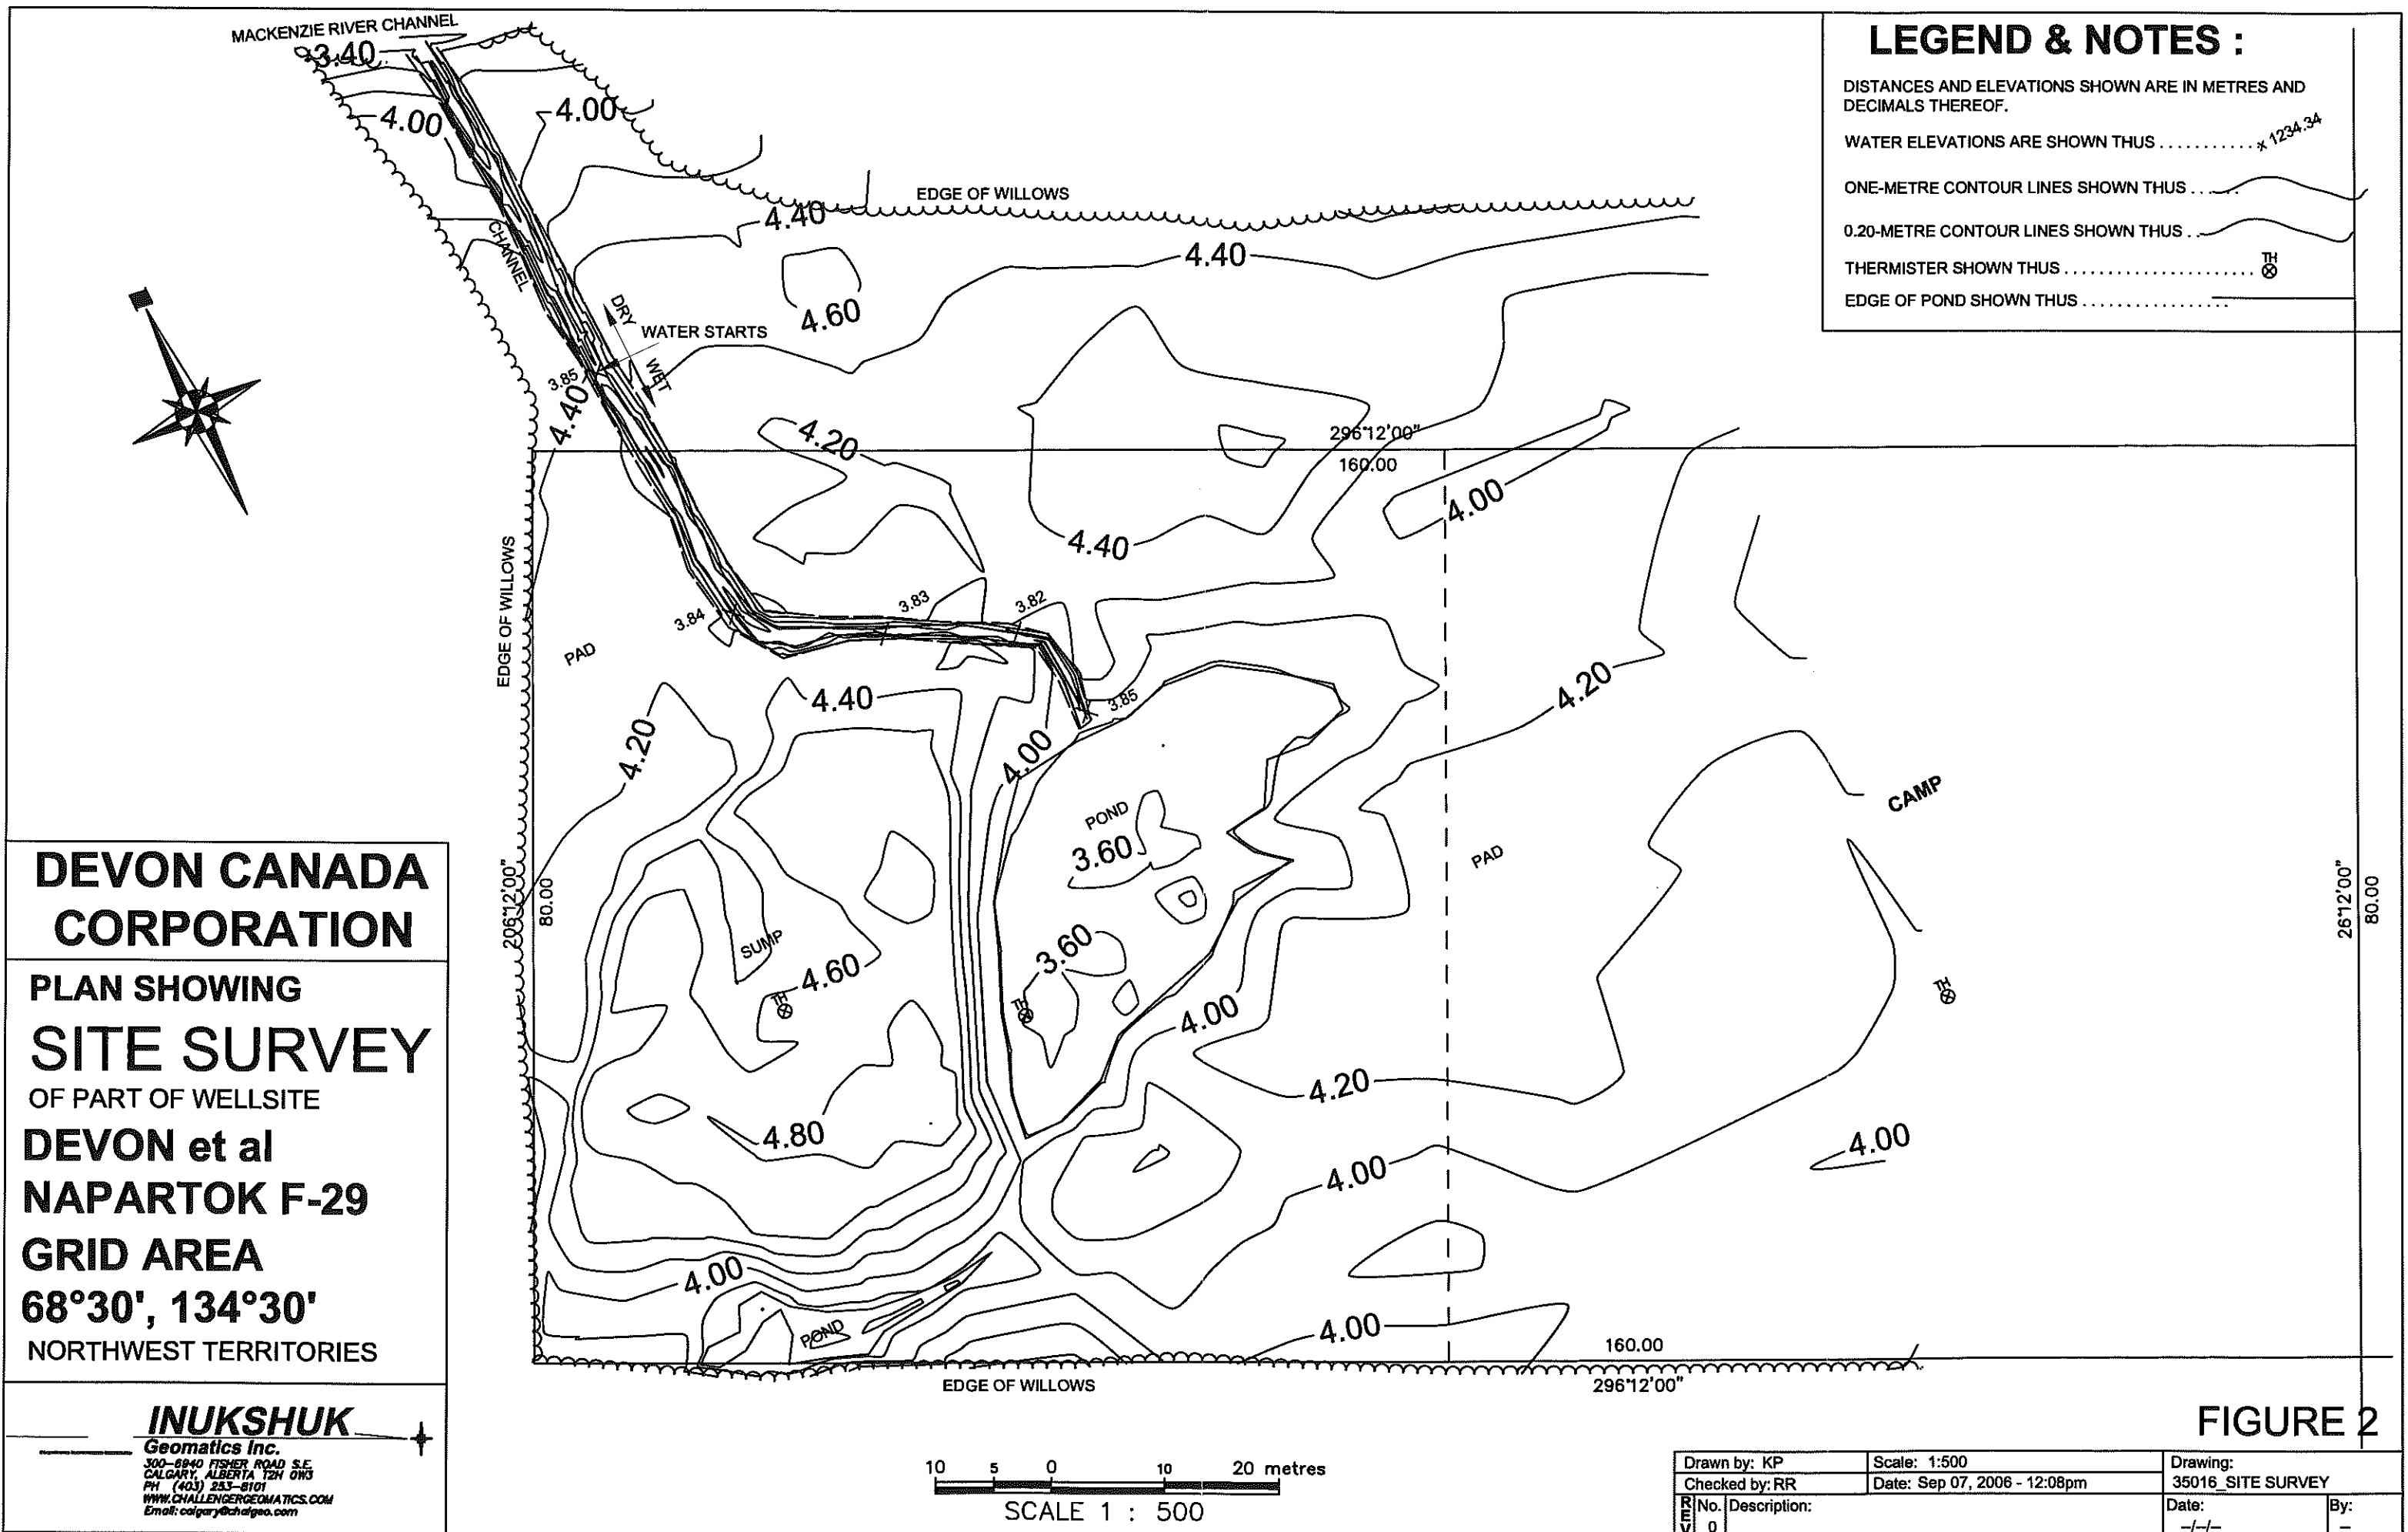
Figure 2 indicates that the sump cap is about 0.2 m to 0.8 m above the level of the surrounding site. EBA 2003 reports that it was initially built-up by 1.5 m to 2.0 m above level grade. The extent to which this loss of relief results from thaw and settlement of ice-rich cap backfill, or from thawing of the icy layers and ground ice in the cover (below ground portion of the cap) that Devon put over the drilling wastes, or from grading work by Devon in 2005, is not clear.

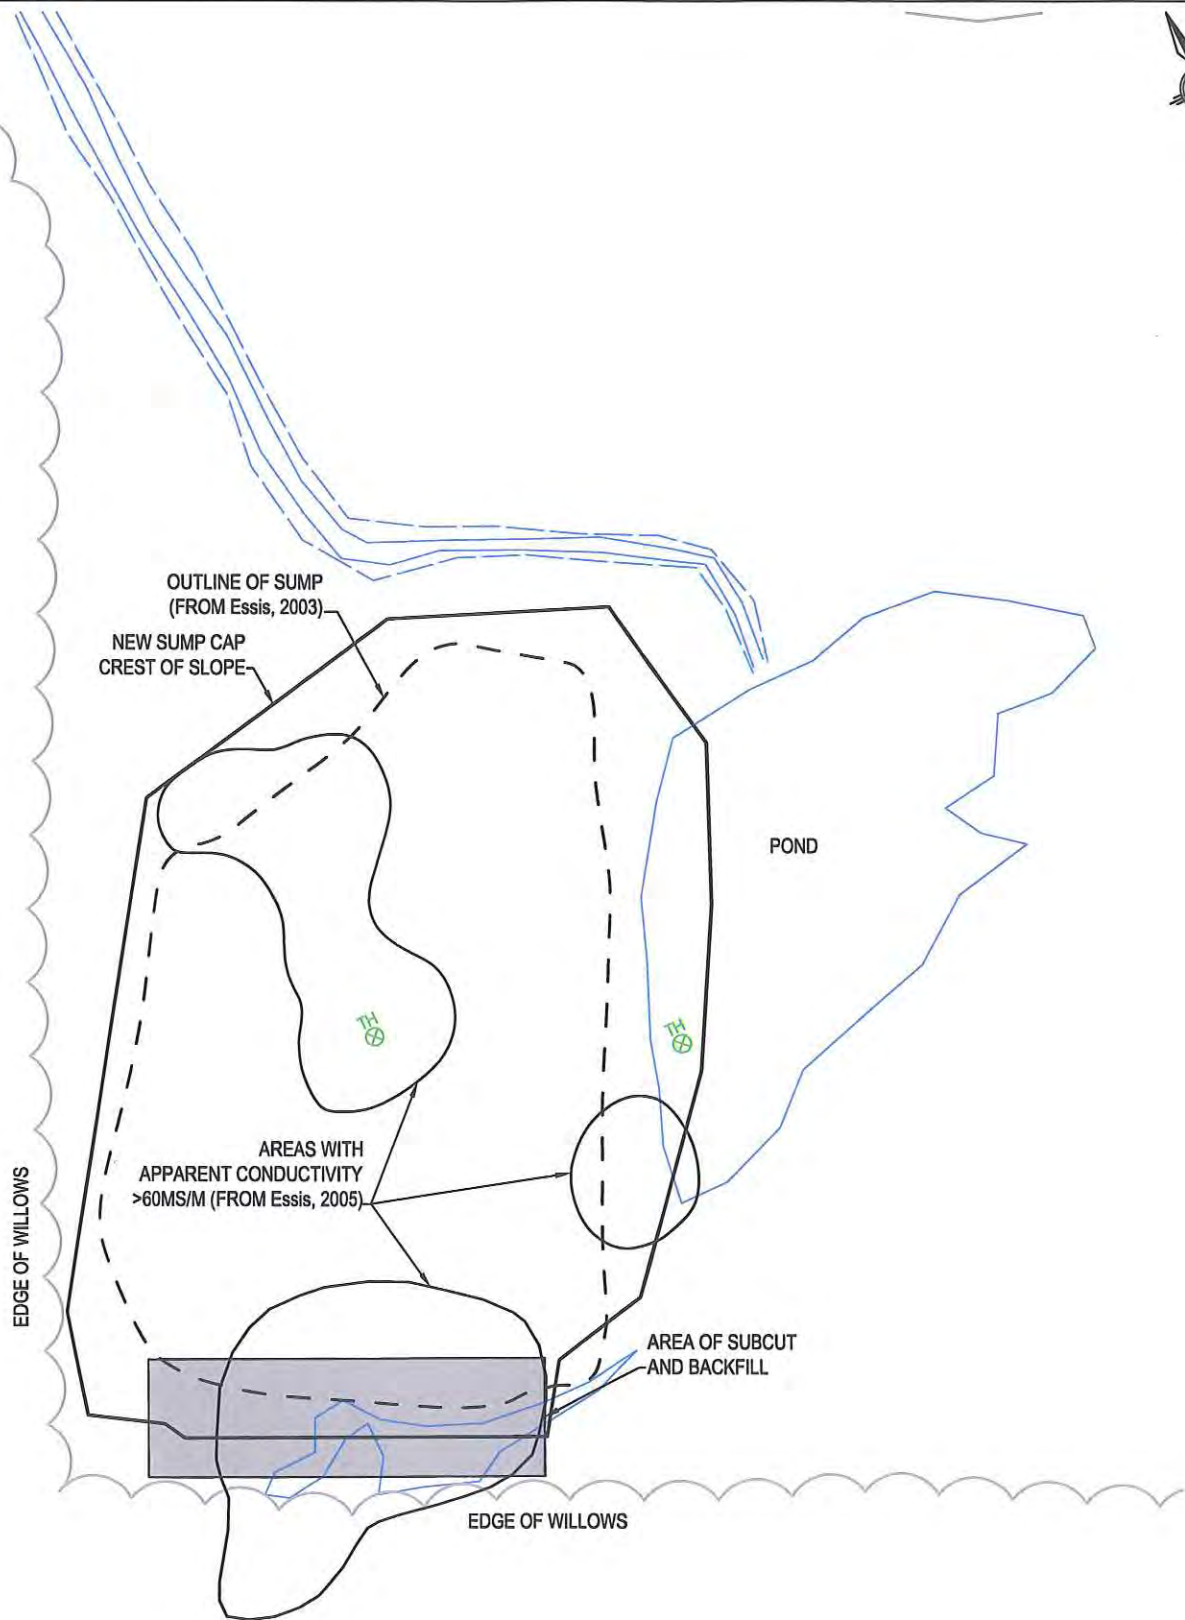
Figure 3

Figure 3, interpreted from the EM surveys conducted by Essis and reported by Newpark in 2005, indicates the extent of three areas of concern. Chemical analyses of soil and water samples (IEG, 2005) show that the primary contamination and contributor to the high apparent conductivity values is potassium chloride (salt). Potassium chloride is a significant component of the buried drilling wastes.

The September 2003 EM survey, conducted by Essis, shows an area of anomalously high apparent conductivity that is approximately 12 m wide between the south end of the sump and the southern lease boundary. Apparent conductivity is generally a measure of the electrical properties of water in the soil pores and more saline soil-water mixes will have higher apparent conductivity values. The 2003 survey did not extend off-lease to identify whether the apparent contamination had spread beyond the lease boundary.

A similar survey conducted in September 2005 by Essis shows the area of apparent contamination between the sump and southern lease boundary had grown to 25 m wide. In the 2005 survey, the plume of inferred contamination can be traced southwesterly to about 80 m off the lease, although the most significant concentrations appear to extend only about 15 m beyond the lease boundary. An area of dead or distressed tree growth is evident in photos of the area adjacent to the lease.

EM surveys across the pond that has formed in the blocked swale on the east side of the sump, suggest that ponding may have impacted the permafrost containment zone adjacent to the sump. A small pocket of elevated apparent conductivity has developed in the pond, suggesting the possible escape of some of the unfrozen saline-rich water associated with the drilling wastes.

A third area of concern that is similarly indicated by high apparent conductivity measurements made by Essis first appeared in the September 2005 EM survey. It is located adjacent to the north (or northwest) corner of the sump. Regrading work by Devon in the summer of 2005 may have something to do with the recent development of this area of high apparent conductivity.

Salt contaminated near surface soils should be removed to a depth of about 1.0 m below grade during the winter of 2007 from the area indicated on Figure 3. Contaminated soils from between the sump and southwestern lease boundary (an area of approximately 25 m x 8 m) should be ripped, excavated, loaded in trucks, and hauled to Inuvik for disposal. The southwestern edge of the excavation should be the lease boundary.

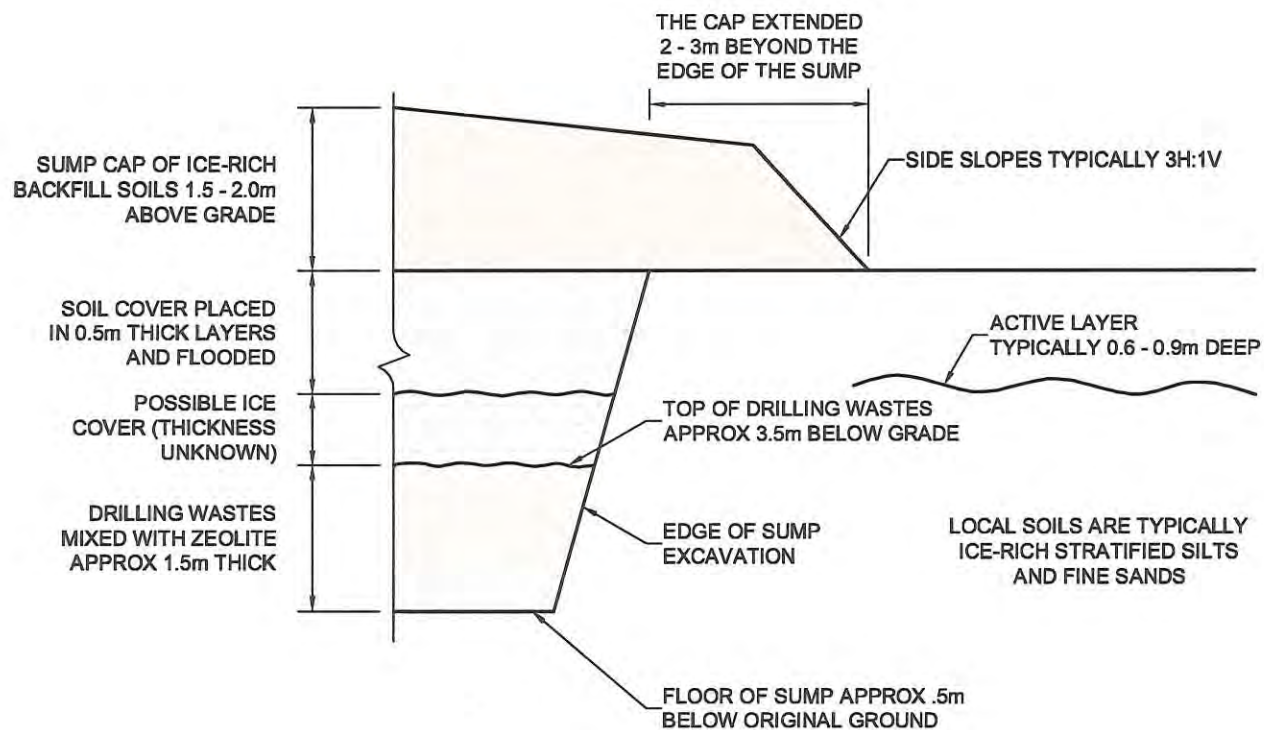
Figure 4 schematically shows the interpreted cross-section of the sump, as it was first completed. The outline of the sump excavation, presented on Figure 3, has been determined conservatively by working back from the toe of the fill, which is reliably distinguishable on the ground and on Inukshuk's surveyed topography. As a minimum, the edge of the excavation should be approximately 6.0 m inside the toe of the fill. [Calculated as 1.5 m (the minimum height of fill) \times 3 (for 3H:1V sideslopes) + 1.5 m (for the minimum distance that the crest is reported to have been outside the excavation)]. The following recommendations assume the edge of the sump excavation conservatively is only 5.0 m inside the limits of the fill.

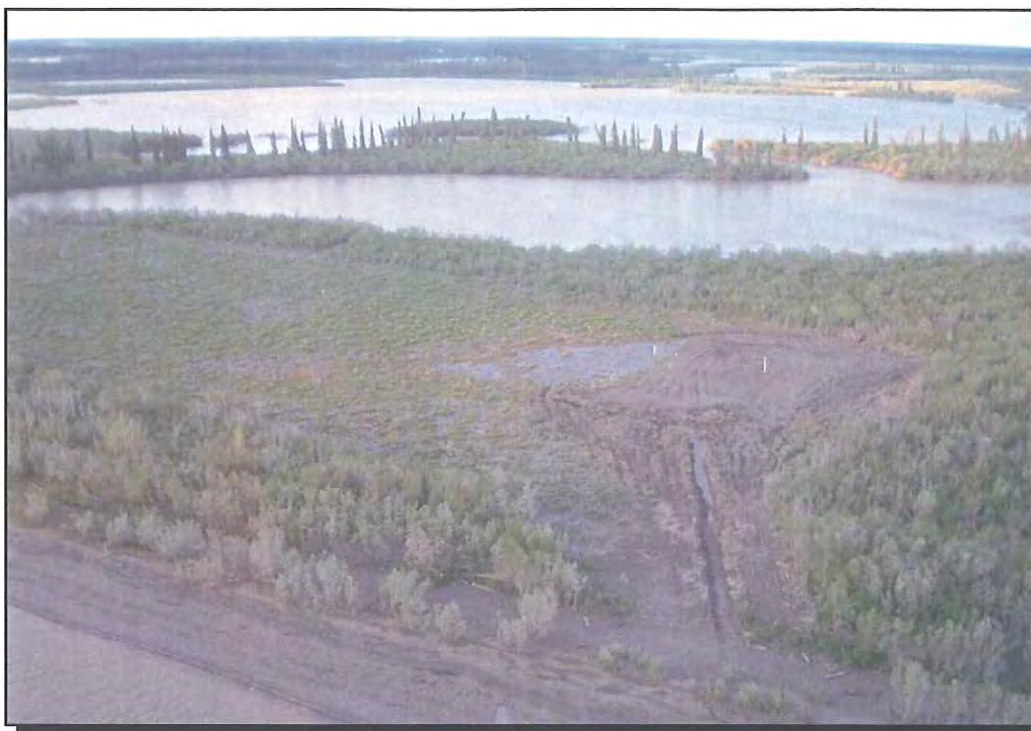
Photo 1

Most of the lease, which was cleared of trees, shows a healthy level of natural re-vegetation since 2003. The sump area, however, is generally bare and shows the imprint of a dozer's tracks. Grading work done to improve drainage from the cap and from the pond on the east side of the sump by Devon in 2005 probably stripped away any natural re-vegetation that may have existed from these areas.

Itiginkpak F-29 Lease and Sump Area – June 16, 2006 (viewed southward)

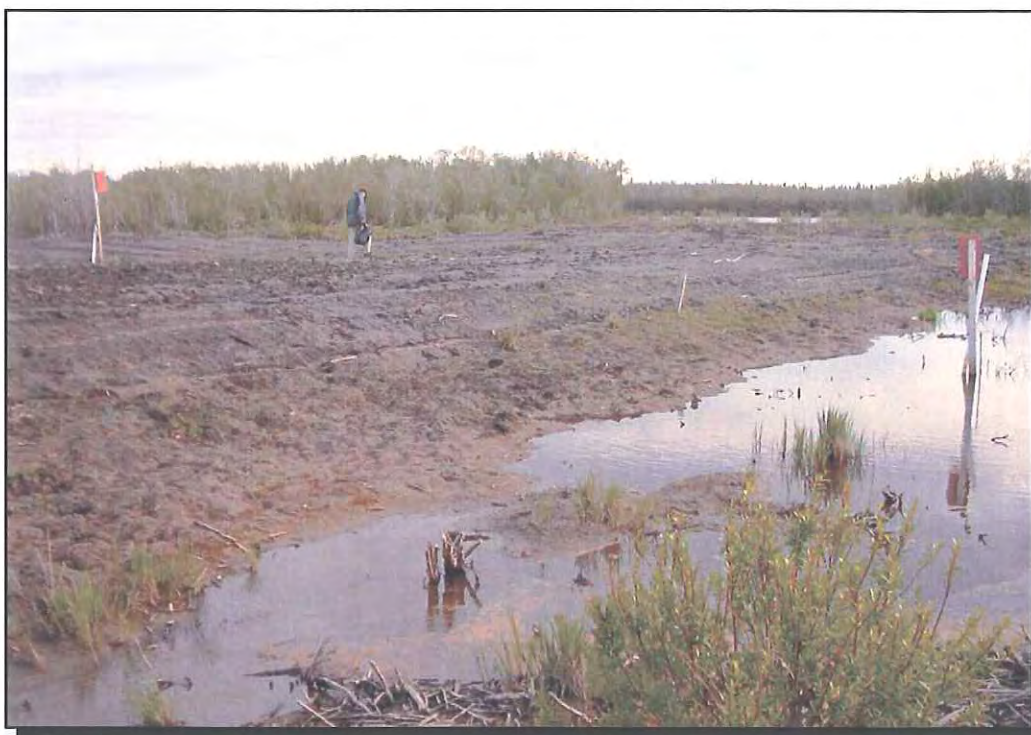
Photo 2

Itiginkpak F-29 Sump Cap and Edge of East Pond (viewed northward)

To push the ponded water away from the sump, the west end of the pond should be filled for a distance of 10 m from the interpreted original edge of the sump excavation, or about 5 m wider than the cap fill outlined above. The fill should not be allowed to block either outlet from the pond. It should extend the length of the sump and have a height of at least 1.5 m above the pond outlet level (to elevation 5.4 m). Final sideslopes on the fill in this section should be 2H:1V. Before the fill is placed, pond ice should be removed from the fill area. The pond ice, which could have a low level of salinity, can be wasted at the east end of the lease. The berm can be constructed of pit-run granular fill, sourced and placed as described above.
