RE: INDUSTRIAL Water Use N7L1-1786

Swimming Point Mackenzie River

INDUSTRIAL WATER USE INSPECTION REPORT

LICENCE #:	N7L1-1786, Swimming Point	EXPIRY DATE:	September 30, 2002
LICENCEE:	Cyntech Tank Services Inc.	PREVIOUS INSPECTION:	New
COMPANY REP:	Mervin S. Fulawka	INSPECTION DATE:	July 31, 2013

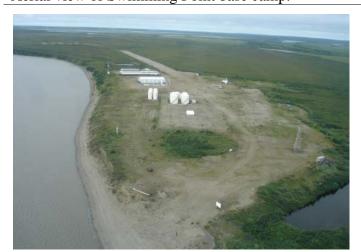
Figure 1 Aerial view of Swimming Point base camp.

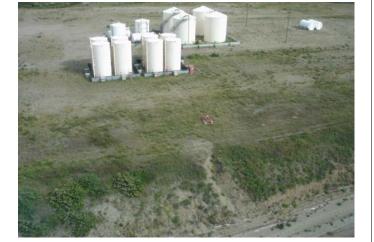
- There does not appear to be any obvious signs of disturbance as a result of hydrostatic testing, if it occurred. However in between the tank farm and the river there is what appears to be an erosion channel on the river bank where the vegetation coverage is slightly different. It is unknown what caused this.

Figure 5 Vegetation and land between tank farm and river. Potential erosion channel where vegetation coverage is different, occurring on river bank between tank farm and river (below fuel line, bottom center of photo).

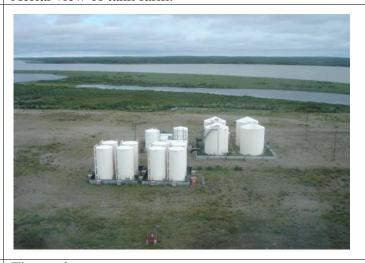
Figure 2 Aerial view of tank farm.

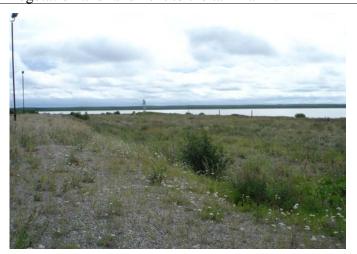
- It is unclear if the discharge of wastewater from the hydrostatic testing of used fuel tanks at the Swimming Point base camp ever took place. There are no indications either way. No records are available for this project.
- No report was provided to determine how much wastewater was discharged.
- The grass area between the tanks and the Mackenzie River was acceptable at the time of Inspection. No indications of impacted vegetation if the discharge of wastewater from hydrostatic testing occurred.

Figure 4 Vegetation and land next to the tank farm.
