**RE: Industrial Water Use N7L1-1797  
CLASS B - INDUSTRIAL**

## INDUSTRIAL WATER USE INSPECTION REPORT

<b>LICENCE #:</b>	N7L1-1797	<b>EXPIRY DATE:</b>	December 31, 2014
<b>LICENCEE:</b>	MGM Energy Corp.	<b>PREVIOUS INSPECTION:</b>	March 2, 2004
<b>COMPANY REP:</b>	Shirley Maaskant	<b>INSPECTION DATE:</b>	October 2, 2012

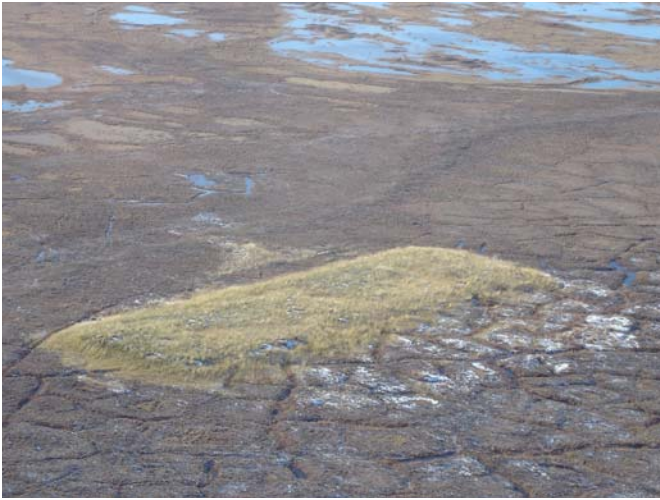
1. The sump cap itself appeared stable with no subsidence or ponding issues on the sump cap except the north side of the sump. There was slight ponding/subsidence present in a couple of areas on the edge of the sump. These seem to be in line with the polygon/permafrost features. The subsidence does not appear to be affecting sump containment from visual observations but it is important to verify this to ensure sump cap stability and the integrity of waste containment.

**Figure 1**  
Aerial overview of drilling waste sump, from the northeast corner. Note the subsidence and polygons presence surrounding the sump.

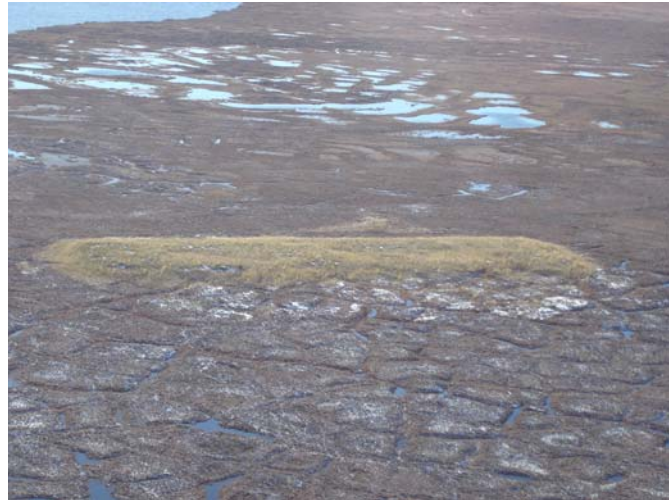
**Figure 2**  
Aerial overview of the sump, from the north end.

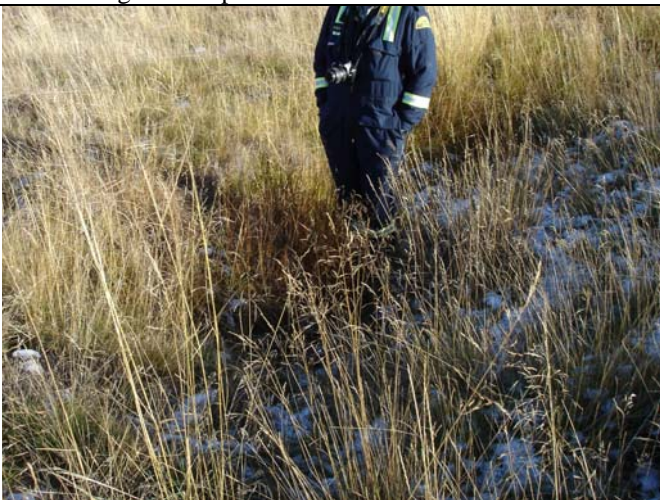
**Figure 3**  
Subsidence along the edge of the northern side of the sump. Polygons were present in the area.

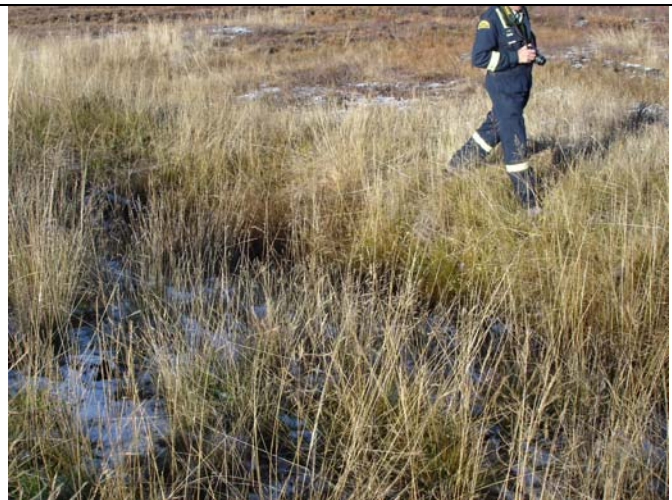
**Figure 4**  
Subsidence present along the edge of the northern side of the sump.

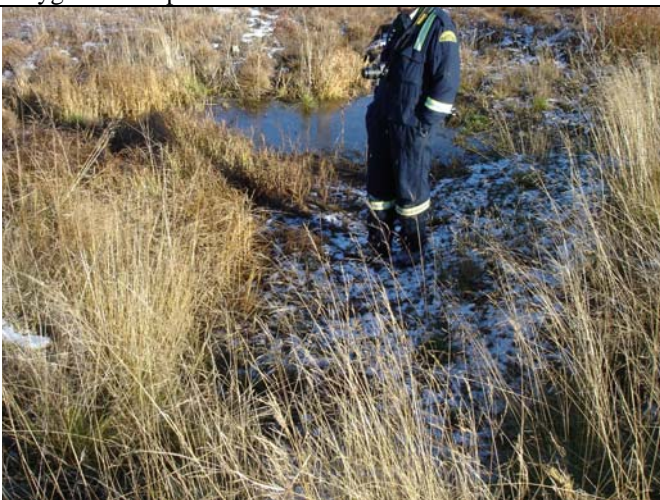
**Figure 5**  
Subsidence and ponding present on the edge of the northern side of the sump.

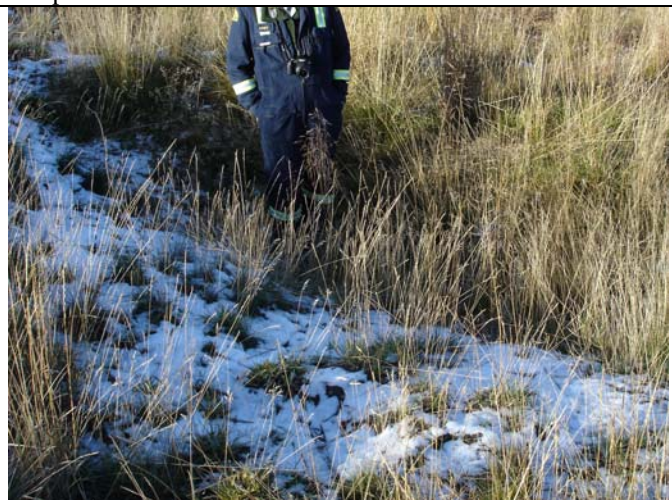
**Figure 6**  
Further subsidence along the edge of the northern side of the sump.
