October 4, 2007

**Re: Water Licence N7L1-1797
Broken Thermister String and Modified Depths of Thermister Strings at
the Umiak N16 Sump**

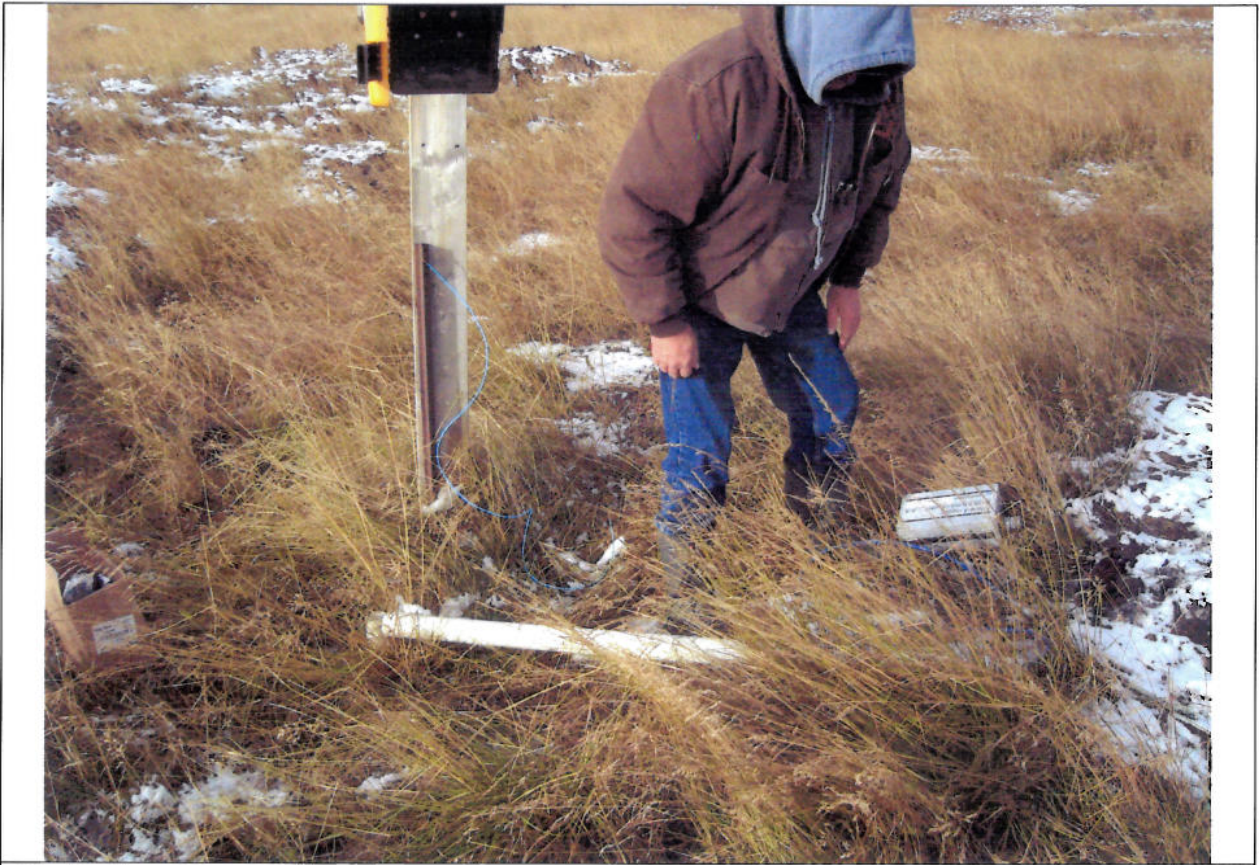
On September 13, 2007, during a soil sampling program and the annual Electromagnetic (EM) surveys at the Umiak N16 sump, the PVC standpipe encasing thermister 1728 was observed to be damaged by wildlife. The PVC standpipe encasing the thermister was broken at the base and the thermister string was visible just above the ground (see Photo 1). Upon further investigation it appeared that the thermister string was not adequately anchored in the ground with either sand and/or pea gravel and may not have been logging at required depths specified by Water License No. N7L1-1797. Table 1 illustrates the initial assumed depths and revised depths of the thermister strings based on the observations during the September 2007 site visit. Currently, three years of a five year sump monitoring program have been completed at the Umiak N16 Sump under Water License Number N7L1-1797.

Thermister string 1728 is broken at the point it attaches to the datalogger and is currently not logging. At this time, it is believed that the thermister string can be rewired and attached to the datalogger and monitoring can continue.

Photo 1. – Broken standpipe

- Re-attaching the existing thermistor string to the 1727 datalogger. This would allow the datalogger to continue logging at the current sensor depths. If it is not feasible to attach the thermistor string to the existing datalogger, a new datalogger will be obtained and installed, ensuring that the colour coded wires are correlated to the depths of the thermistor sensors.
- Installing new datalogger containment boxes for all dataloggers at a secure height to reduce the potential of damage to the thermistor strings from wildlife.
- Replacing the existing wood posts with metal posts to support all dataloggers.
- Install adequate sand and/or pea gravel support at the existing thermistor strings.
