RE: INDUSTRIAL Water Use N7L1-1814

Johnson Point Unnamed River

INDUSTRIAL WATER USE INSPECTION REPORT

LICENCE #:	N7L1-1814, Johnson Point	EXPIRY DATE:	July 09, 2009
LICENCEE:	Contaminants & Remediation Directorate	PREVIOUS INSPECTION:	New
COMPANY REP:	Bill Coedy	INSPECTION DATE:	August 30, 2013

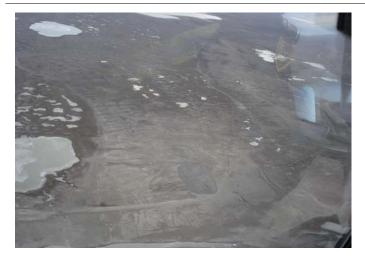
Area adjacent to small lake and access road.

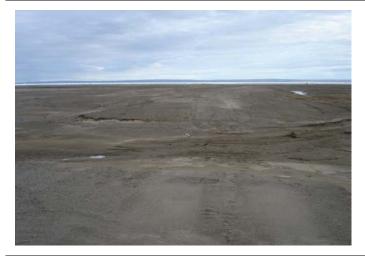
Figure 3
Along access road and facing southeast towards runway.

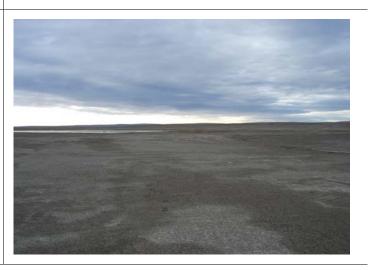
Figure 4Area adjacent to runway where access road intersects.

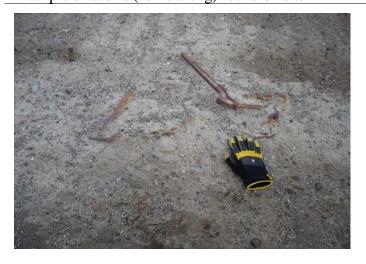
- Minimal debris waste was observed such as a metal come along on the most southerly treated soil disposal area. It is thought that this might have been from the recent remediation activity (Water Licence N7L1-1824) if not some of the past historic/staging activities associated with Johnson Point. When Contaminants & Remediation Directorate - Aboriginal Affairs and Northern Development is in the area doing monitoring etc any debris exposed on site should be removed for proper disposal.

Figure 5 Example of debris (come along) found on site.
