**JOHNSON POINT SITE INVESTIGATION
BANKS ISLAND, JULY 23, 2002**

Prepared by: Terry Skjonsberg, Chief Park Warden, Aulavik National Park

Parks Canada, Western Arctic Field Unit

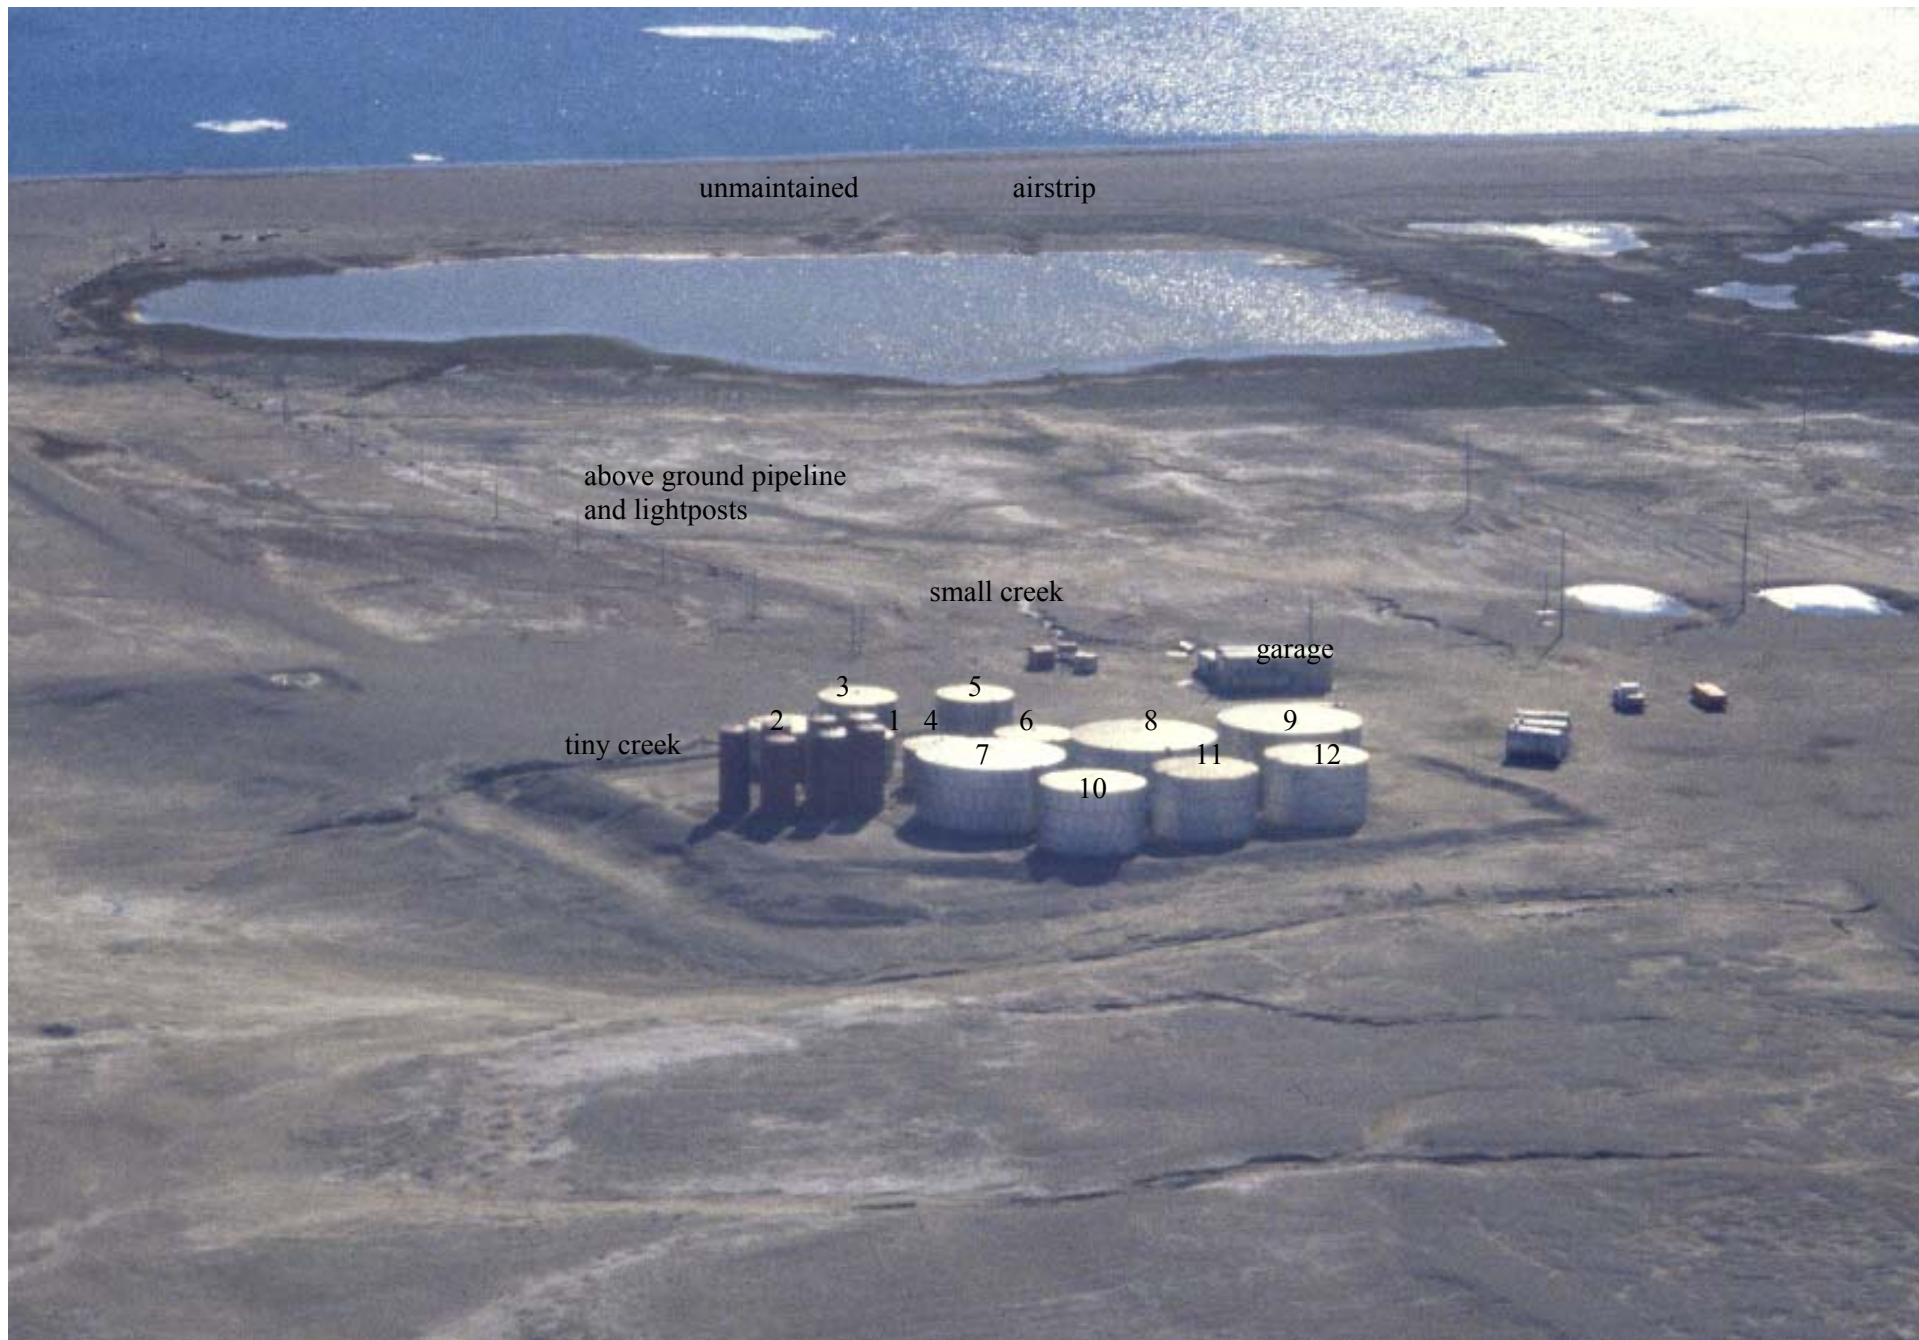
Two tiny creeks that flowed away from the site had a red coloration to the soils and an oily sheen to the water. The creeks did not seem to carry the oily sheen very far as the creeks appeared normal beyond 50 meters from the site. These creeks are identified on Figures 1 and 3.

Figure 1. Johnson Point Site – aerial photo looking east.

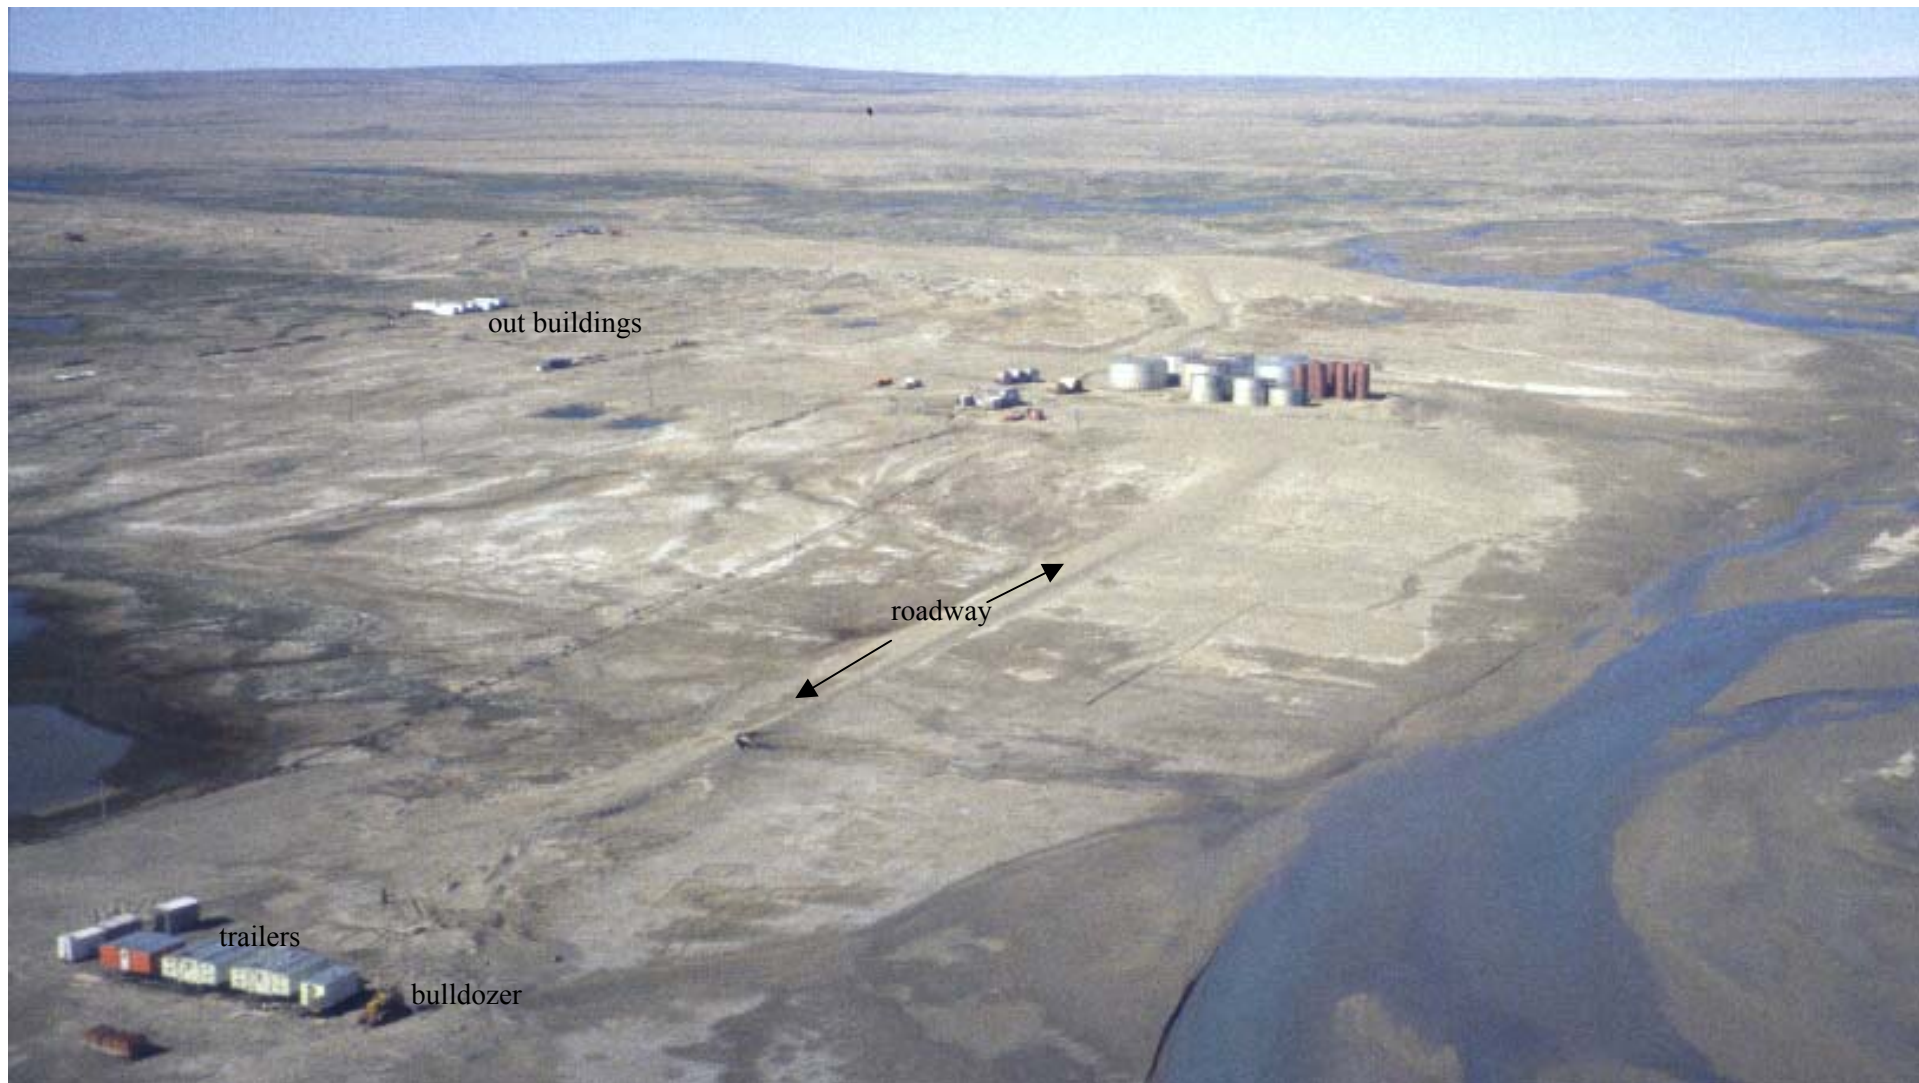
Figure 2. Johnson Point Site – aerial photo looking west.

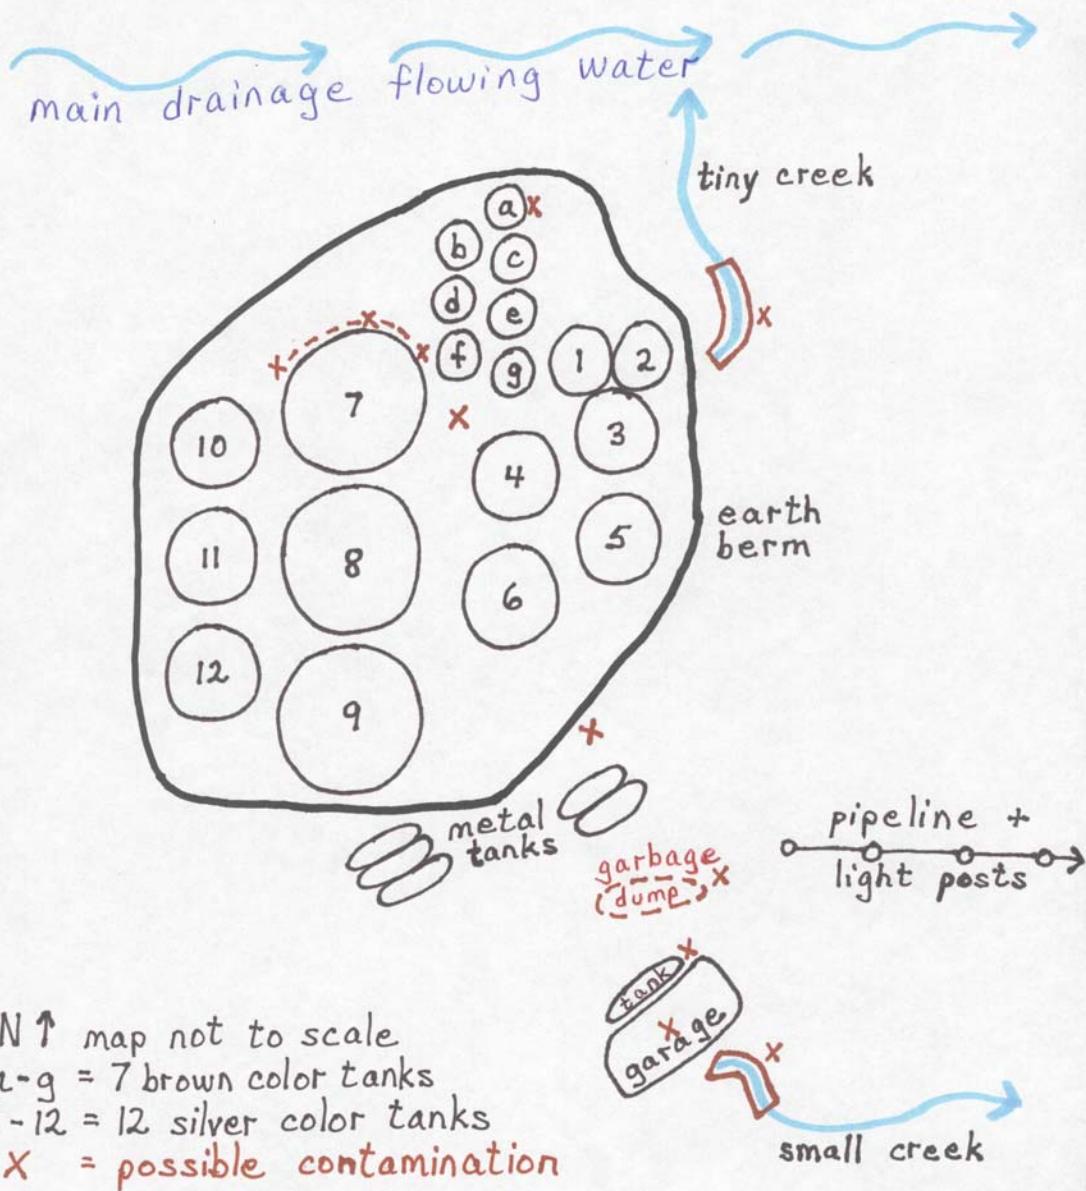
Figure 3 : Johnson Point Site

silver-coloured tanks, approximately 6 m high and 5 m in diameter (Figures 1-3). Three of the silver tanks “1-3” contain at least two metres of hydrocarbon fluids. All of these tanks are standing upright on the ground. There were 5 smaller fuel tanks outside the southern edge of the earthen berm. In addition, there was a fuel tank associated with the wooden garage. These six tanks are lying on the ground on their side. Figure 3 shows the location of fuel tanks.

There were some areas around the fuel tanks that showed signs of ongoing fuel leaks (Figure 3). One valve stem at the bottom of fuel tank “a” had a slow drip leak to it. The valve stem on the fuel tank at the wooden garage also had a slow leak. Fuel tank “7” seemed to have a leak at the metal seam at ground level. In addition, there were two spots on the ground that were damp and smelled of hydrocarbon fuels. One spot was inside the earthen berm and the second was outside it. These two ground spots were several meters from the nearest above ground source of contamination. All contaminated spots are marked with an “x” on Figure 3.
