RE: **Industrial Water Use (N7L1-1824)**

An inspection was conducted of the Johnson Point Site Remediation/Clean-up on August 12, 2010. Enclosed is a copy of the Industrial Water Use Inspection Report.

INDUSTRIAL WATER USE INSPECTION REPORT

DATE:	August 12, 2010	COMPANY REP:	Bill Coedy
LICENCEE:	Contaminants & Remediation Directorate	LICENCE #:	N7L1-1824

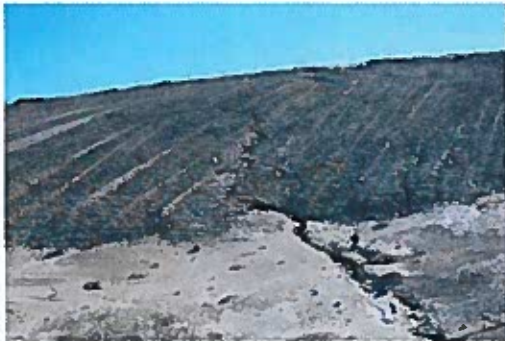
1. Evidence of erosion was observed on Soil Disposal Areas. Small erosion channels noted from water running down slope towards area drainage which leads to the Unnamed River (see Figures 1, 2 and 3). Site post reclamation monitoring activities should include water sampling down hill and in the river down stream to confirm if there are any environmental impacts from soil erosion of these Soil Disposal Areas.

Figure 1
Erosion is occurring on Soil Disposal Areas.

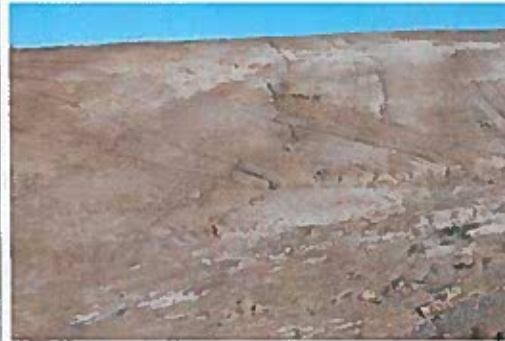
Figure 2
Wide array of erosion channels along face of Soil Disposal Area.

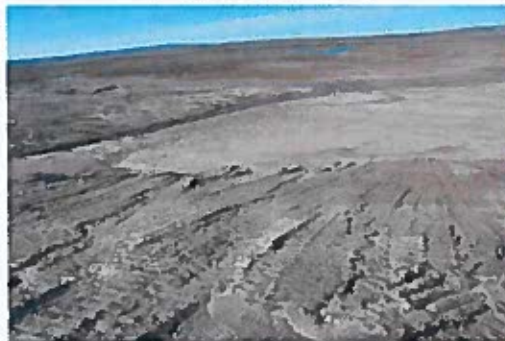
Figure 3
Water erosion running down slope towards area drainage which leads to Unnamed River.

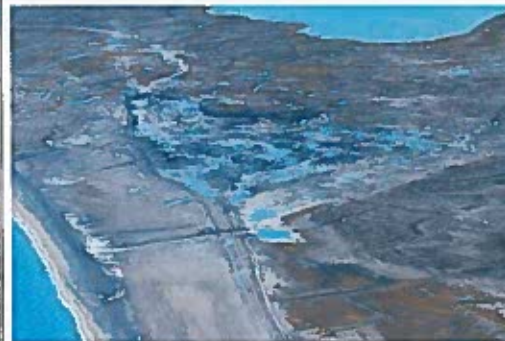
1. Project remediation and reclamation activities on site have finished. However the borrow area (see Figure 4) located at the end of the runway continues to have active permafrost degradation and improper drainage of water from the site due to little contouring and restoration. The section of the access road removed for granular material (see Figure 5)

continues to have slumping and subsidence present. These areas have remained the same due to being too wet and further attempts at reclamation would have caused more damage. Contouring of these sites would aid in returning them to prior condition, aid with proper drainage and restore permafrost stability.

Figure 4
The borrow areas disturbance to permafrost without full restoration continues to have slumping and subsidence.

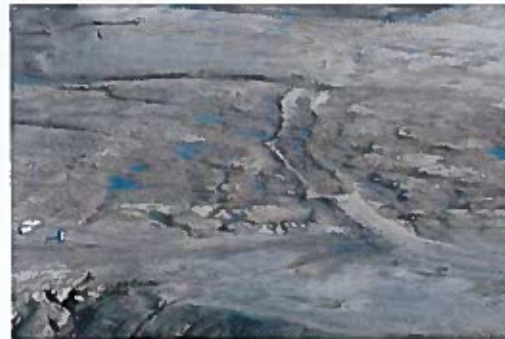
Figure 5
The section of the access road removed for granular material, slumping and subsidence present.

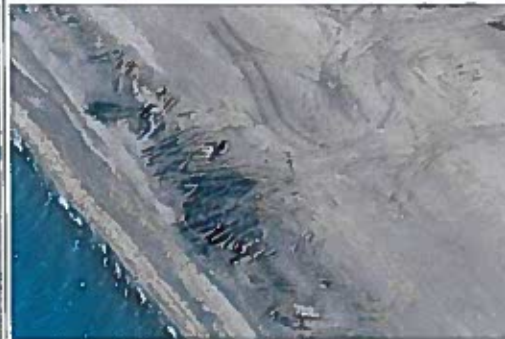
2. Area of barge demobilization was quite untidy. Large disturbance to shore and large depression estimated to be a metre deep and several square metres in size (see Figure 6). Large piles of shore material associated with this disturbance present. Efforts should be made to restore this area.

Figure 6
Area of barge demobilization had large disturbance to shore.
