**RE: INDUSTRIAL Water Use N7L1-1824
CLASS B - INDUSTRIAL
Johnson Point
Unnamed River**

INDUSTRIAL WATER USE INSPECTION REPORT

| LICENCE #: | N7L1-1824, Johnson Point | EXPIRY DATE: | May 31, 2013 |

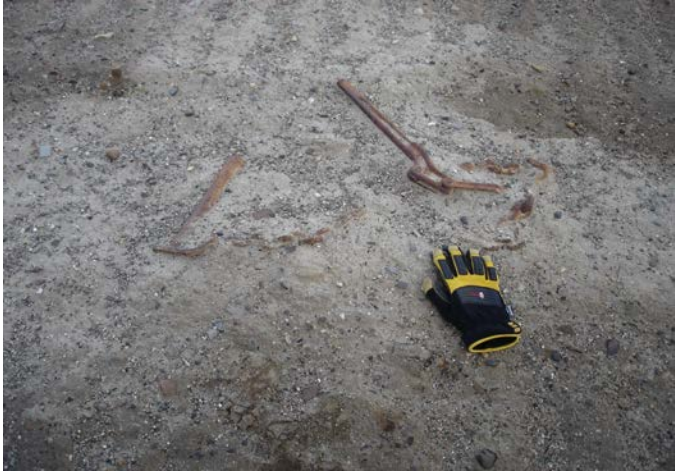
- Landfills still well secured and erosion is being controlled by the armour stone surrounding and covering the various sites.
- The soil disposal areas are looking acceptable with stable slopes and sides. Minimal erosion is present but small compared to the surrounding areas that are naturally experiencing a lot more erosion.
- Minimal debris waste was observed such as a metal come along on the most southerly treated soil disposal area. It is thought that this might have been from the recent remediation activity (Water Licence N7L1-1824) if not some of the past historic/staging activities associated with Johnson Point. When Aboriginal Affairs and Northern Development - Contaminants & Remediation Directorate is in the area doing monitoring etc any debris exposed on site should be removed for proper disposal.

| <p>Figure 1 Example of debris (come along) found on site.</p> | <p>Figure 2 Backfilled excavation area adjacent to river.</p> |

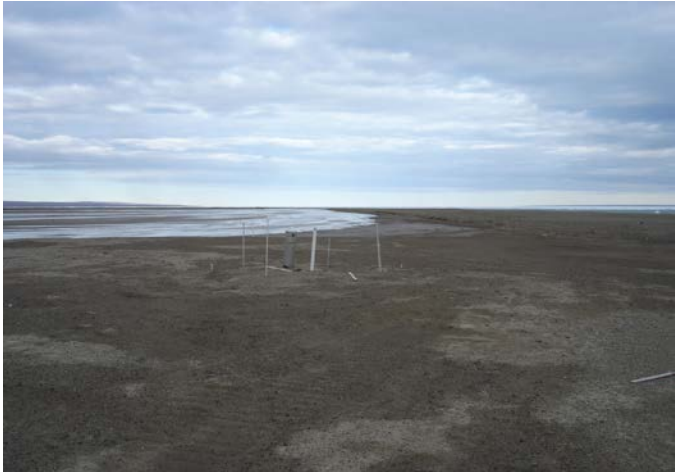
- Drainage for the site is being maintained and is naturally establishing itself in the area.
- Restoration work has succeeded in the area especially the excavations on the apron area, along the shore area, near runway and bordering the river. These areas were disturbed to excavate contaminated ground material to either clean or approved depths and then backfilled. Stability was a concern due to the amount of area that was disturbed and as it was unknown if the permafrost would re-integrate into the backfilled material. Thermistors were installed to monitor the areas of most concern in conjunction with scheduled site visits to Johnson Point.

| <p>Figure 3 Thermistor amidst backfilled excavation area adjacent to river.</p> | <p>Figure 4 Access road and drainage area intersection.</p> |

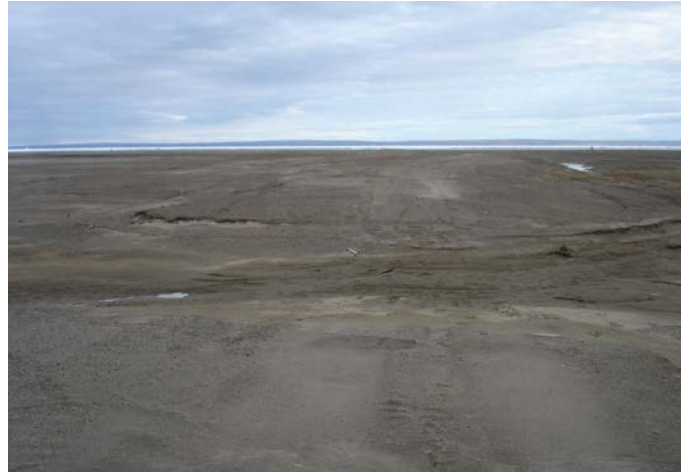
- Erosion - acceptable - Area restoration has been completed. All equipment, camp and materials have been removed from the site.
- Thermistors remain on site and are in acceptable condition.

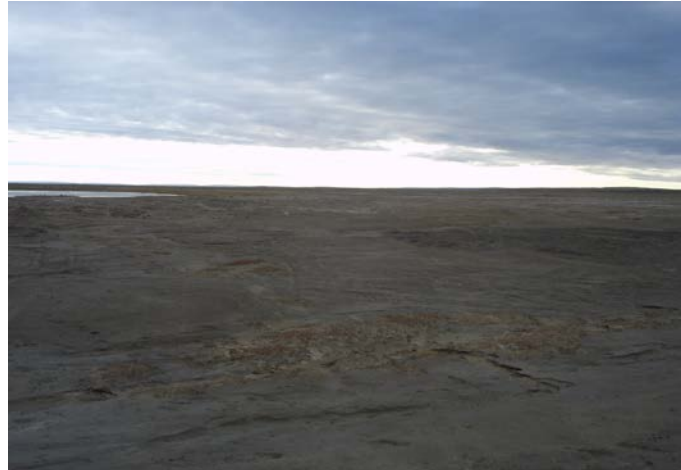
- Former camp area, treated greywater effluent discharge area and settling lagoon area were in good condition with no concerns.

| <p>Figure 5 Access road along former settling lagoon and camp area.</p> | <p>Figure 6 Treated wastewater discharge area.</p> |

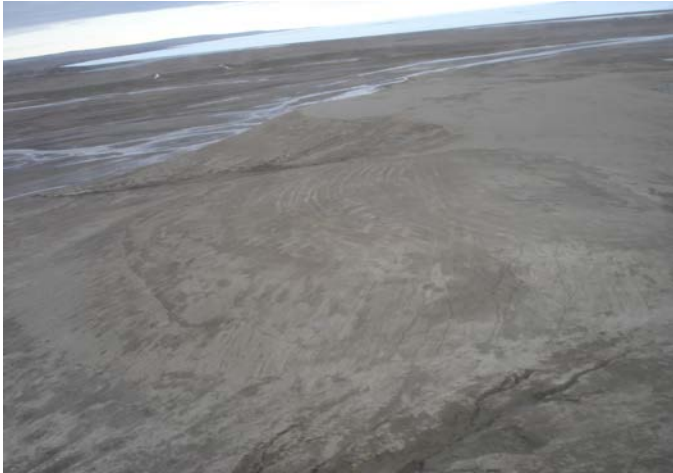
Figure 7

Treated soil disposal area.

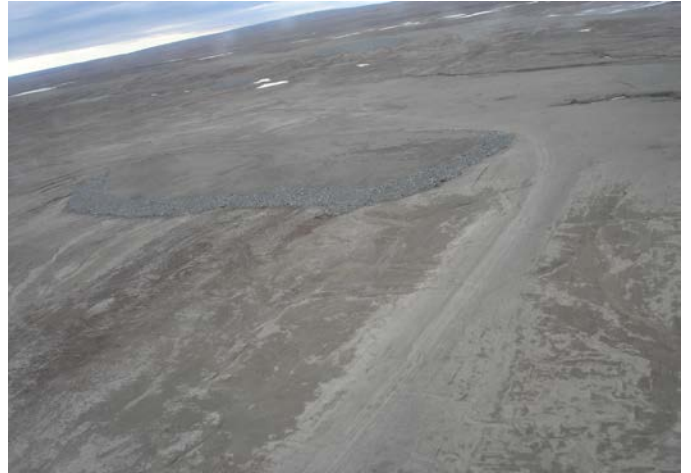
Figure 8

Landfill A.

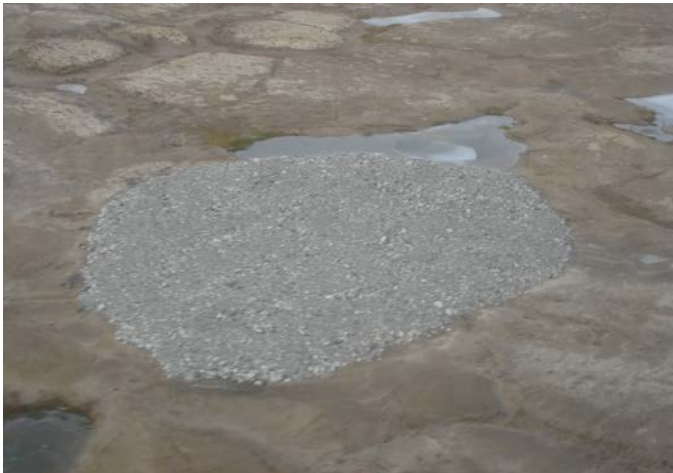
Figure 9

Landfill B

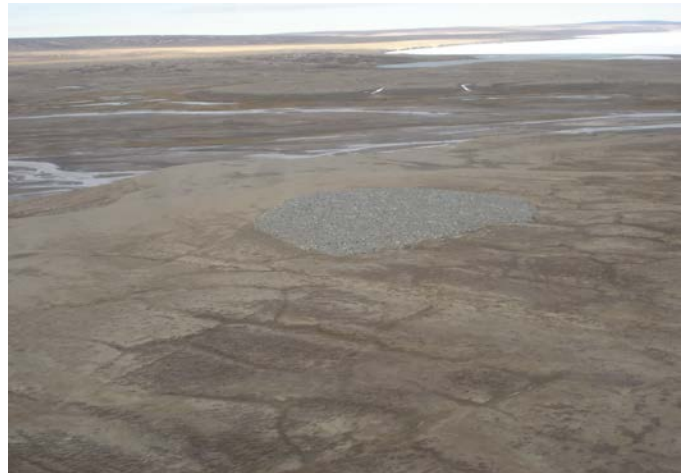
Figure 10

Landfill C

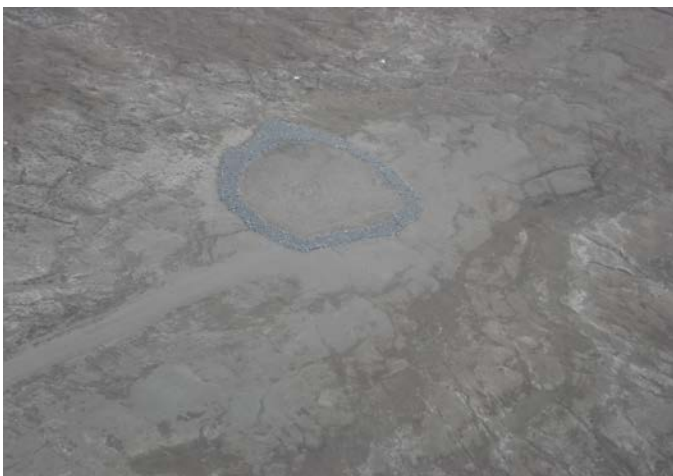
Figure 11

Landfill D

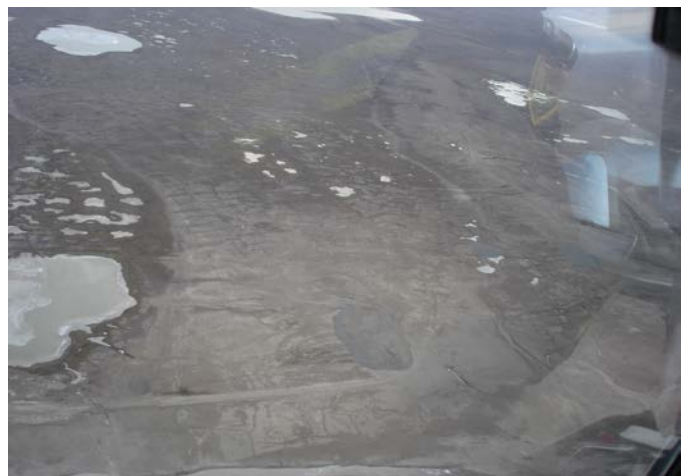
Figure 12

Aerial view of area north of runway, small unnamed lake and access road.
