RE: Industrial Water Use (N7L1-1824)

An inspection was conducted of the Johnson Point Site Remediation/Clean-up on July 8, 2010. Enclosed is a copy of the Industrial Water Use Inspection Report.

INDUSTRIAL WATER USE INSPECTION REPORT

DATE:	July 8, 2010	COMPANY REP:	Bill Coedy
LICENCEE:	Contaminants & Remediation Directorate	LICENCE #:	N7L1-1824

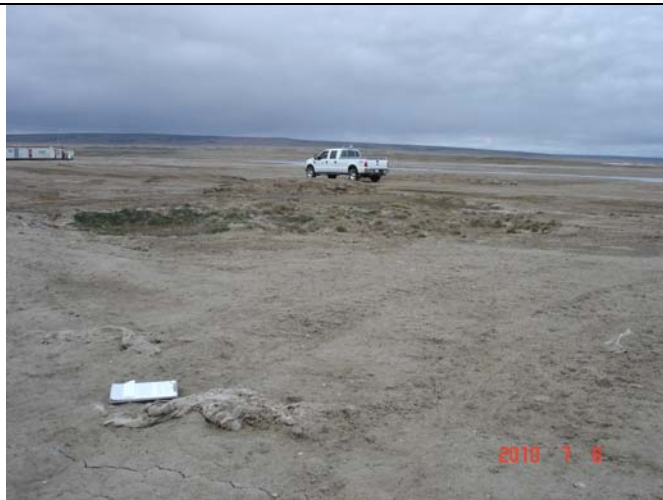
Figure 1

1. Debris such as sand bags near the road on the north end of the Unnamed Lake in addition to small waste metal appear throughout the site (see Figure 1). Ensure there is a final walk around to clean up any remaining debris.
2. Hydraulic fluid leak at the allu bucket from hoses (see Figure 2). Needs to be cleaned up and properly disposed of. Proper storage of equipment needs to occur to minimize any spills or leaks. Ensure any other spills or leaks are cleaned up upon demobilization from site.
3. Checked affected areas for both Spill 09-514 and 09-540. They are acceptable and the spill files can now be closed.

Debris on site that needs to be removed.

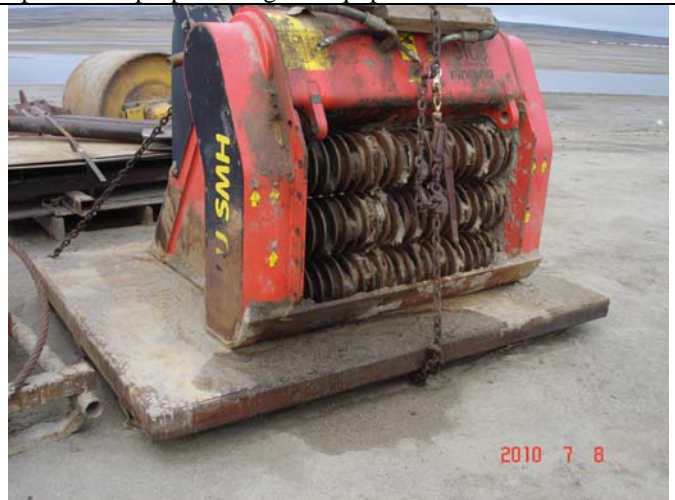
Figure 2

Hydraulic fluid leak from allu bucket that needs to be cleaned up. Ensure proper storage of equipment.

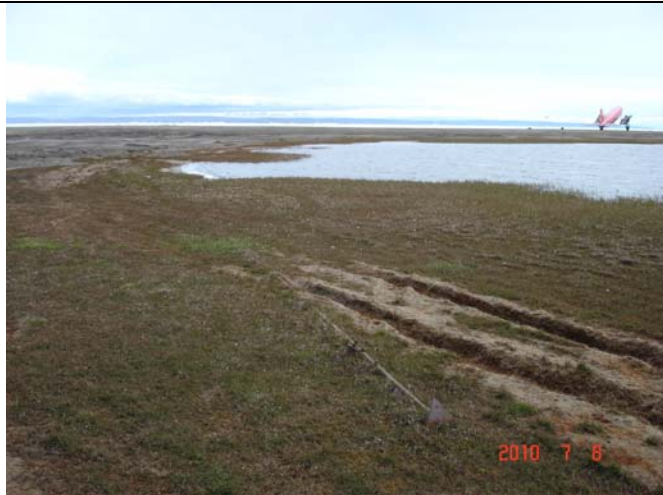
Figure 3

1. A long metal rod with attachments at the north end of Unnamed Lake. This debris should be removed with metal waste from the area (see Figure 3).
2. Site of grey water treatment cells and discharge area look acceptable, cells had been removed.

A long metal rod at the north end of Unnamed Lake that should be removed.

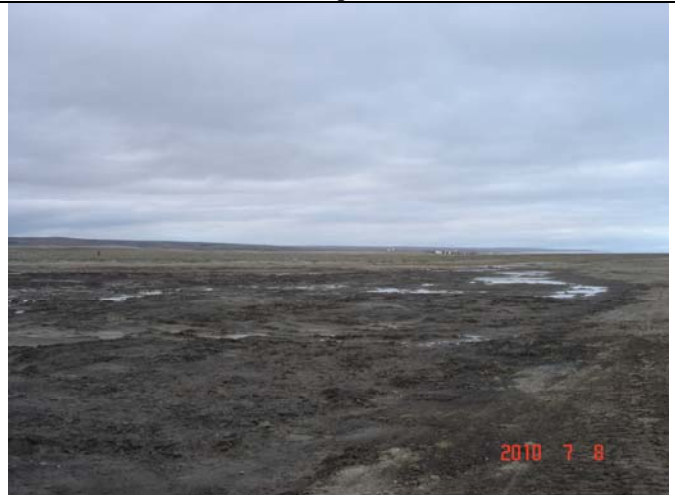
Figure 4

2. The quarry for granular material at the end of the runway appears to have little contouring or restoration completed from limitations due to conditions from permafrost degradation. Contouring of this area would aid in returning the site to similar condition prior to excavation and aid with proper drainage of water from the site (see Figure 4). In order to prevent sedimentation issues, use silt fences and minimize disturbance to water and the drainage ditch while in the area.

Quarry at end of runway in need of further contouring to return site to similar condition prior to excavation.
