Indian and Northern Affairs Canada

**REMEDIAL ACTION PLAN
JOHNSON POINT STAGING AREA
JOHNSON POINT, NORTHWEST TERRITORIES**

1740200

December 2007

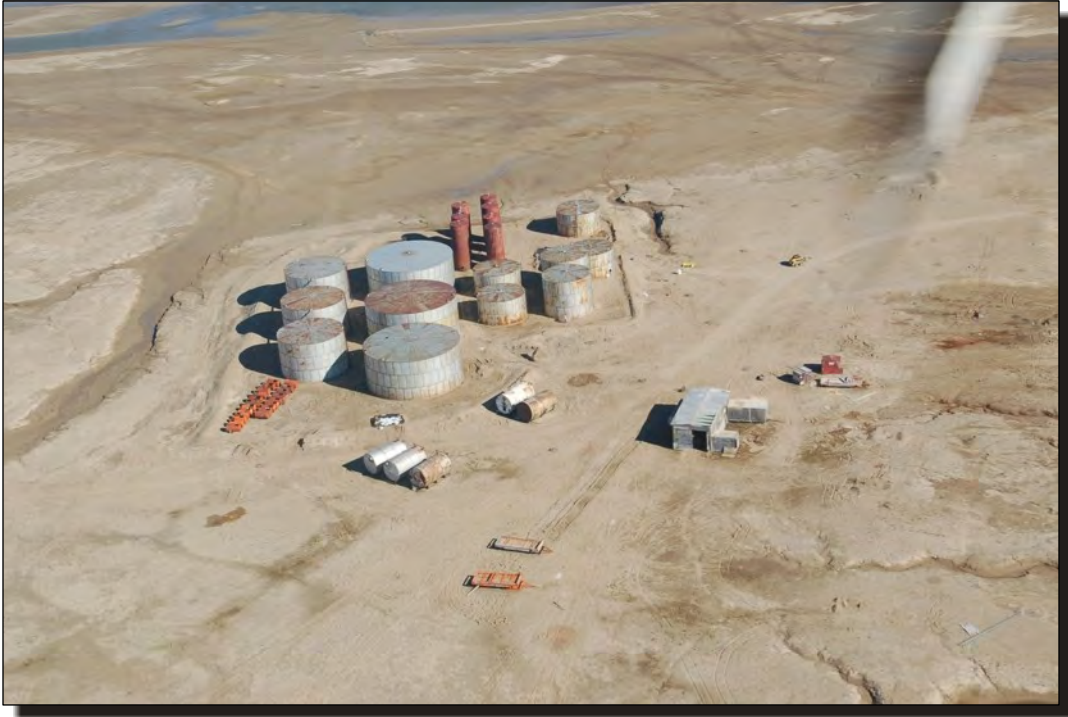
Photo 1
Aerial oblique of tank farm area.

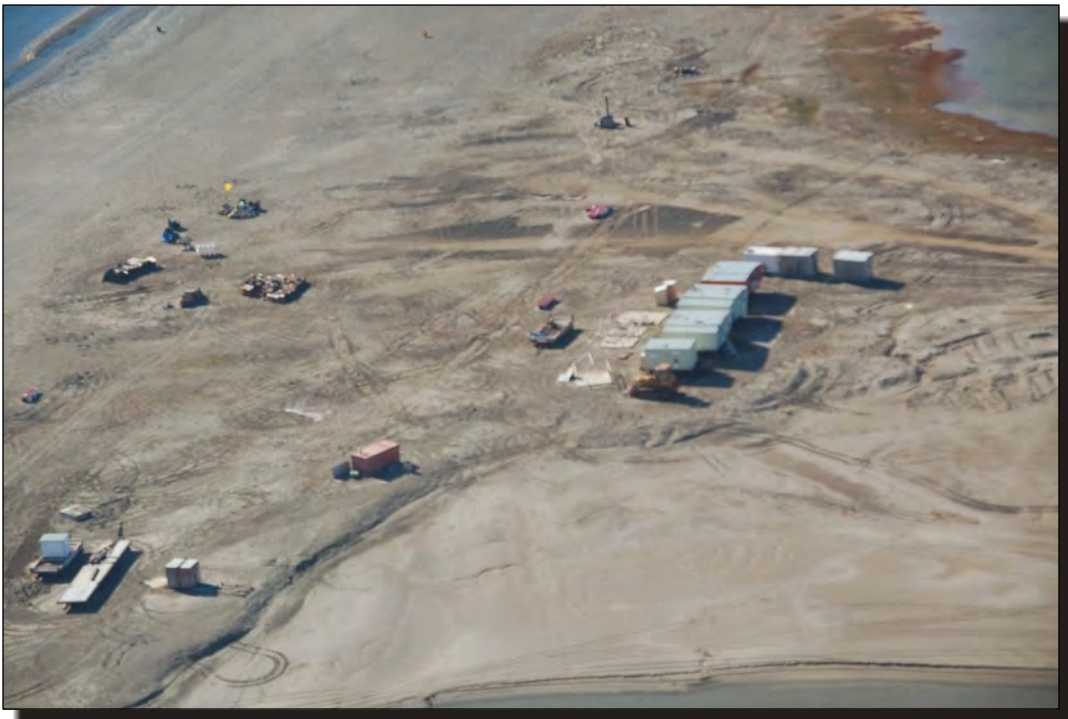
Photo 2
Aerial oblique of apron area.

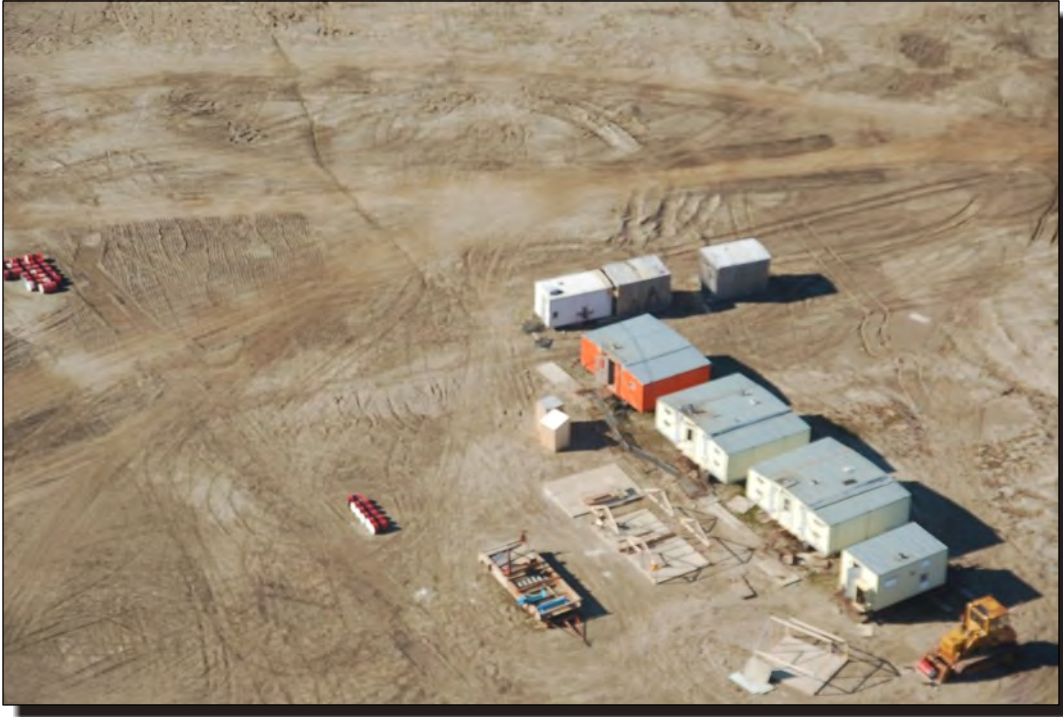
Photo 3
Close up aerial oblique of apron area.

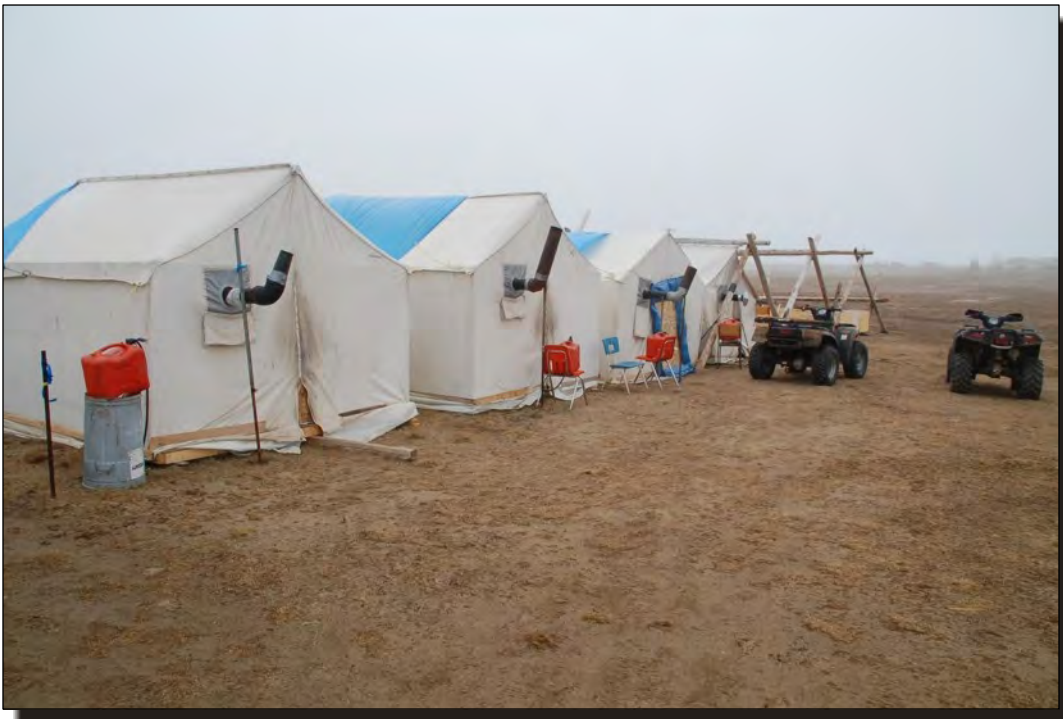
Photo 4
Camp area.

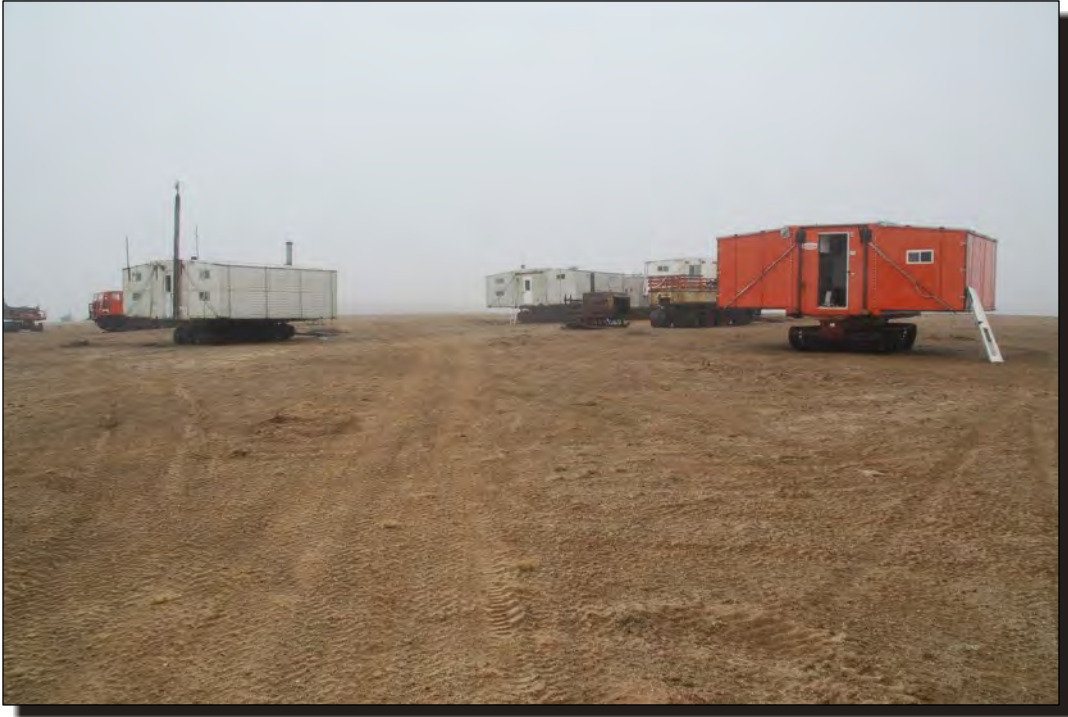
Photo 5
Trailer at upper base.

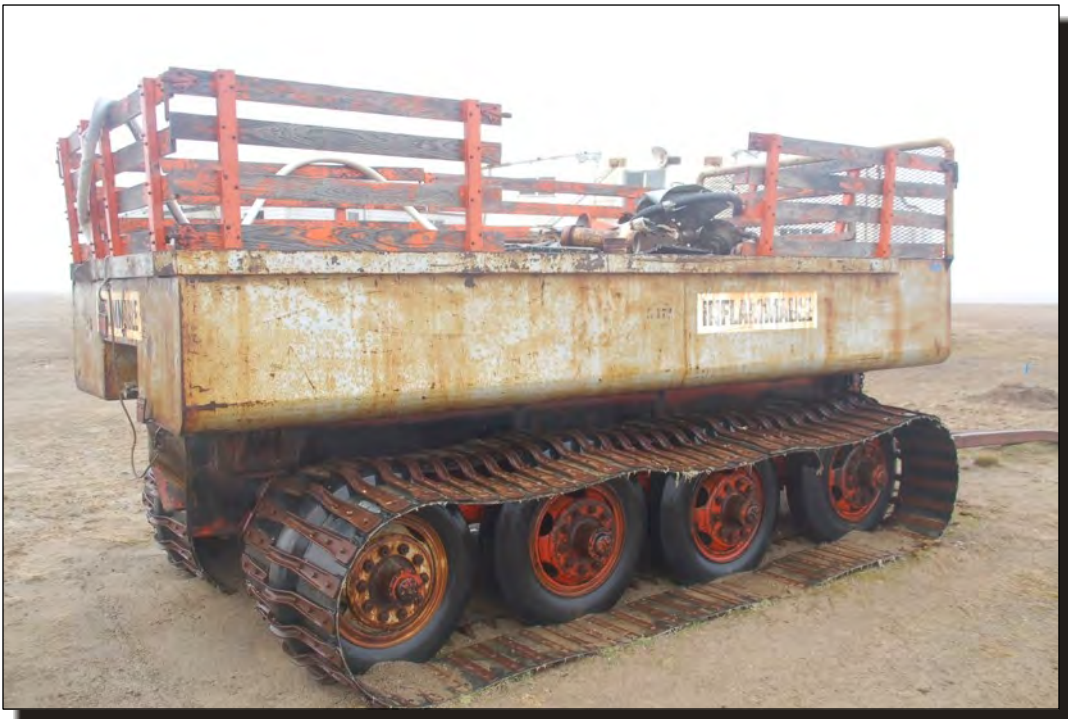
Photo 6
Equipment at upper base.

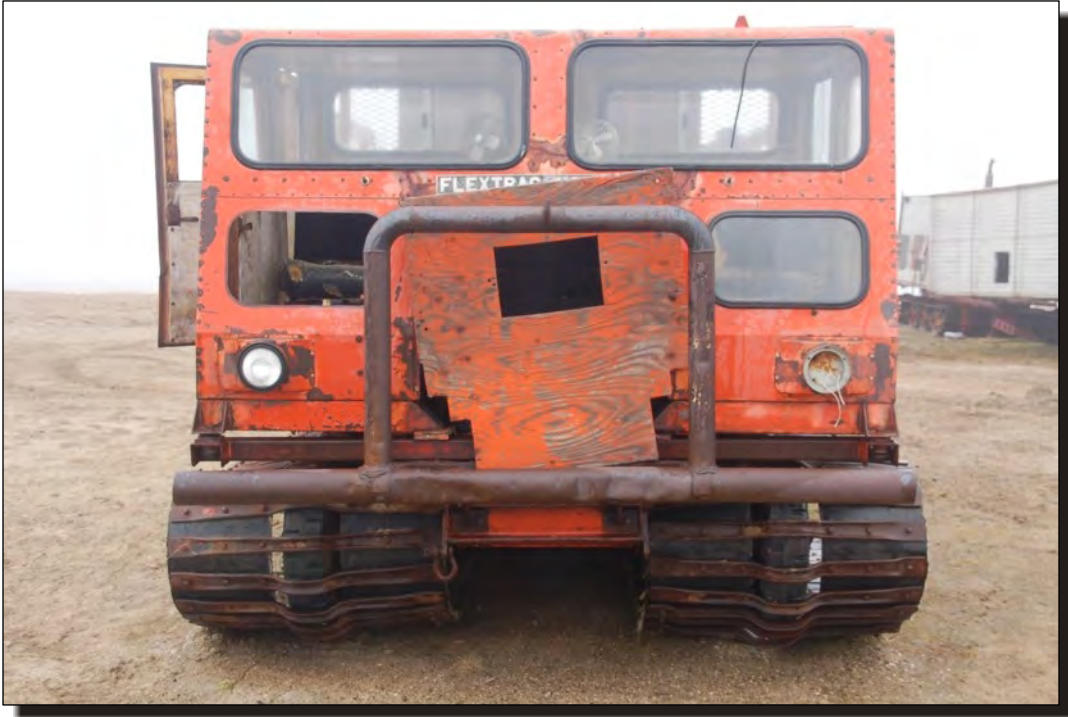
Photo 7
Nodwell at upper base.

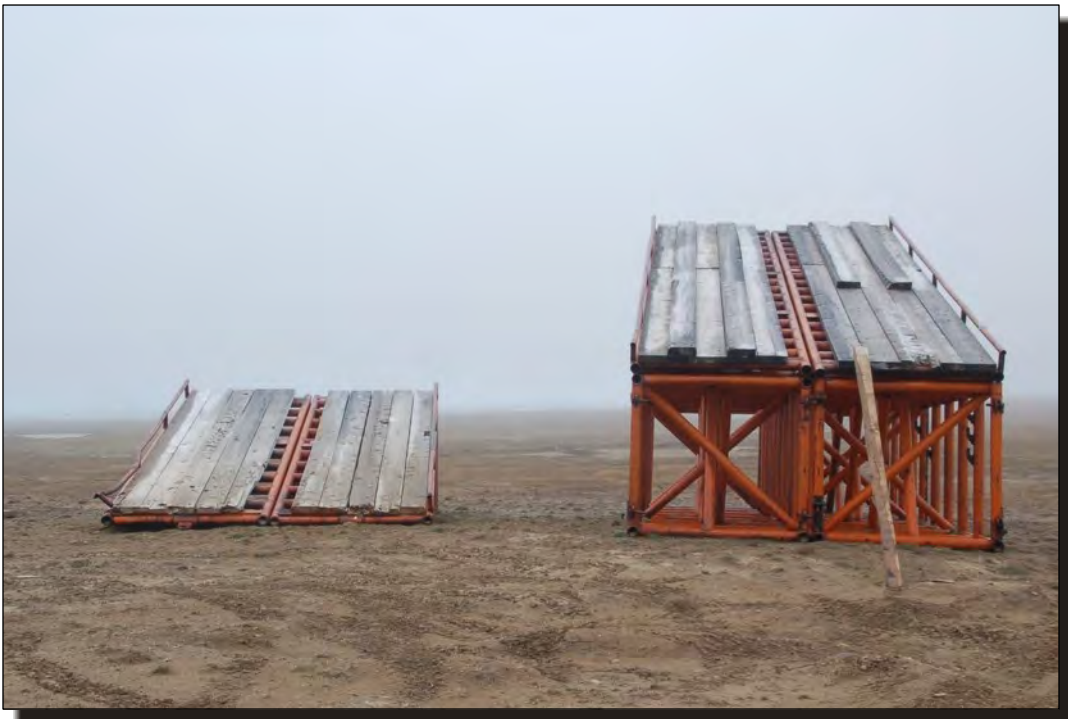
Photo 8
Loading racks at upper base.

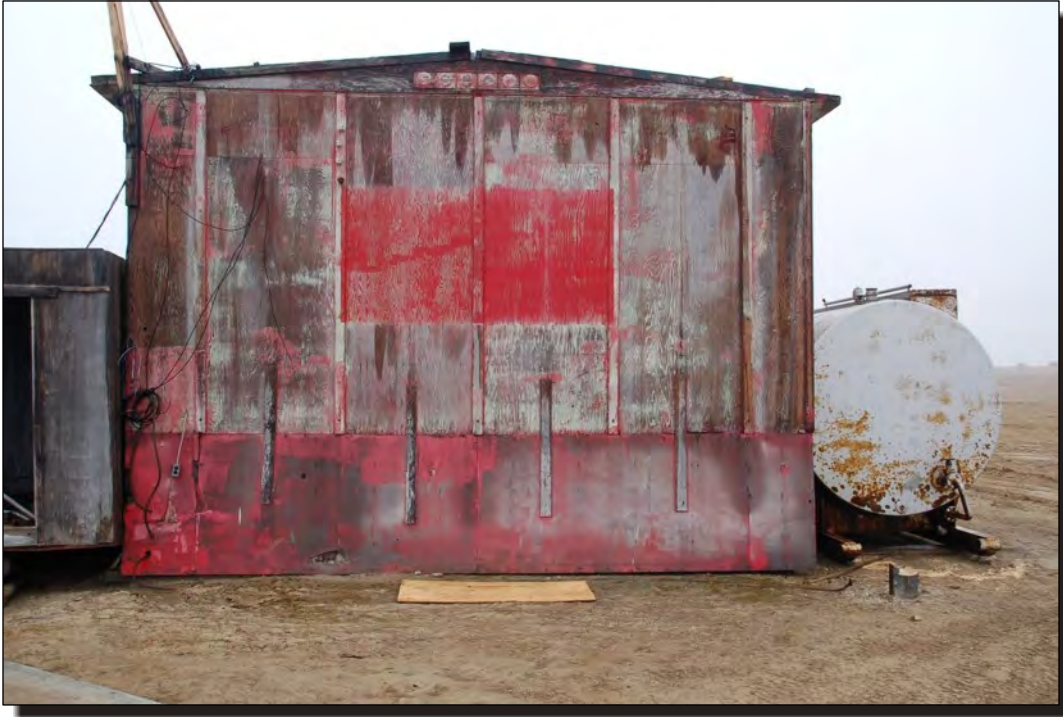
Photo 9
Garage near tank farm.

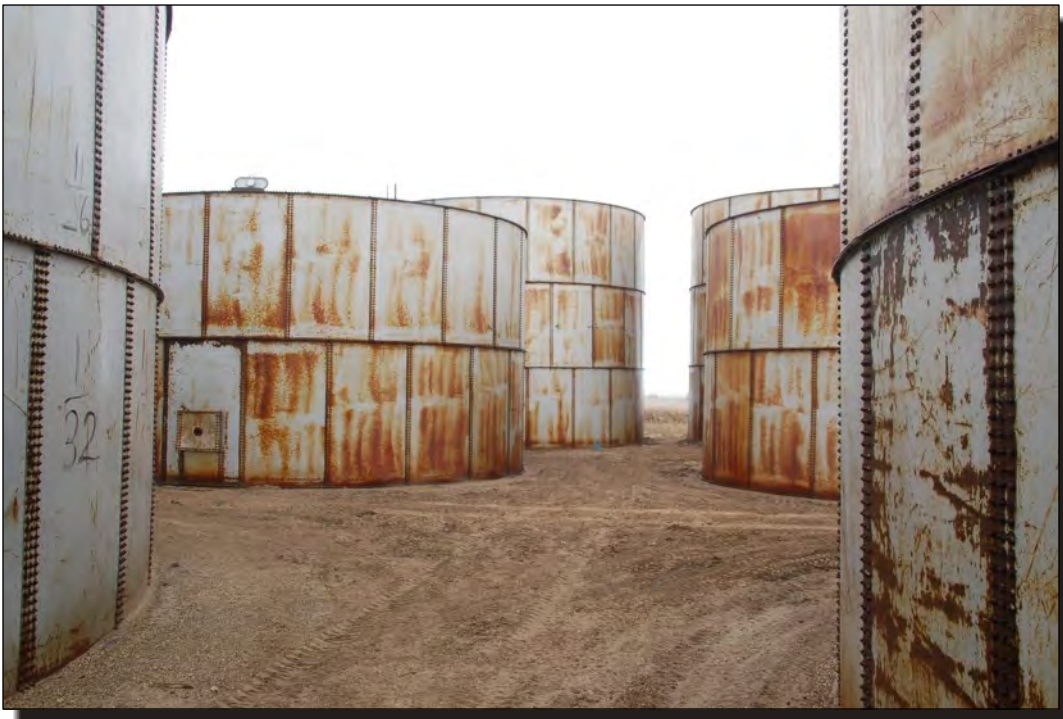
Photo 10
Tank farm.

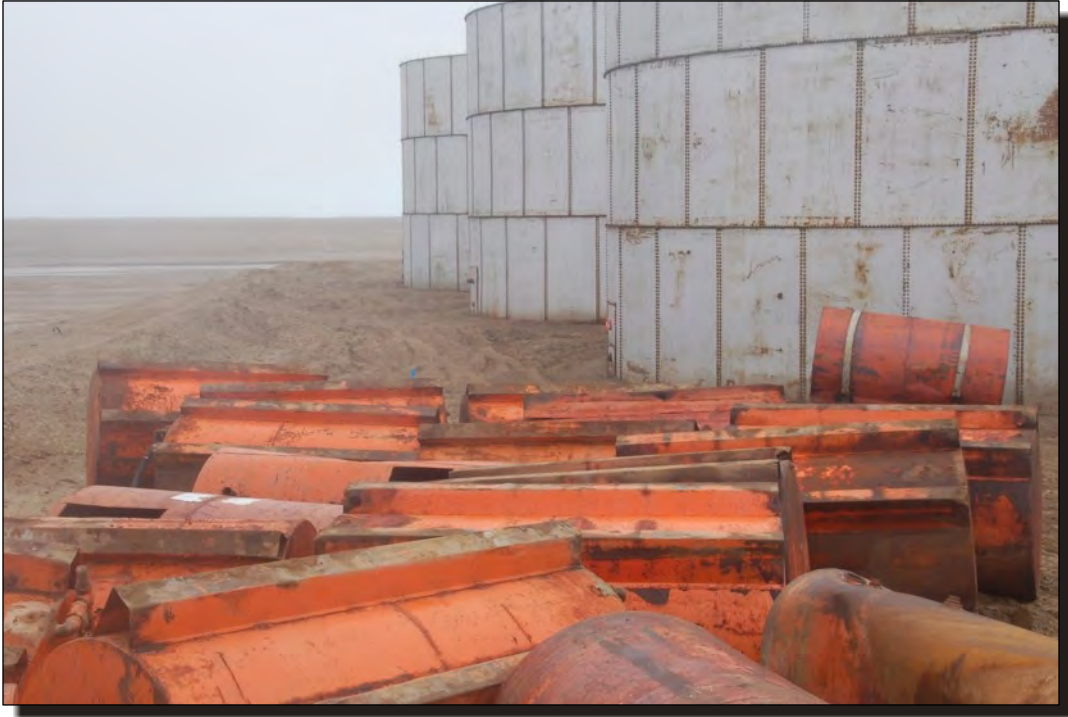
Photo 11
Utility tanks taken to tank farm.

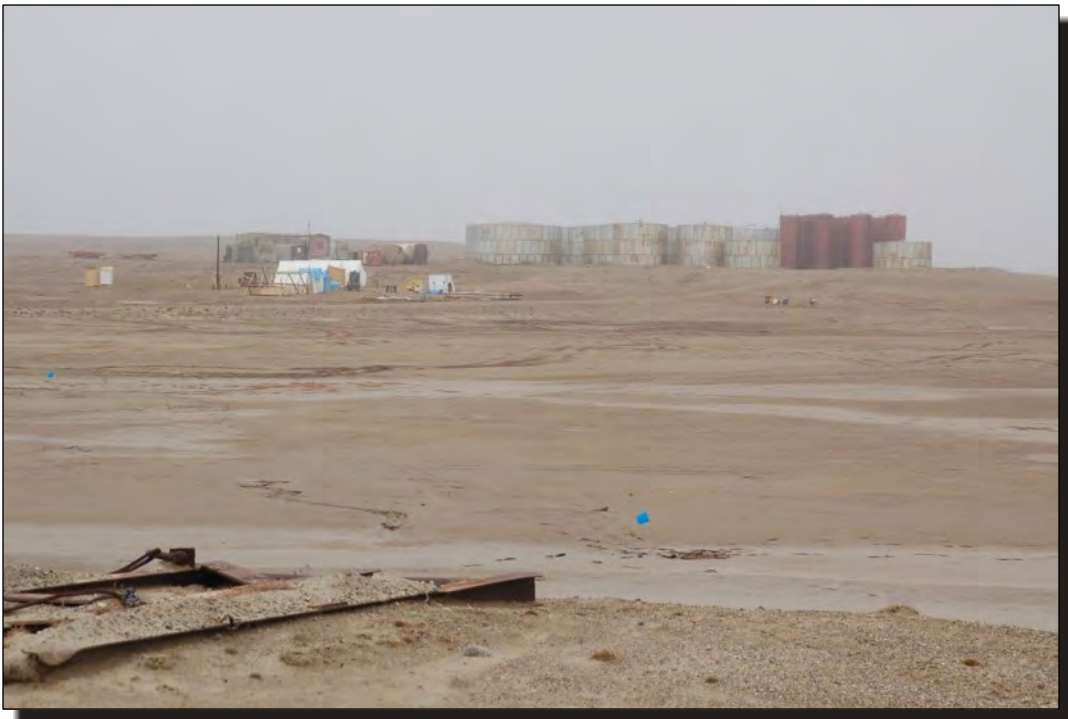
Photo 12
Tank farm with camp in foreground.

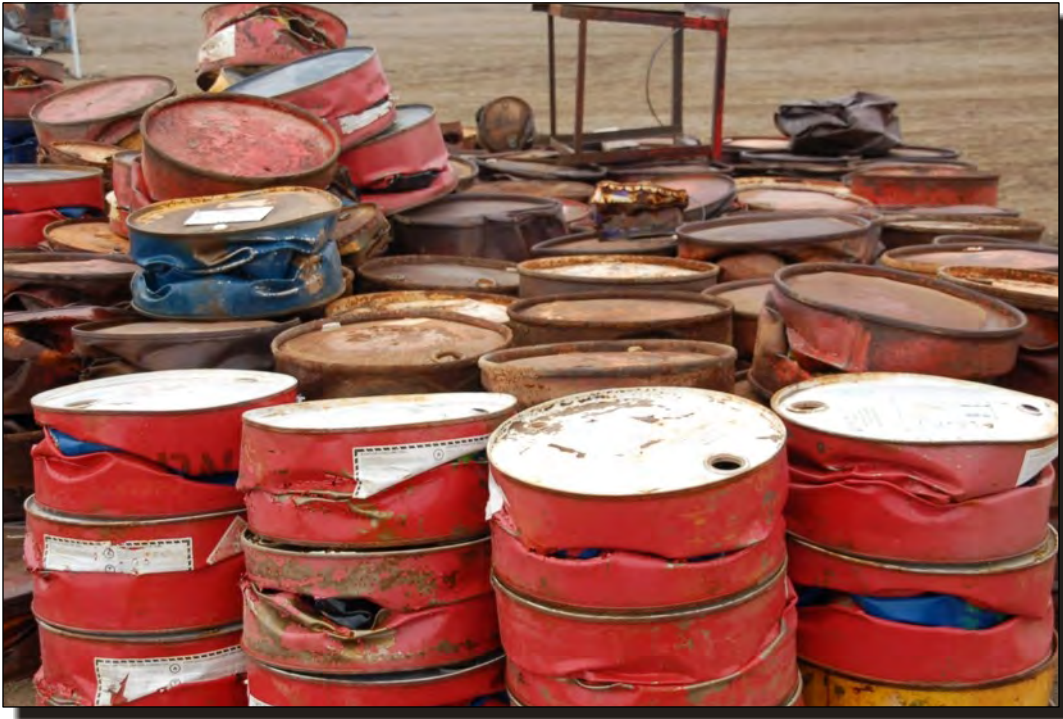
Photo 13
Crushed barrels at apron.

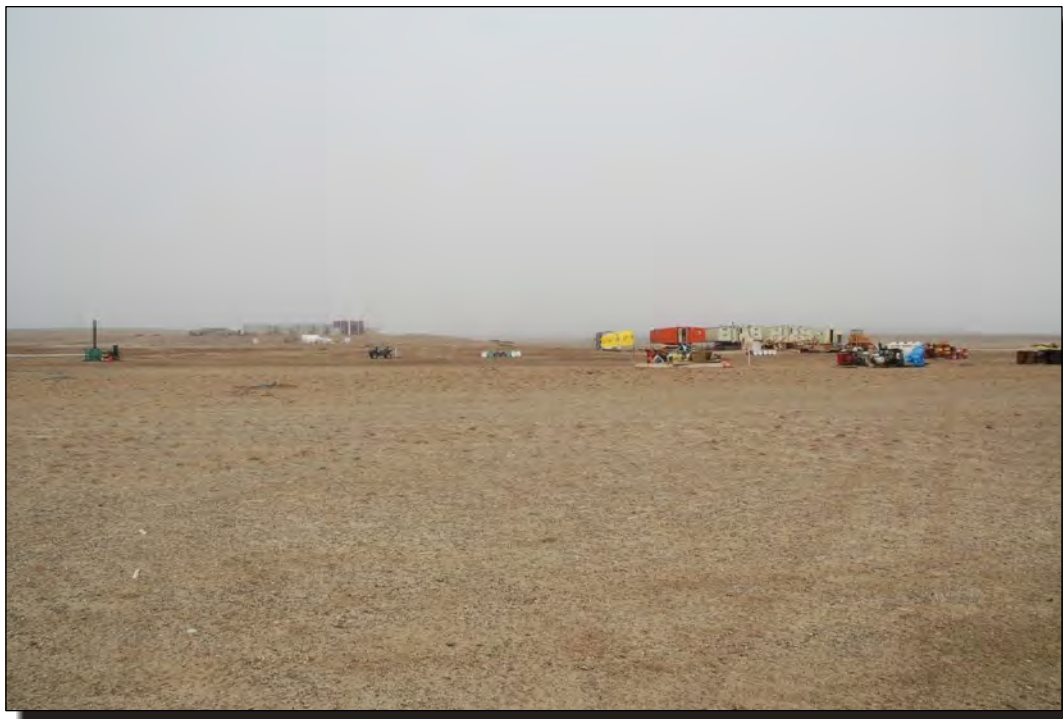
Photo 14
Apron area as seen standing on runway.

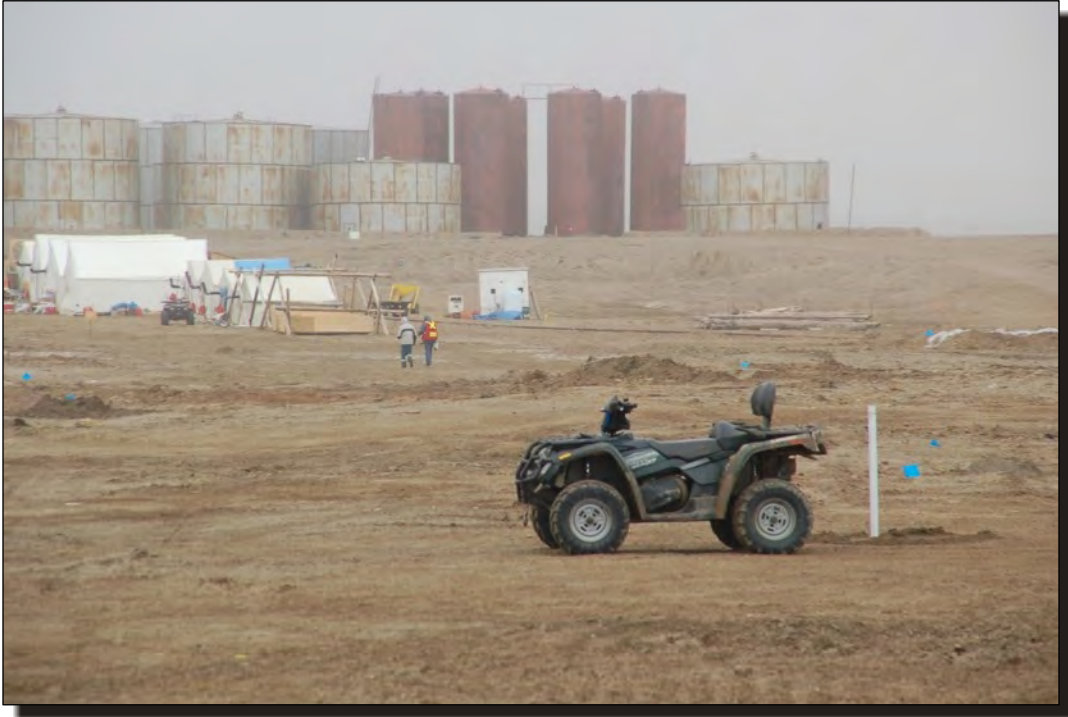
Photo 15
Camp and tank farm as seen from apron area.

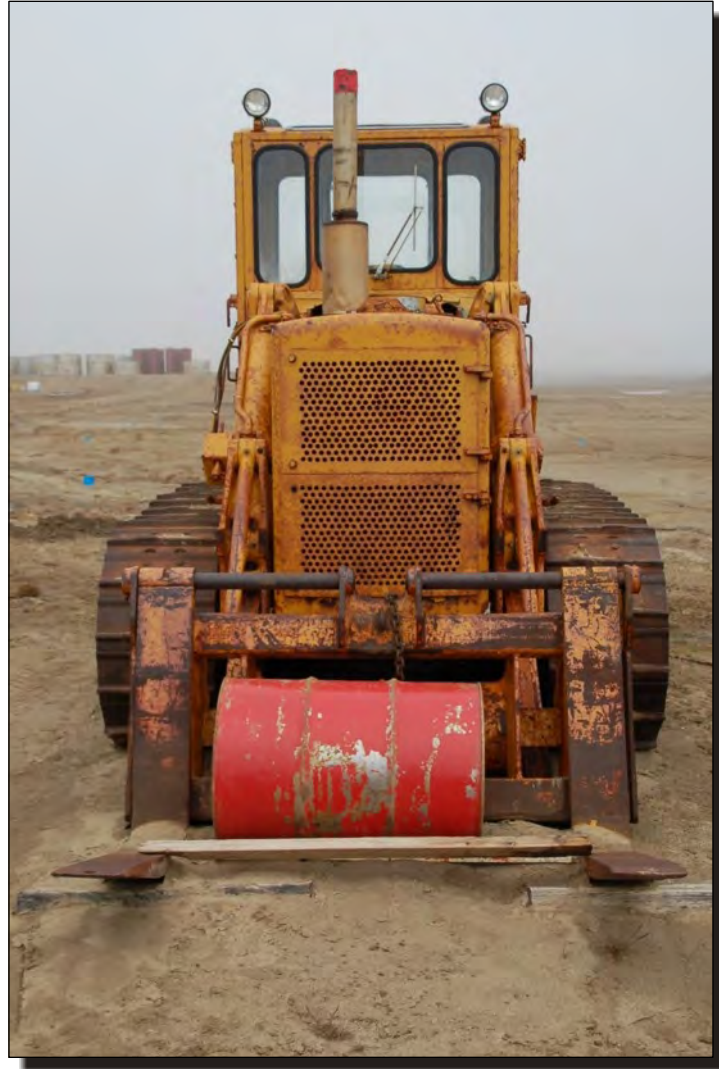
Photo 16
Front end loader at apron area.

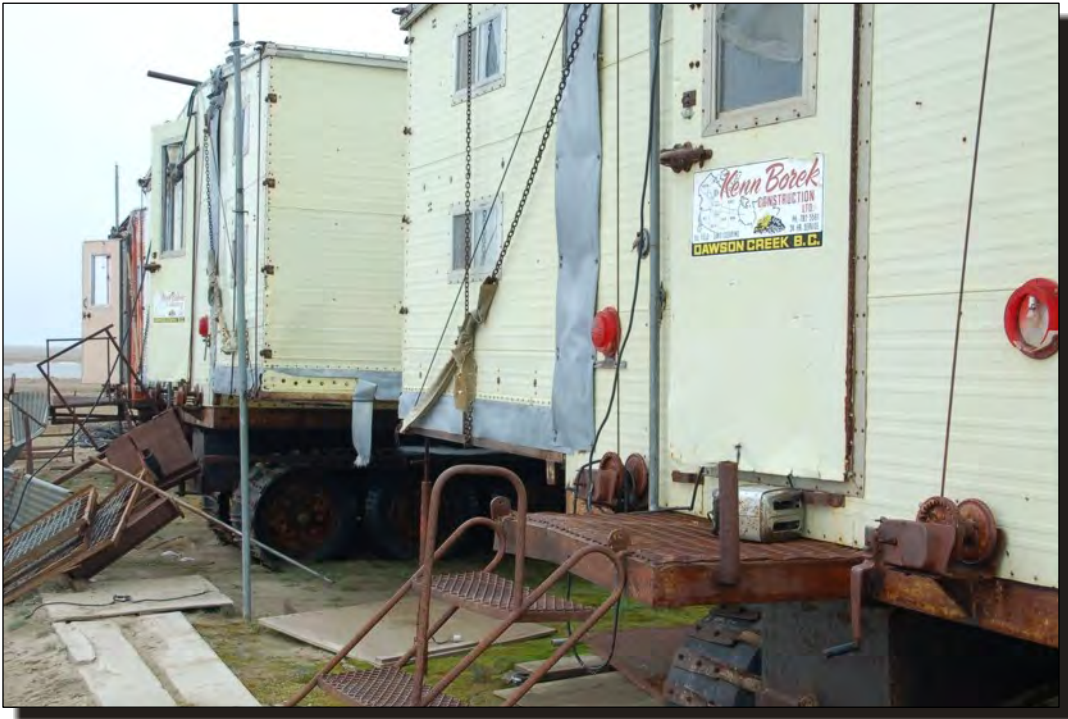
Photo 17
Close up of trailers at apron area.

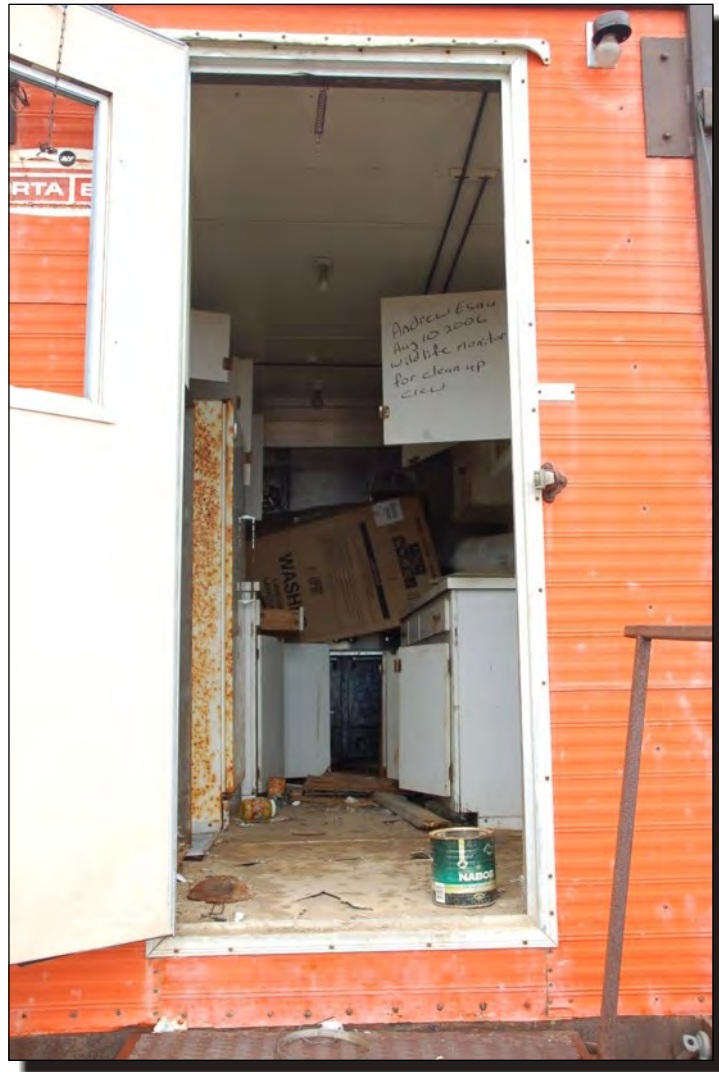
Only one sample was found to contain asbestos. This was the linoleum floor material in the Nodwell camp trailers at the airstrip.

Photo 18
Interior of trailers at apron area.

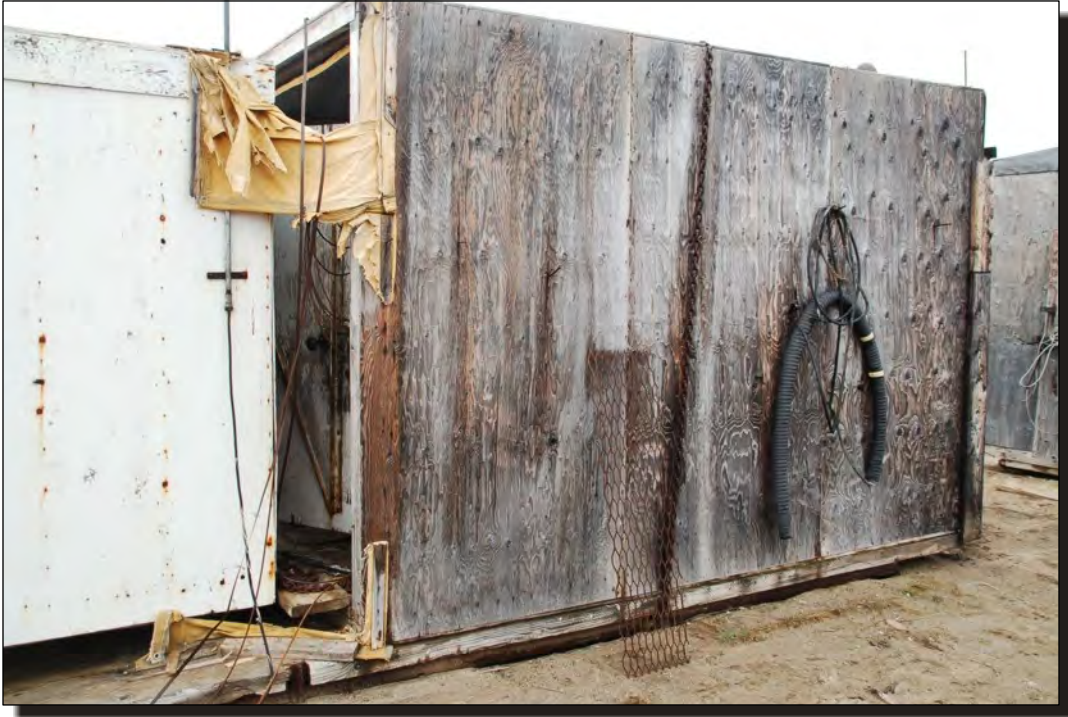
Photo 19
Shed at apron area.

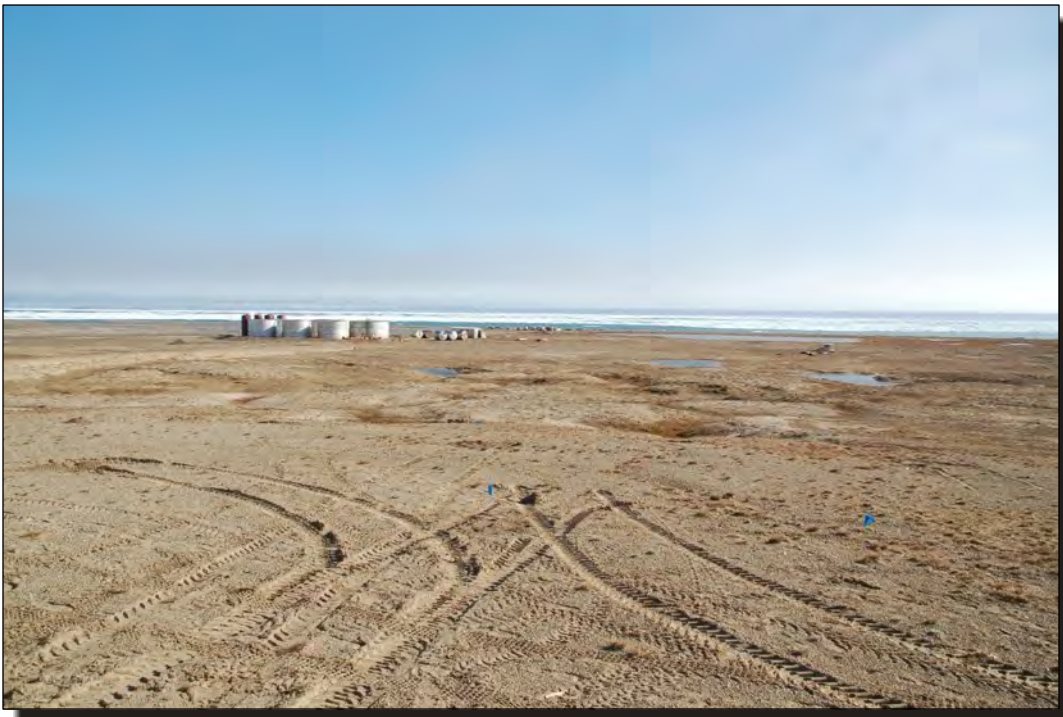
Photo 22
Tank farm as seen from upper base.
