# Shell Canada Energy

**Unipkat I-22**

## *2014 Monitoring and Maintenance Program Summary Report*

February 05, 2015

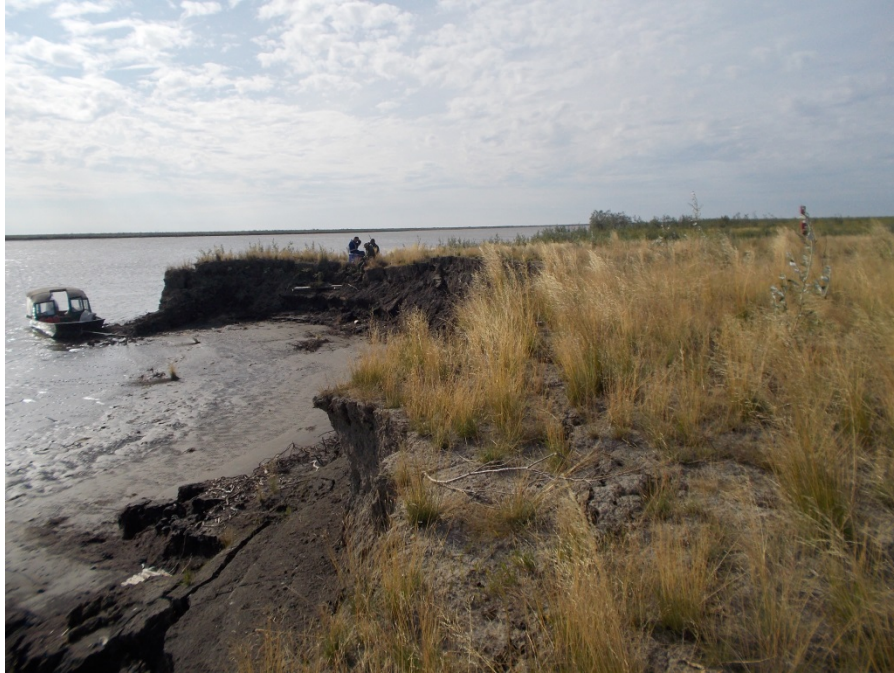
The backfilled former drilling sump area and shoreline exhibited signs of erosion where sloughing has resulted in soil loss (Appendix I; Photographs 1 and 2). At the section of shoreline observed to have the greatest degree of erosion, the shoreline has eroded approximately 3 m since August 2013, approximately 12 m since June 2012, and approximately 16 m since June 2011. Cracks in the earth were observed approximately 10 m back from the bank (Appendix I; Photograph 3).

At the time of the assessment, vegetation appeared to be establishing on the majority of the backfill cap and appeared to be more sparse west, north, and east of the backfill cap (Appendix I; Photographs 1-5).

**Photograph 1: Vegetation establishing on the backfill cap and willow staking (August 12, 2014).**

Site maintenance activities conducted on August 12, 2014 involved planting approximately thirty willow stakes along the riverbank to assist with slope stabilization (Appendix I; Photographs 1, 2, and 4). In addition, areas of sparse vegetation were reseeded with a native seed mix and covered with coconut matting (Appendix I; Photographs 7 to 11).

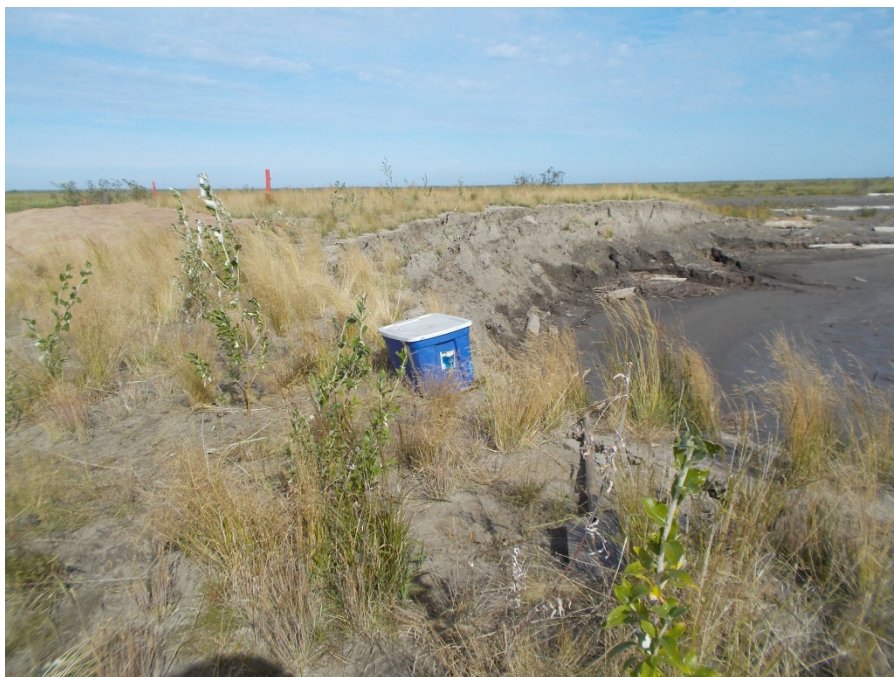
**Photograph 2: Shoreline and willow staking (August 12, 2014).**

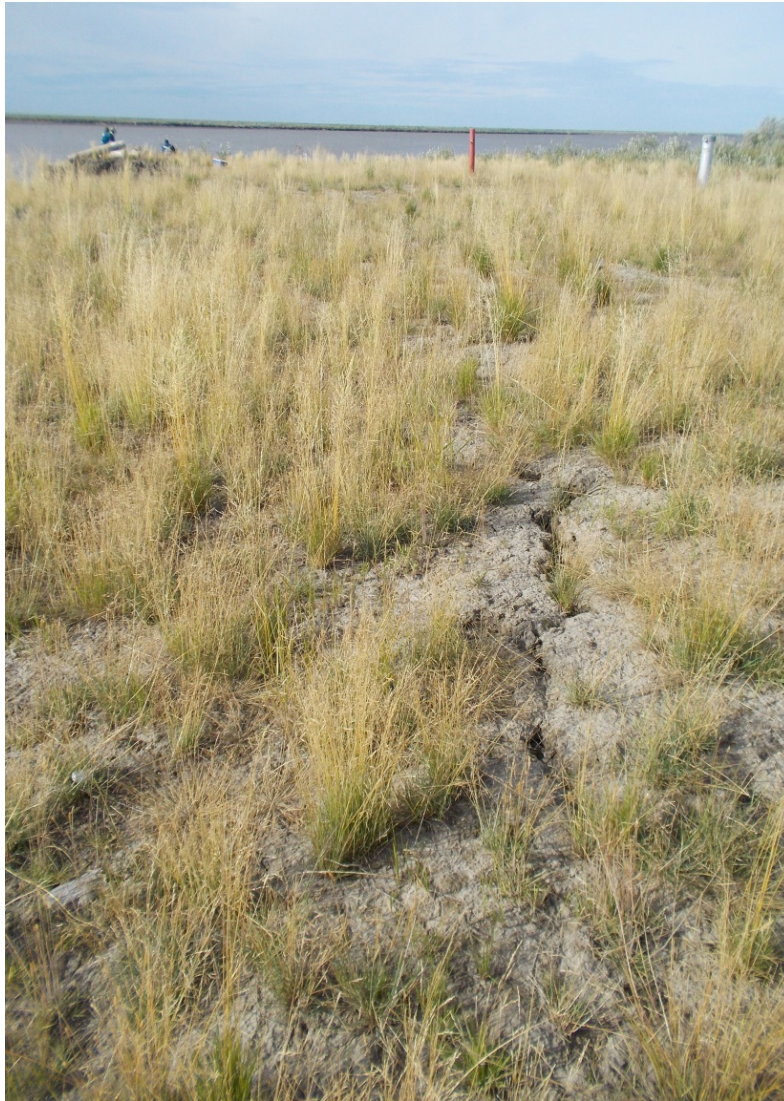
**Photograph 3: Vegetation establishing on backfill cap. Cracks observed approximately 10 m back from the bank (August 12, 2014).**

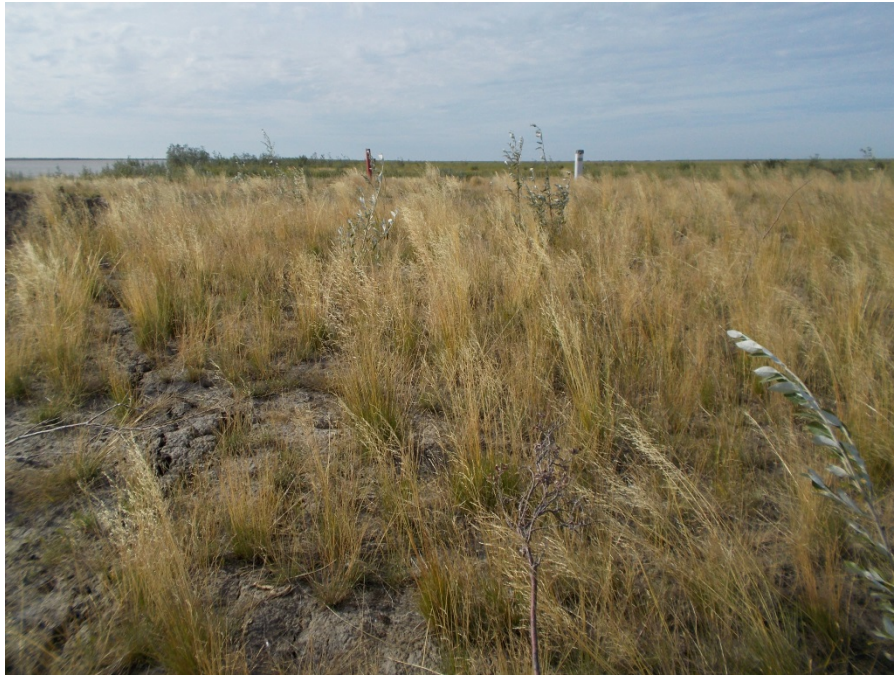
**Photograph 4: Vegetation establishing on the backfill cap and willow staking (August 12, 2014).**

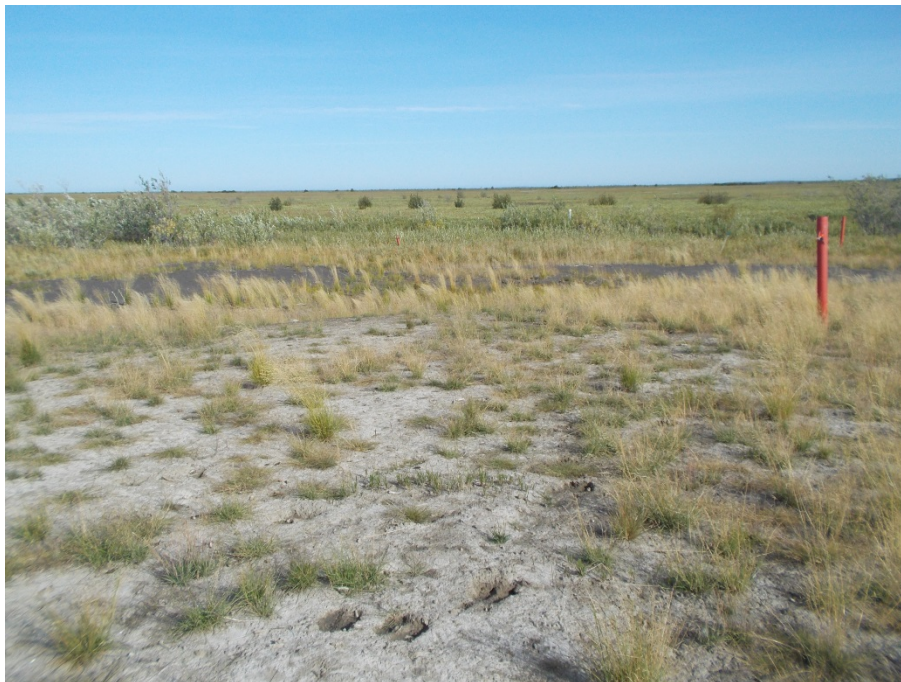
**Photograph 5: Area of sparse vegetation on western and northern portion of the backfill cap (August 12, 2014).**

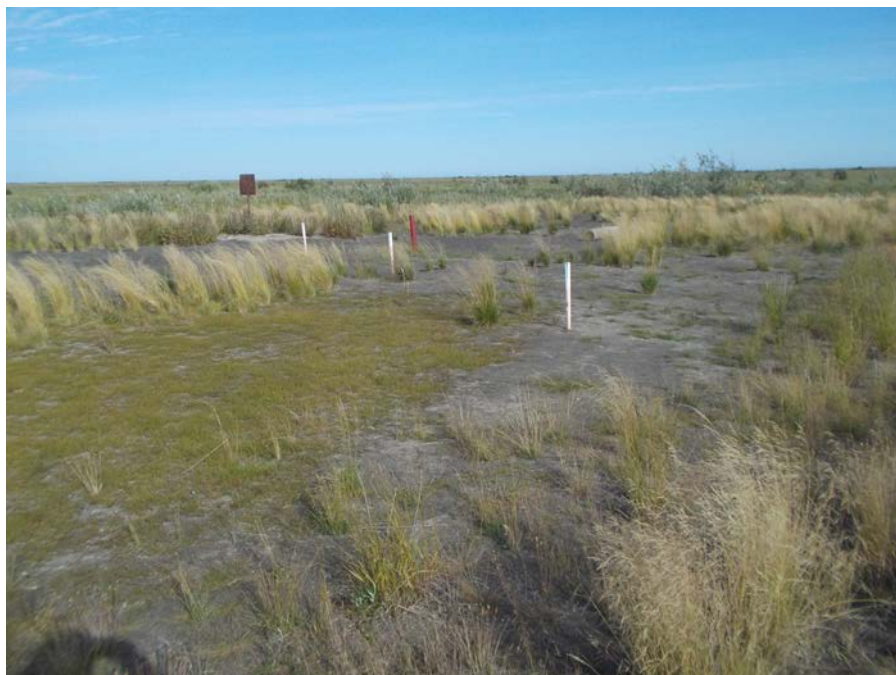
**Photograph 6: Area of sparse vegetation west of the backfill cap (August 12, 2014).**
