**RE: Industrial Water Use N7L1-1831  
CLASS B - INDUSTRIAL  
Mackenzie River - Arvoknar Channel**

## INDUSTRIAL WATER USE INSPECTION REPORT

<b>LICENCE #:</b>	N7L1-1831	<b>EXPIRY DATE:</b>	September 30, 2013
<b>LICENCEE:</b>	Shell Canada Ltd.	<b>PREVIOUS INSPECTION:</b>	March 23, 2011
<b>COMPANY REP:</b>	Randall Warren	<b>INSPECTION DATE:</b>	April 07, 2011

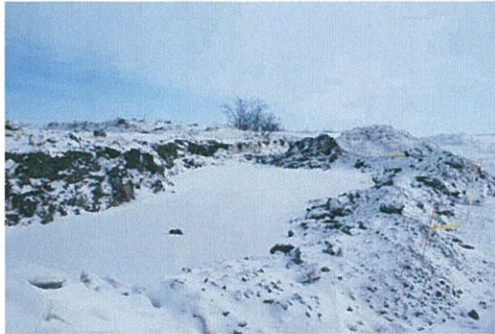
1. Flare Pit Excavation - On March 31, 2011, while deepening the excavation and removing additional soil/debris from the south wall (river side) an incident occurred in which the excavation pit filled in with water from the adjacent river beneath the ice. The surface area was bermed so as to avoid flooding the ice (see Figure 1). DFO and INAC were contacted immediately to report the

situation and seek advice. A slight sheen was observed on the surface of the ponded water following the flooding. A hydrocarbon absorbent boom was used to collect this from the surface.

A layer of ice began to form on the surface of the pond within about 30 minutes of flooding. Water samples were collected from the ponded water in the excavation and Arvoknar Channel to assess water chemistry and determine a suitable disposal option. Once the results came back, depending on the outcome the NWT Spill Line would then be contacted.

The results from the ponded water have since come back from the lab and show elevated levels of hydrocarbons. The excavation will be sealed off from the river and dewatered. The water will be put in a storage tank to be taken to the site of the containment cell to be later shipped out for disposal at an approved disposal facility. When the excavation is sealed against the river, work will continue along the east side of the hole leaving a greater extent of grounded ice between the new excavation extents and the river.

**Figure 1**  
Flare pit excavation filled in with water from the adjacent river. The surface area was bermed so as to avoid flooding the ice.

**With the results for the ponded water coming back with hydrocarbons the incident needs to be called in to the NWT Spill Report Line.**

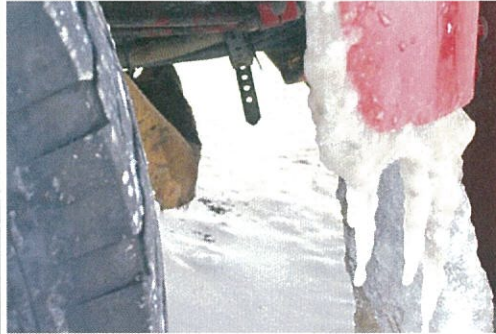
2. During the Inspection, drips of oil were noticed from the Water Truck. There was a belly tarp and a drip tray present but the oil was missing both items (see Figure 2). This was reported to the representative on site- Sam Bird with IEG. Given this development there should be a closer assessment of the watering hole to ensure any small drips of oil that might be present are chopped out of the ice for proper disposal.

**Figure 2**  
Water Truck dripping oil but was missing the belly tarp and a drip tray.

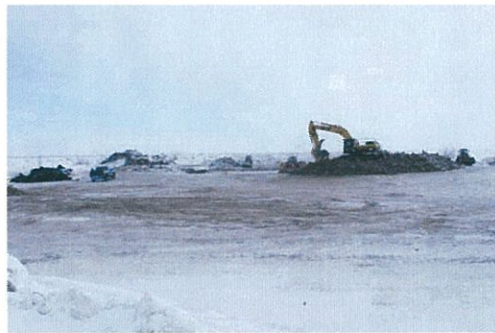
- Drilling sump is done being excavated. The trucks were hauling the last loads of waste material. Roads were clean of soil.
- Lined storage area for the excavated contaminated material from the sump has been removed (see Figure 3).
- The soil that was tracked from the excavation of the sump and on the surrounding work site was scraped up after the last load of contaminated soil was taken out.
- Waste water is being shipped to the Inuvik Sewage Lagoon. There have been a number of loads ranging between 6,000L-10,000L and occurring every 3-4 days.
- Drip trays were present and being utilized where appropriate.
- Camp is situated on a ground fast ice area across the river from the sump excavation.
- The project is tentatively planned to be completed on Tuesday, April 19, 2011.

**Figure 3**  
Lined storage area for the excavated contaminated material from the sump has been removed.

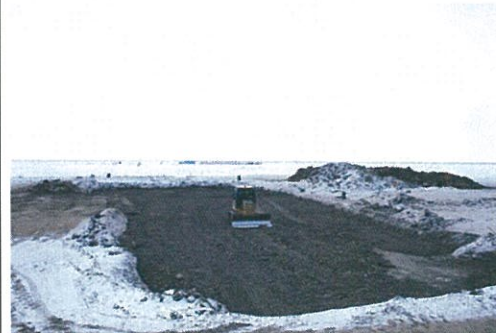
- Excavation is almost fully backfilled. Can barely see the outline of where the excavation was located (see Figure 4). Backfill consists of a mixture of overburden and material from the sandbar borrow source. Each layer is compacted with a packer and watered down. In the excavation a depth of approximately 1.5 metres is filled in per day.

**Figure 4**  
Excavation is almost fully backfilled. Can barely see the outline of where the excavation was located. Overburden and material from the sandbar borrow source is put down in lifts then compacted with a packer and watered down.

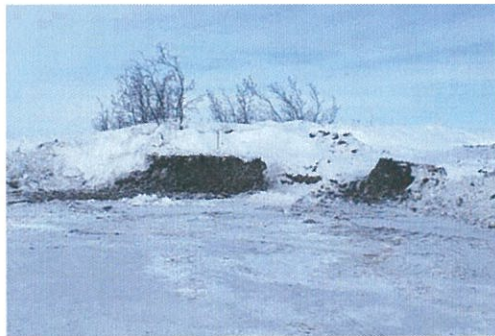
- Camp sump excavation has been backfilled and restored to match the surrounding bank etc. (see Figure 5).
- Surficial soil was blown around the borrow source at the sand bar and the backfilling of the sump excavation. Stripped snow cover has soil mixed with it. Soil laden snow will be rolled back on to the excavated areas when the project is complete and iced down with water. Piles of snow surrounding the excavations are acting as a windbreak.

**Figure 5**  
Camp sump excavation has been backfilled and restored to match the surrounding bank.

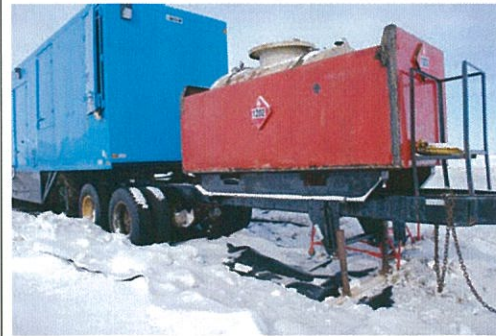
- Excess material from the sandbar borrow source has been taken for storage in Inuvik in case it is needed for the future.
- Fuel storage areas - main tanker truck and the camp generator fuel tank (see Figure 6), with secondary containment in addition to a bermed synthetic liner looked acceptable.

**Figure 6**  
Camp generator fuel tank storage area.
