**RE: Industrial Water Use N7L1-1831
CLASS B - INDUSTRIAL
Mackenzie River – Arvoknar Channel**

INDUSTRIAL WATER USE INSPECTION REPORT

LICENCE #:	N7L1-1831	EXPIRY DATE:	September 30, 2013
LICENCEE:	Shell Canada Limited	PREVIOUS INSPECTION:	April 7, 2011
COMPANY REP:	Randall Warren	INSPECTION DATE:	August 24, 2011

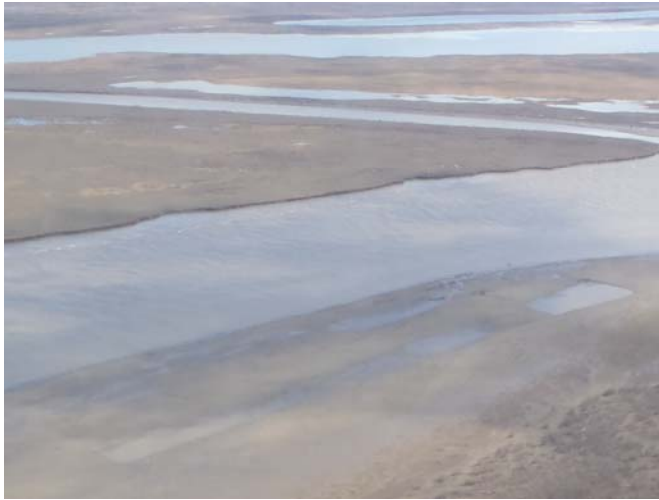
- Sand bar – borrow site appears to have re-established itself well. Can still see the imprint of the excavation but site looks stable (see Figures 1 and 3).

Figure 1
Sand bar borrow source for backfilling the Unipkat I-22 sump excavation, June 14, 2011 – DFO photo.

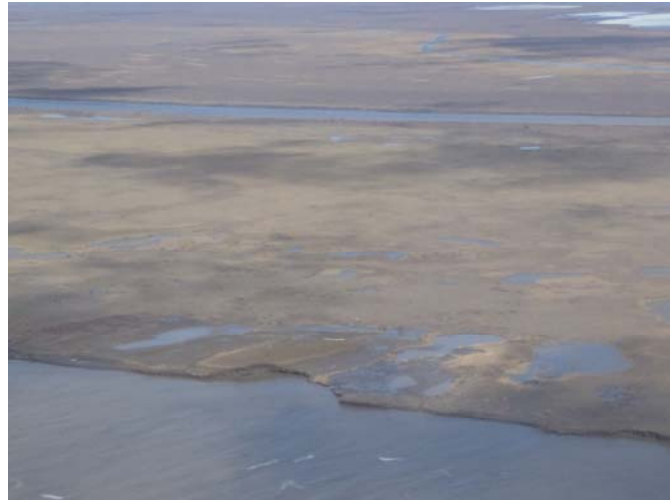
1. River has eroded away the river bank and all the way to the former sump area. From photos taken at different time periods, it appears that the erosion is progressing further and larger as time progresses (see Figures 2, 4, 5, 6).
2. Subsidence and what appears to be a sink hole developing on the northwest corner of the former sump area. Rest of backfilled sump appears to be stable and the cap has been well sloped and compacted (see Figure 6). Continued monitoring is needed but the long term solution would be to give this matter the appropriate action such as filling in the subsidence. This would aid in ensuring long term stability.

Figure 2
Unipkat I-22 sump was excavated then backfilled but now has erosion of the bank and former sump area, June 14, 2011 – DFO photo.

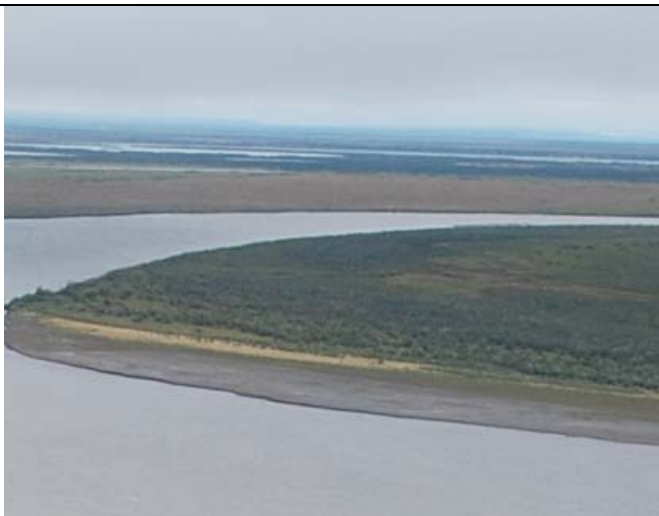
Figure 3
Sand bar borrow source for backfilling the Unipkat I-22 sump excavation, August 24, 2011.

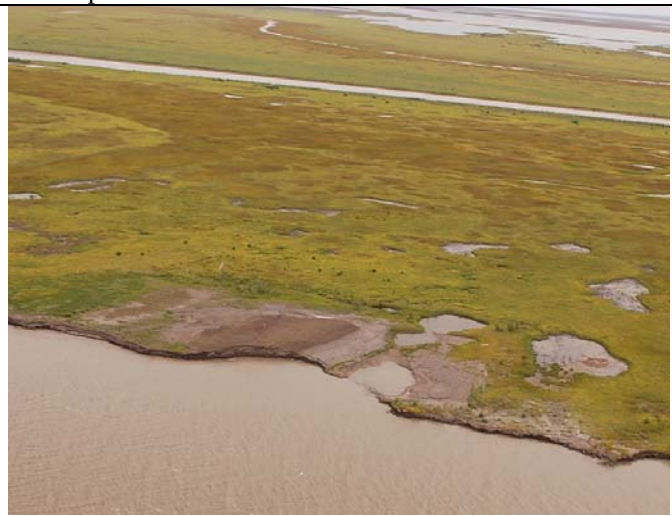
Figure 4
Unipkat I-22 area with further erosion (than seen in Figure 2 above). More subsidence and sediment taken from river banks, August 24, 2011.

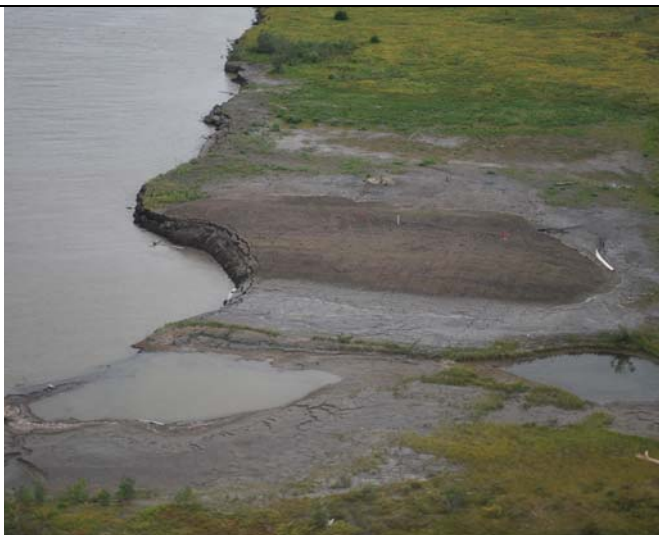
Figure 5
Area erosion showing how much of site has been decreased. Please note the thermistor at the edge of the former sump site that is now lying in the river, all the soil around it is gone, August 24, 2011.

1. It appears the 2011 Annual Report has not been submitted. This is a violation of Part B: General Conditions, Item 1 of the Water Licence. Please note the Annual Reports are due no later than September 30, 2011 and 2012 respectively and a Final Report is due no later than September 1, 2013.
2. Due to erosion and the river bank receding into the former sump area that was backfilled, the thermistor closest to the river is lying in the river. The soil surrounding it has now been washed away. This equipment should be retrieved, downloaded, and decommissioned as it can now be a hazard (see Figures 5 and 6).

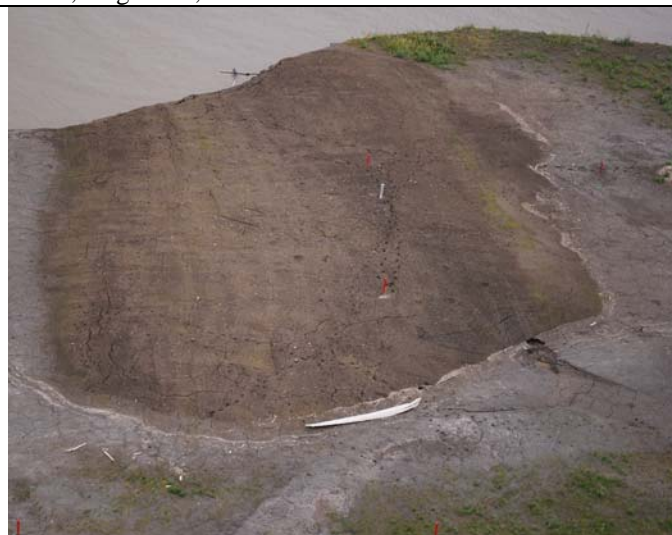
Figure 6
Sump backfill area with erosion of southeast corner. Subsidence and what appears to be a sink hole on the northwest corner of the former sump area, August 24, 2011.
