Aboriginal Affairs and
Northern Development Canada

**RE: INDUSTRIAL Water Use N7L1-1831
CLASS B – INDUSTRIAL
Unipkat I-22
Mackenzie River – Arvoknar Ch**

INDUSTRIAL WATER USE INSPECTION REPORT

LICENCE #:	N7L1-1831, Unipkat I-22	EXPIRY DATE:	September 30, 2013
LICENCEE:	Shell Canada Ltd.	PREVIOUS INSPECTION:	October 2, 2012
COMPANY REP:	Randall Warren	INSPECTION DATE:	July 31, 2013

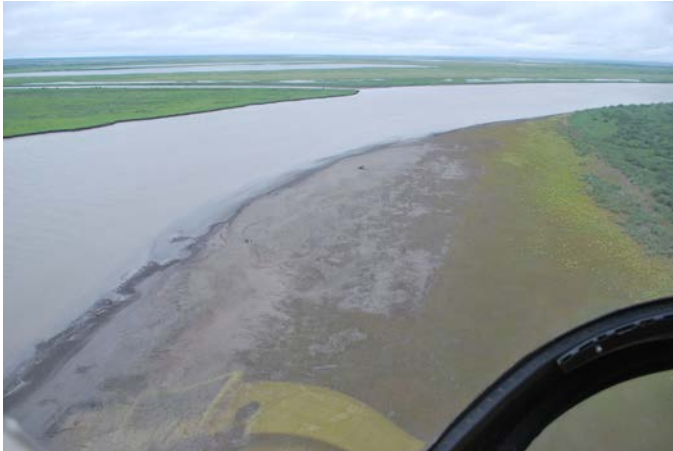
Figure 1

- Sand bar and bank borrow area has stabilized with further sediment being deposited onto the borrow area. No longer a definable excavation site as before, since the lines and indications of the excavation are less distinguishable. Still see disturbance and indentation but well filled in 30-40% vegetation growth.

Sand bar barrow source for backfilling the Unipkat I-22 sump excavation. Vegetation is re-establishing itself and excavation outline is reduced.

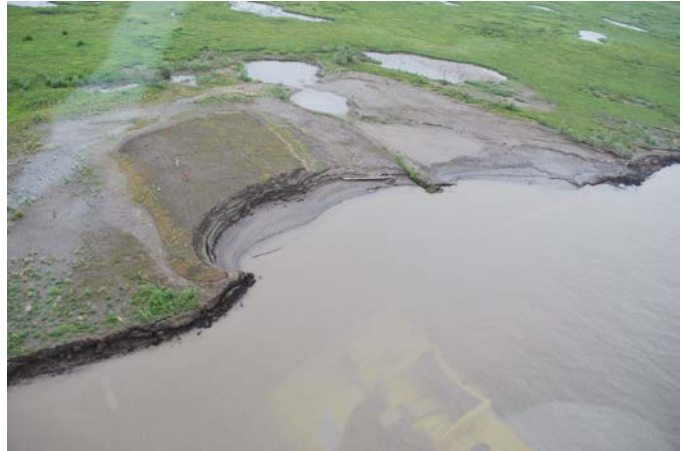
Figure 2

1. Further erosion is occurring along river edge bordering the excavation/backfill area. It continues to appear that erosion is progressing further and larger as time progresses into this area.
2. Backfill cap erosion issues remain and could lead to the cap material being destabilized. Please refer to Restoration Activities under General Conditions/Reports/Plans below.

- Existing pond adjacent to the sump excavation site is no longer present as the river erosion has accessed the pond and emptied it.
- Vegetation growth on disturbed areas at the sump excavation site are at about 20-30%.

Area erosion showing how much of site has been decreased as indicated from the river edge including ponded water near the river which has since drained out.

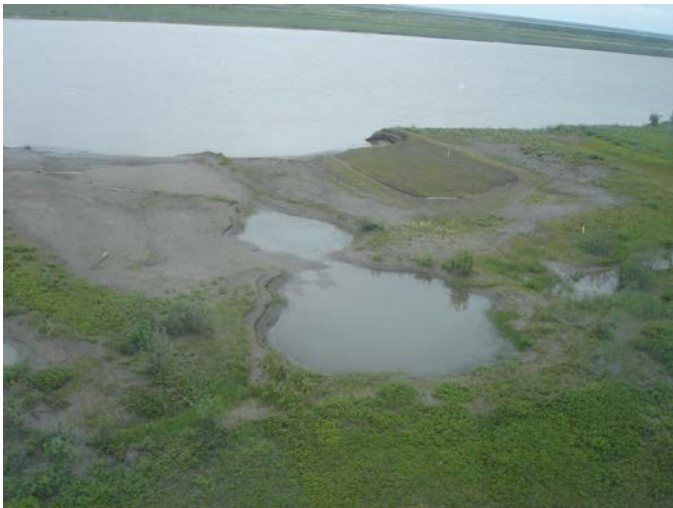
Figure 3

1. While it is understood that the area is in a process of stabilization, there are a lot of cracks present throughout the backfill cap and signs of settling. These cracks could lead to further erosion of the backfill cap with rain or flooding in the area. A plan of action is requested towards preventing further erosion from reaching the bentonite blanket and the contaminated area, including what procedures will be done if this occurs to deal with the contaminated soil that remains on site.

Unipkat I-22 sump was excavated then backfilled but there continues to be stabilization, erosion and subsidence occurring. Former sink hole and erosion of northwest corner is no longer visible.

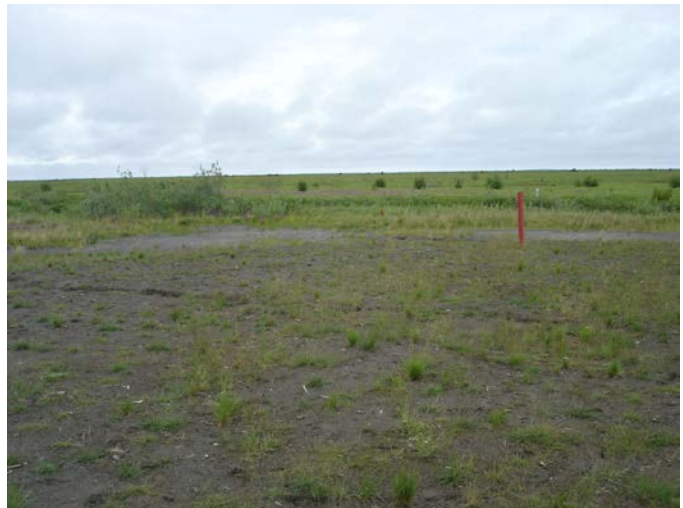
Figure 4

Surface of the backfilled sump excavation with associated vegetation growth and settling.

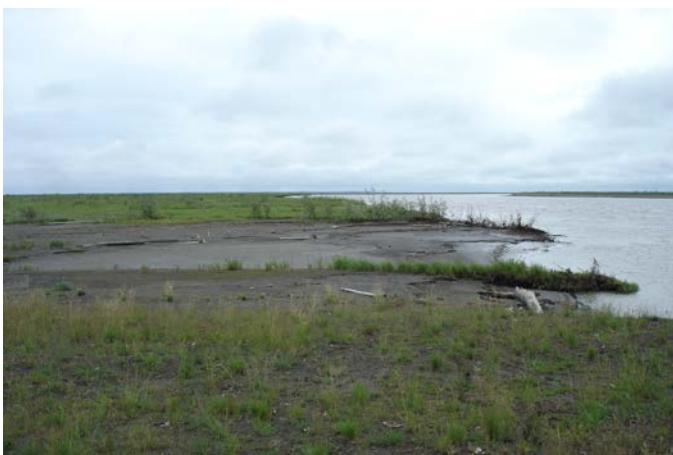
Figure 5

Southeast corner of the backfilled excavation area and adjacent subsided area with ponded water that has since been drained out to the river.

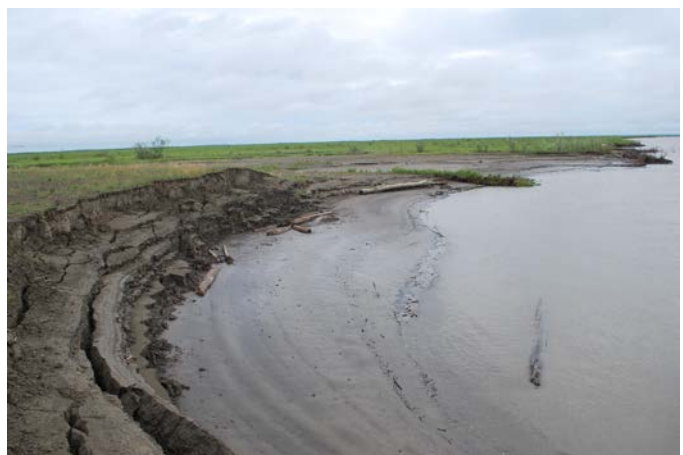
Figure 6

Extent of erosion of the backfilled excavation and associated river bank.
