RE: INDUSTRIAL Water Use N7L1-1831

CLASS B - INDUSTRIAL

Arvoknar Channel

Enclosed is a copy of the Industrial Water Use Inspection Report.

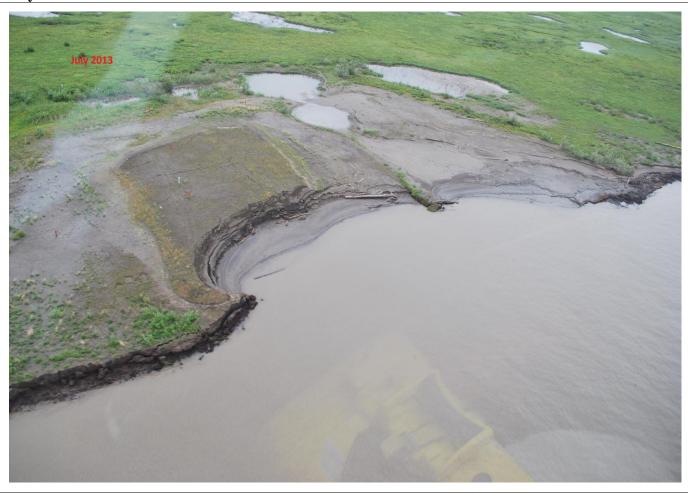
It is evident that further erosion has occurred, Figure 1 shows july 2013 photo, Figure 2 shows July 31 2014 photo of the same area, as you may notice the piling are very visible. Please refer to the General conditions comments section of this report.

Inspection Images: Figure 1 July 2013

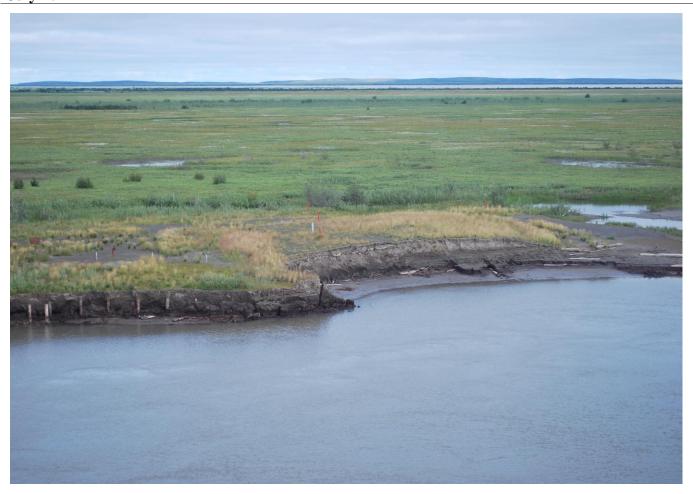
Figure 2 July 2014

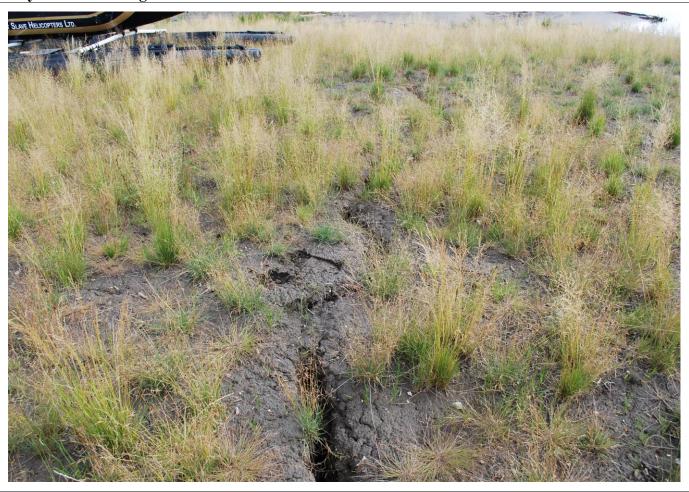
Good vegetation growth on the cap, however there are still a couple of large cracks on the backfilled areas. These cracks were mentioned in last years water license inspection as a concern as they could lead to further erosion, further a plan of action was requested in regards to preventing future erosions from occuring and reaching the bentonite blanket and the contaminated soil that remains on site.

Figure 3 very visible cracking

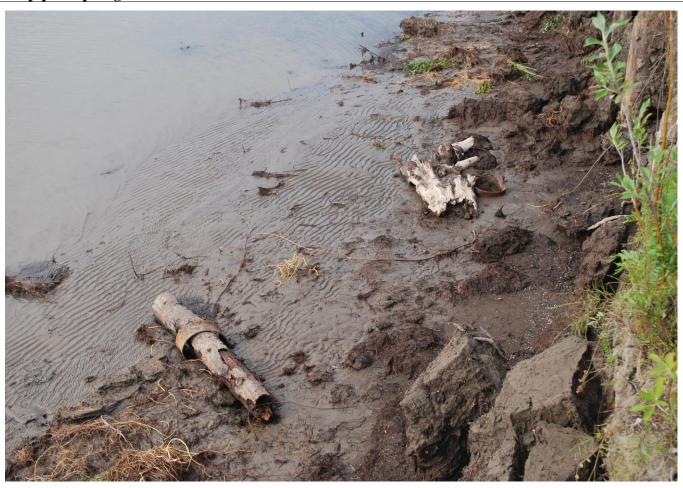
By the shoreline a number of pilings are visible and laying on shore partial metal piping around them.

Figure 4 cut pipe on pilings
