**RE: Industrial Water Use N7L1-1831
CLASS B - INDUSTRIAL
Mackenzie River - Arvoknar Channel**

INDUSTRIAL WATER USE INSPECTION REPORT

LICENCE #:	N7L1-1831	EXPIRY DATE:	September 30, 2013
LICENCEE:	Shell Canada Ltd.	PREVIOUS INSPECTION:	New
COMPANY REP:	Randall Warren	INSPECTION DATE:	March 17, 2011

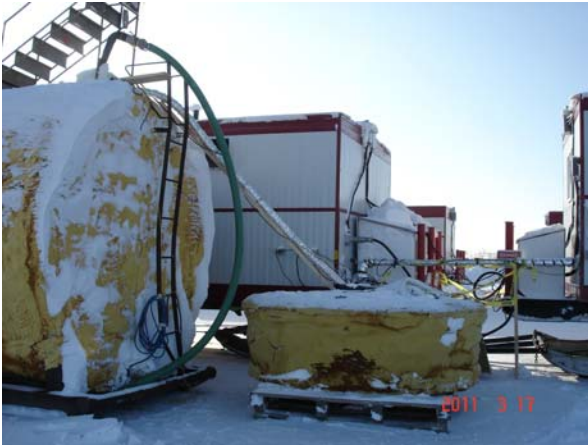
- The camp is situated on a ground fast ice area across the river from the sump excavation.
- Sewage is being transported to the Town of Inuvik Sewage Lagoon. To date one load of 7500 L went out on March 16, 2011 and another load of 7000L on March 22, 2011. Sewage storage area and piping looked clean (see Figure 1).
- The site appeared very clean, no spills were noticed during the inspection. Drip trays were present and being utilized where appropriate (see Figure 2).

Figure 1
Sewage storage area/piping clean and tidy.

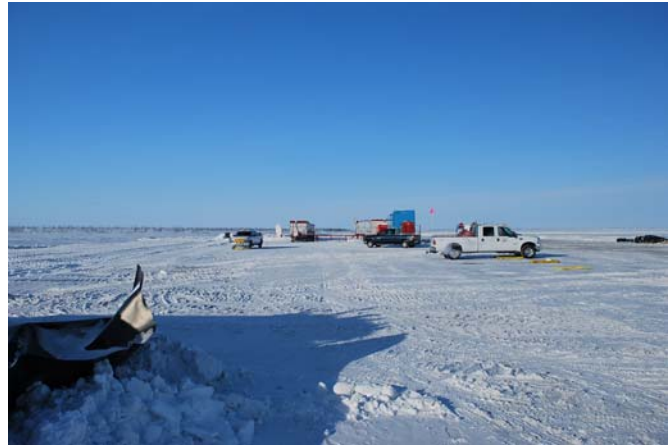
Figure 2
Drip trays were being utilized.

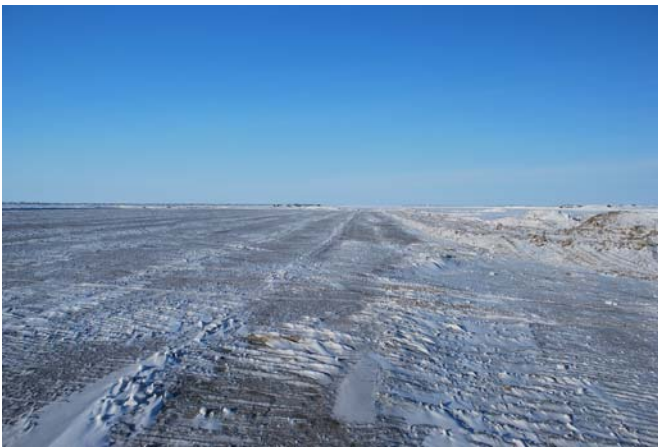
1. It was apparent on site that the sand bar and the excavation to the east of the sump have a lot of surficial soil that is being blown around and in some areas the stripped snow cover has soil mixed with it (see Figure 3). According to project staff the soil laden snow will be rolled back on to the excavations when the project is complete and also iced down with water. There are piles of snow surrounding the excavations which is acting as a wind break.
2. It is important to note that attention will need to be paid to the sump excavation, in that if there is excessive wind or dispersal of sump/contaminated material, more wind breaks might be required and/or contaminated soil piles/areas be watered down to maintain control of loose contaminated soil material.

Figure 3
Surficial soil being blown onto snow and mixed with stripped snow cover.

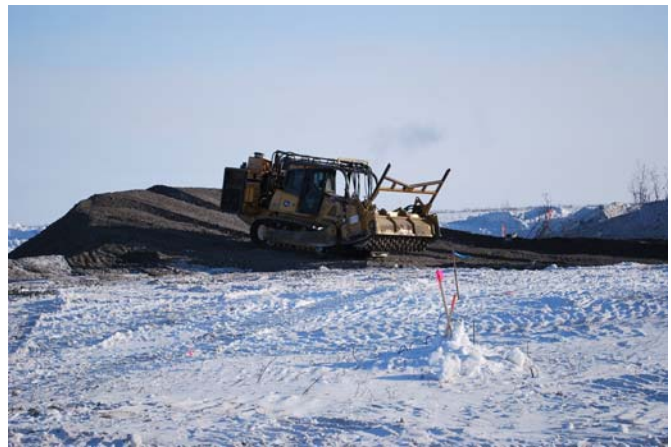
Figure 4
Iron Wolf excavating excess material on the east side of the sump.

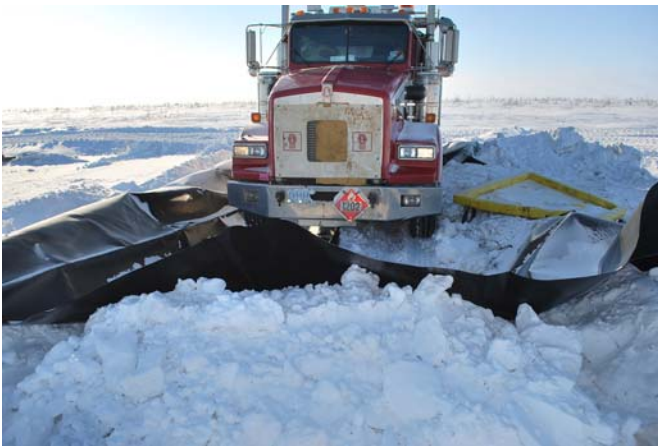
Figure 5
Main tanker truck fuel storage area - bermed with synthetic liner.

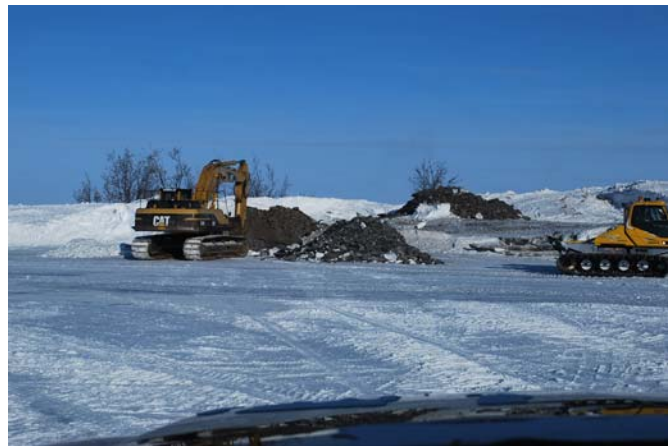
- The sandbar to be used as a borrow area to provide fill for the excavation has been stripped of the snow cover in preparation for excavation by the Iron Wolf.
- Contingency Plan and Water Licence were present with other documentation and authorizations.
- Excess material in windrows etc. on the east side of the sump is currently being excavated by the Iron Wolf. This material will be able to be used as fill for the sump excavation (see Figure 4).
- Fuel storage was acceptable, both fuel storage areas (main tanker and the camp generator fuel tank) had a bermed area with a synthetic liner (see Figure 5).
- The camp sump was being excavated by an excavator during the inspection with the flare pit to follow (see Figure 6).

Figure 6
Excavator removing camp sump.
