**RE: Industrial Water Use N7L1-1831  
CLASS B - INDUSTRIAL  
Mackenzie River - Arvoknar Channel**

## INDUSTRIAL WATER USE INSPECTION REPORT

<b>LICENCE #:</b>	N7L1-1831	<b>EXPIRY DATE:</b>	September 30, 2013
<b>LICENCEE:</b>	Shell Canada Ltd.	<b>PREVIOUS INSPECTION:</b>	March 17, 2011
<b>COMPANY REP:</b>	Randall Warren	<b>INSPECTION DATE:</b>	March 23, 2011

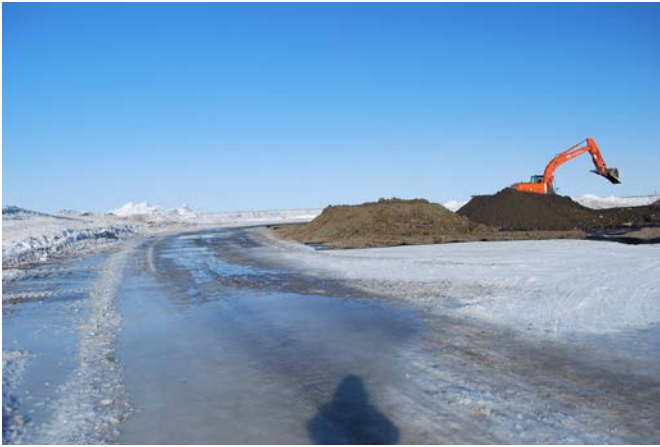
**Figure 1**

1. It was apparent from the excavation of the sump that it and the surrounding work site is getting soil tracked in and around the ice pad established on the well lease. It was noted to project staff that this tracked material needs to be graded at the end of the project and shipped out to the containment cell (see Figure 1).

Tracked material on the ice pad from excavation of the sump needs to be graded at the end of the project and shipped to the containment cell.

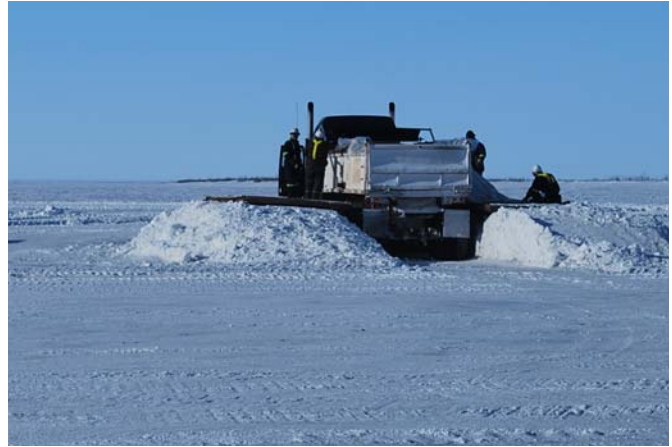
**Figure 2**

- Sewage is being transported to the Town of Inuvik's Sewage Lagoon. To date 2 loads have been shipped - 7500L on March 16, 2011 and 7000L on March 22, 2011.
- Site continues to be clean of spills and drip trays are being used.
- Trucks to haul waste material have had their trailers lined with plastic to prevent accidental spillage (see Figure 2).
- A crew was dispatched to clean up any spilled material from the access road and highway. Roads looked clean.

Trucks to haul waste have had their trailers lined with plastic to prevent accidental spillage.

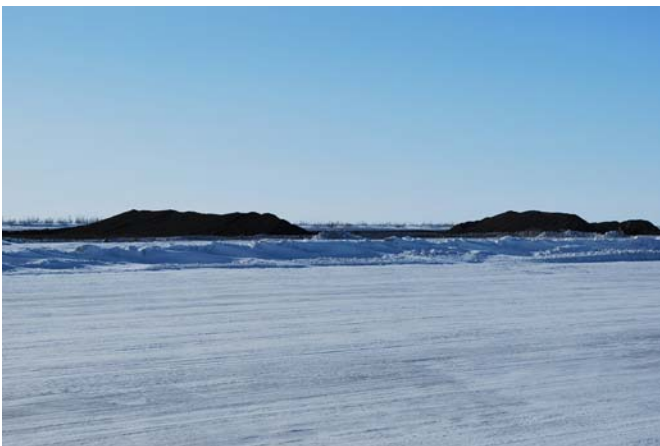
**Figure 3**

1. As stated in the previous inspection, surficial soil was blown around the site of the sump excavation and the borrow source at the sand bar. The stripped snow cover had soil mixed with it. Project staff said soil laden snow will be rolled back on to the excavations when the project is complete and also iced down with water. There are piles of snow surrounding soil acting as a windbreak.
2. The sandbar borrow source has had the Iron Wolf grind up the surficial material which was being piled in 3 large piles. Attention will need to continue to ensure that if there's any excess wind or dispersal of material that more windbreaks may be required, soil piles and disturbed soil areas may need to be watered down to maintain control of loose material (see Figure 3).

The sand bar borrow source has had surficial material ground up by the Iron Wolf and put in large piles to await removal

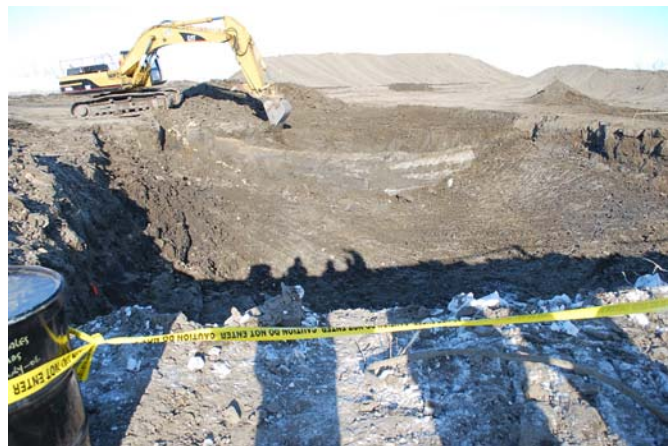
**Figure 4**

- The sump is being dug out by an excavator. This proved more precise and faster as the material is frozen but soft enough. This has cut down on the dust present and windblown material (see Figure 4).
- Excavated contaminated material from the sump and surrounding area was being stockpiled on a synthetic liner next to the sump excavation prior to shipping to the containment cell(see Figure 5).
- Camp sump and flare pit (see Figure 6) have been excavated but are awaiting confirmation from samples taken and sent to the lab.
- Both fuel storage areas (main tanker truck and the camp generator fuel tank) have secondary containment in addition to the bermed synthetic liner present.
- Water Licence was present.
- Iron Wolf is no longer on site.

The sump is being dug out by an excavator as the material is frozen but soft enough, so less dust and windblown material.

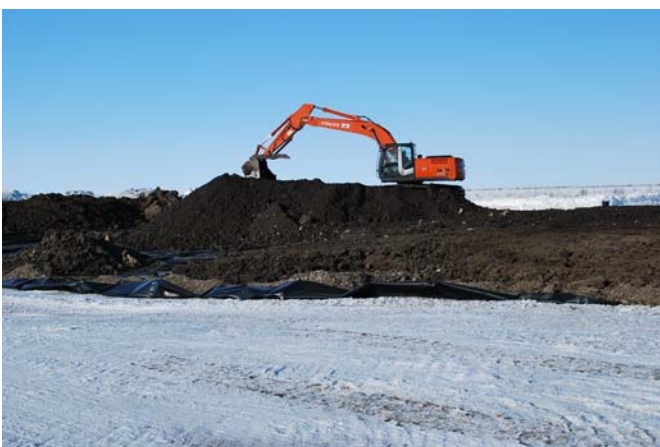
**Figure 5**

Excavated material from the sump is put on the synthetic liner to await shipping to the containment cell.

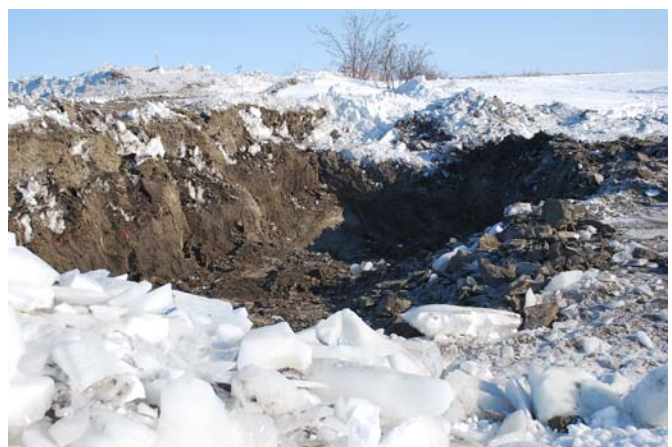
**Figure 6**

The flare pit has been excavated and is awaiting lab results.
