**RE: Industrial Water Use N7L1-1831
CLASS B - INDUSTRIAL
Mackenzie River – Arvoknar Channel**

INDUSTRIAL WATER USE INSPECTION REPORT

LICENCE #:	N7L1-1831	EXPIRY DATE:	September 30, 2013
LICENCEE:	Shell Canada Ltd.	PREVIOUS INSPECTION:	August 24, 2011
COMPANY REP:	Randall Warren	INSPECTION DATE:	October 2, 2012

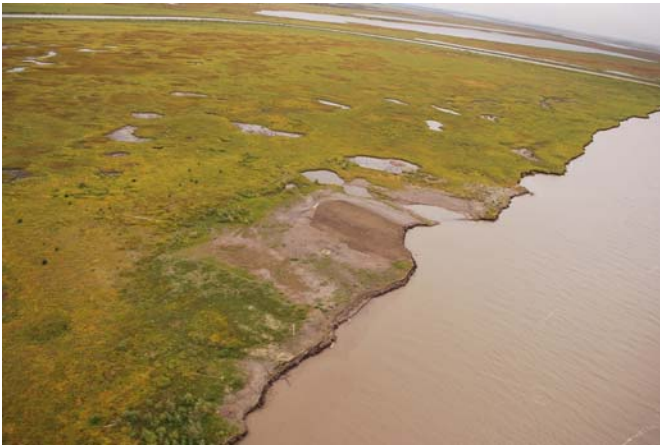
Figure 1
Unipkat I-22 area and associated erosion, August 24, 2011.

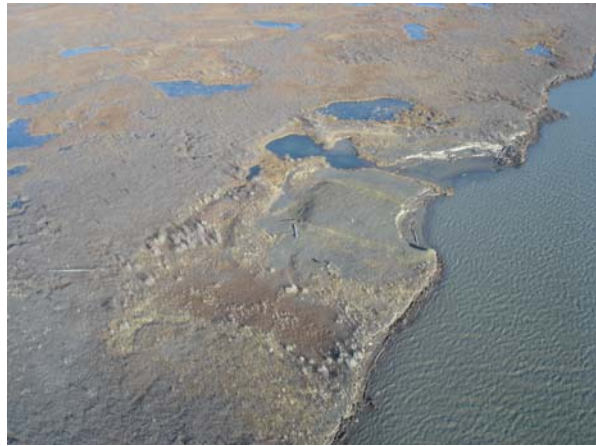
1. Subsidence depressions on northside of backfilled sump excavation. Continued monitoring is needed but to aid in long term stability appropriate action is needed such as filling in the subsidence.
2. Large cracking throughout backfilled excavation. Increased erosion on excavation along riverbank edge. As stated in the Inspection from last year it appears that the erosion is progressing further and larger as time progresses.

Figure 2
Unipkat I-22 area with further erosion (than seen in Figure 1) of actual sump excavation backfill material and river bank, October 2, 2012.

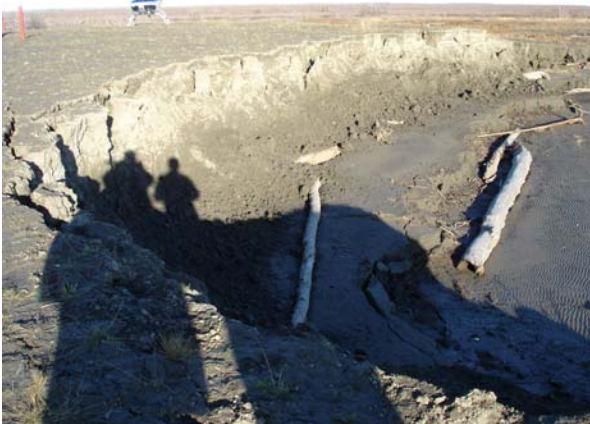
Figure 3
Close up of erosion and further river embankment that has been washed away, October 2, 2012.

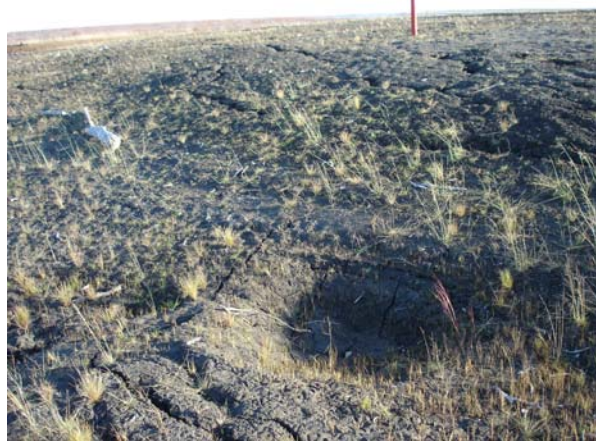
Figure 4
Sink hole at the sump excavation. Continued monitoring is needed to assess any further subsidence and to mitigate possible risks to site stability, October 2, 2012.

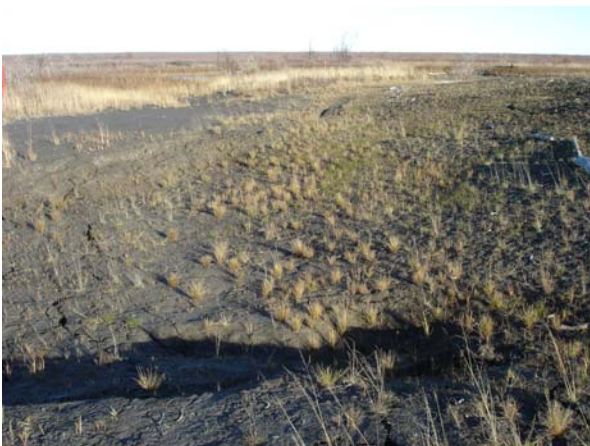
Figure 5
Erosion channel that exists on site. Continued monitoring is needed to mitigate possible risks to site stability by increased erosion, October 2, 2012.

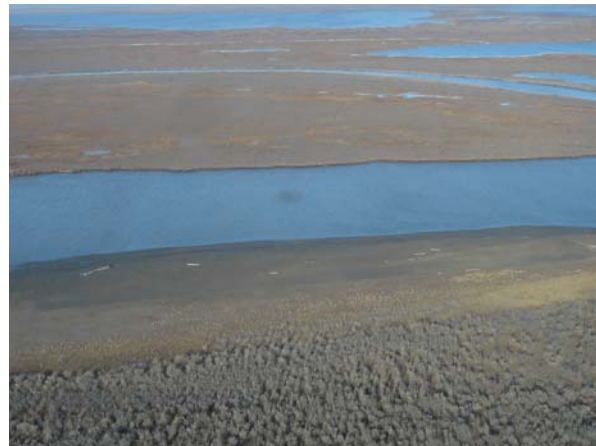
Figure 6
Sand bar borrow source for backfilling the Unipkat I-22 sump excavation, October 2, 2012.
