Hamlet of Paulatuk  
1 Main Road  
Paulatuk, NT X0E 1N0

**File Number** N7L3-1691  
**Type of Operation** Type B – MUNICIPAL Water License  
**Location** Paulatuk

**«INSP\_TYPE» WATER USE INSPECTION REPORT**

<b>LICENCE #:</b>	<b>N7L3 - 1619</b>	<b>EXPIRY DATE:</b>	<b>Nov 20, 2020</b>
<b>LICENCEE:</b>	<b>Hamlet of Paulatuk</b>	<b>PREVIOUS INSPECTION:</b>	<b>August 11, 2015</b>
<b>COMPANY REP:</b>	<b>Mayor Ray Ruben Sr</b>	<b>INSPECTION DATE:</b>	<b>July 16, 2019</b>

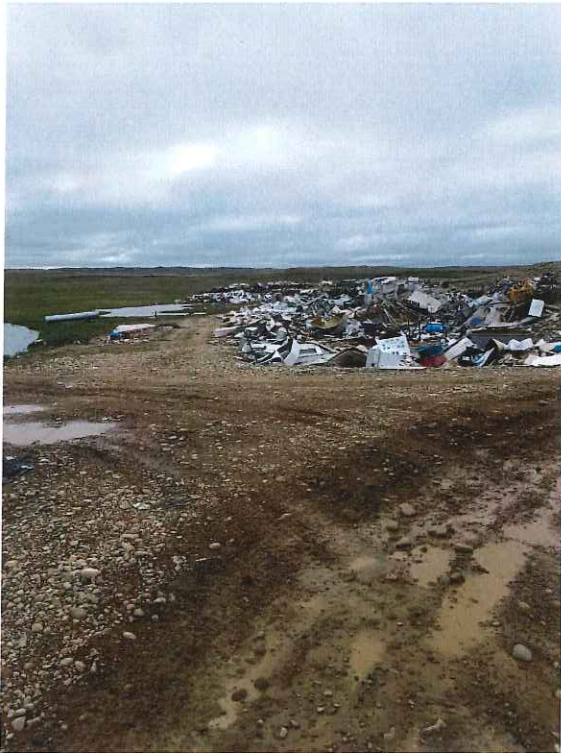
- Hamlet staff collected SNP samples prior to my inspection
- No Segregation of debris. Where do they drop off appliances, dead batteries, old tires, regular household garbage, empty propane bottles
- No signage of where to dump tires, appliances, batteries, paint, steel
- Foreman stated tried to do segregation but public still dumping all over

Figure 1 No Segregation

- Place spill kit at WTP
- Sewage dumping station and chutes require lot of work to prevent chute from being knocked off pallet padding, foundation
- WTP to be locked at all times when no one around as chemicals located in WTP building
- Landfill requires lot of cleanup, segregation and signage

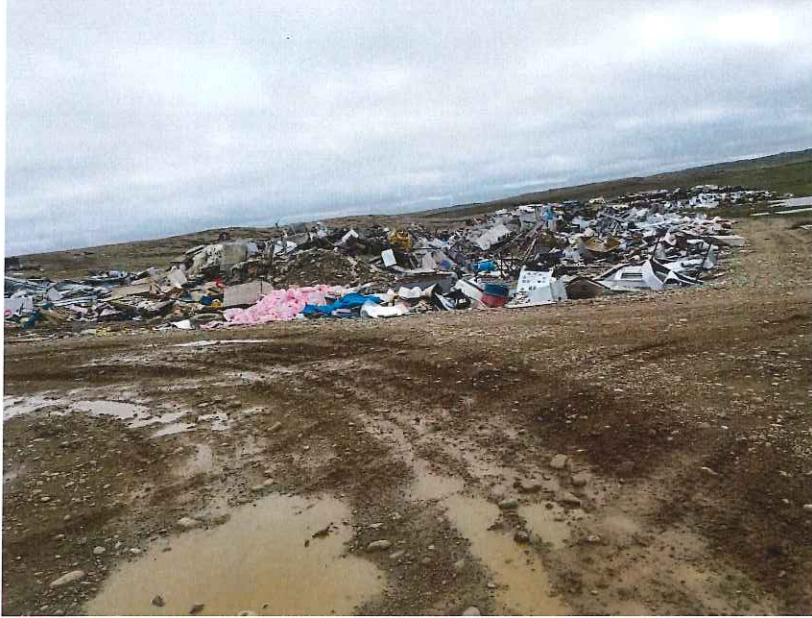
Figure 2 No Segregation

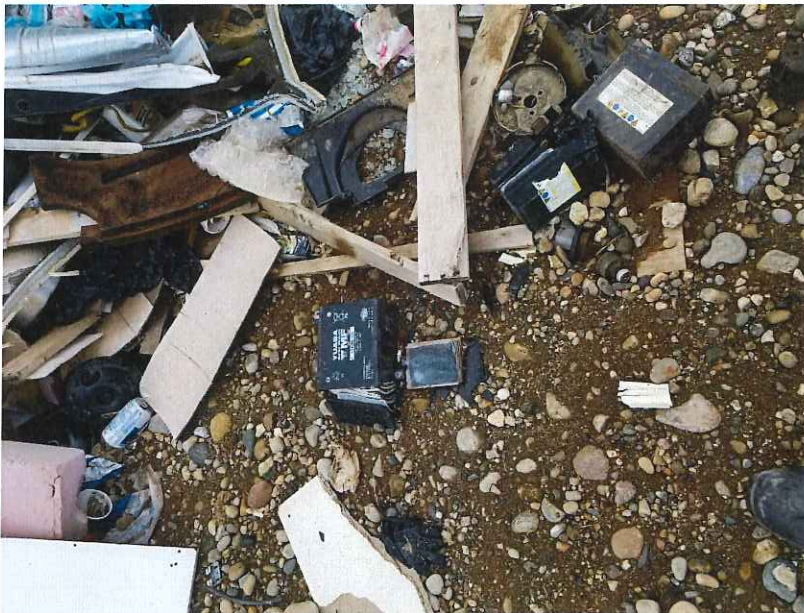
Figure 3 Batteries disposed on ground, not on pallets. Battery acid leaked onto the ground

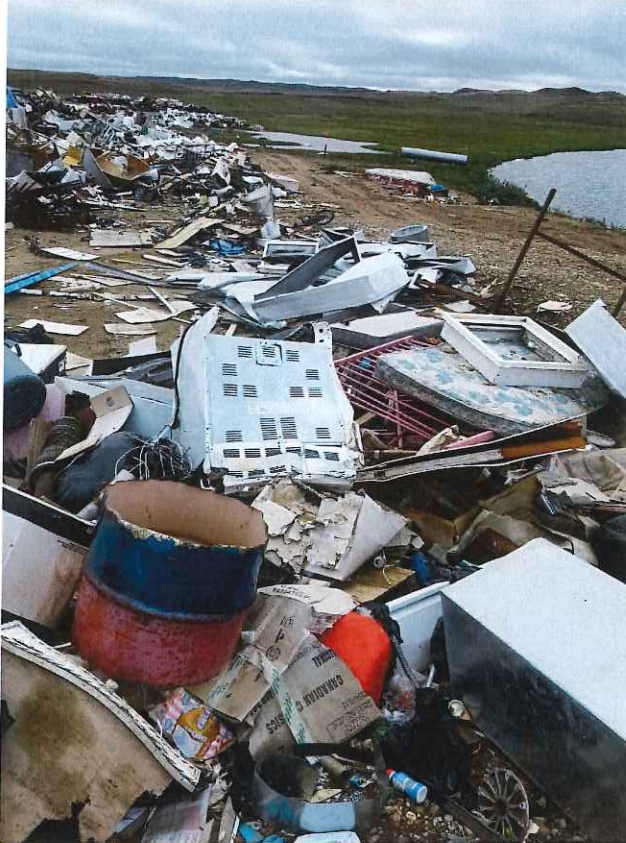
Figure 4 No Segregation, appliances dumped with other trash

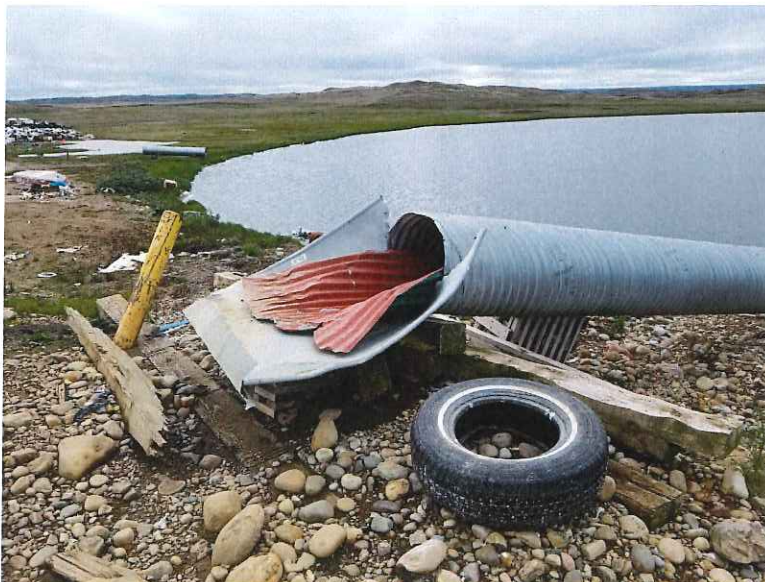
- SNP samples were collected prior to my inspection
- Regular SNP samples being conducted by Hamlet staff
- Dumping chute needs work, pallets holding chute up, Chute ready to drop if accidentally hit by sewage truck backing up
- No smell from lagoon
- No signage. I did not know I was standing by the sewage truck chute as there was no signage
- Public waste in lagoon
- Good freeboard
- Access road in good shape
- Sewage truck pad in such poor condition, unsafe for workers

Figure 5 Unsafe Sewage Truck Chute, Poor Foundation

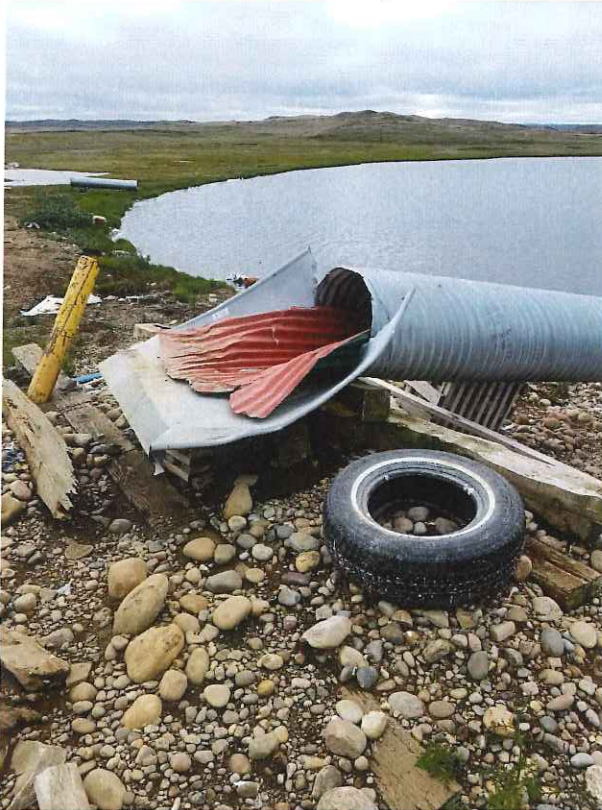
Figure 6 Unsafe sewage dump chute
