<b>File Number</b>	<b>N7L3-1531</b>
<b>Type of Operation</b>	<b>CLASS B - MUNICIPAL</b>
<b>Location</b>	<b>Sachs Harbour</b>

## WATER USE INSPECTION REPORT

LICENCE #:	N7L3-1531	EXPIRY DATE:	November 20, 2022
LICENCEE:	Hamlet of Sachs Harbour	PREVIOUS INSPECTION:	September 09, 2015
COMPANY REP:	Adella Carpenter – Acting SAO	INSPECTION DATE:	October 17, 2019

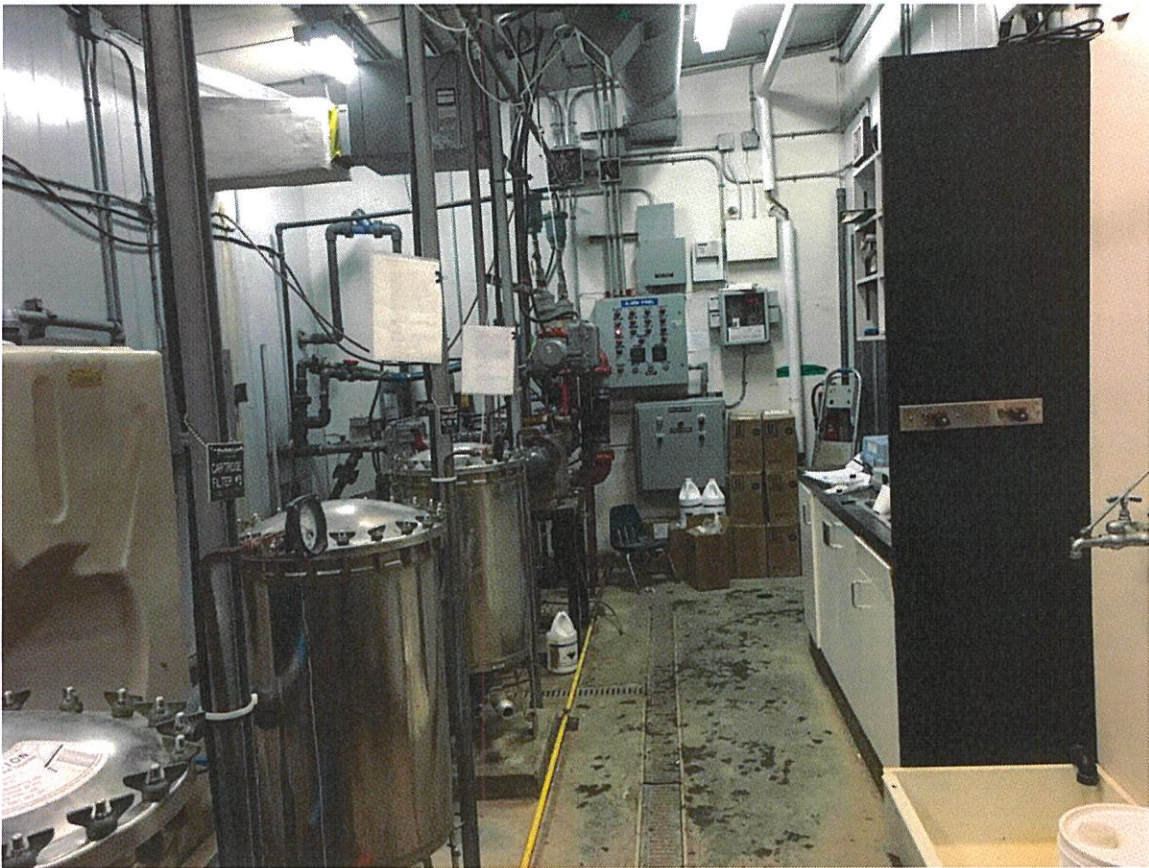
- <sup>2</sup>The WTP was in tidy condition at the time of inspection; however, housekeeping and organization can be improved. Multiple bottles of hypochlorite were scattered around the entrance. Chemicals should be locked away in a specific area for safe storage and keeping.

Figure 1: Housekeeping inside Water Treatment Plant. Multiple bottles of hypochlorite visible in the background.

- Find a new location for Water Treatment Plant key.
- Secure all chemicals within Water Treatment Plant.
- Fix and/or modify leaking water outlet pipe.
- Ensure all secondary containments are clear of water, snow and/or debris.
- Remove the bags of insulation from the Sewage Disposal Facility and dispose of correctly.
- Replace the 45 gallon drum acting as a brace for the sewage chute.
- Address the lot of drums at the landfill. Empty all of the drums completely then store drums closed on their side.
- Be more proactive in accepting/declining construction debris and materials.
- Address the refrigerant agents in the disposed of refrigeration units.

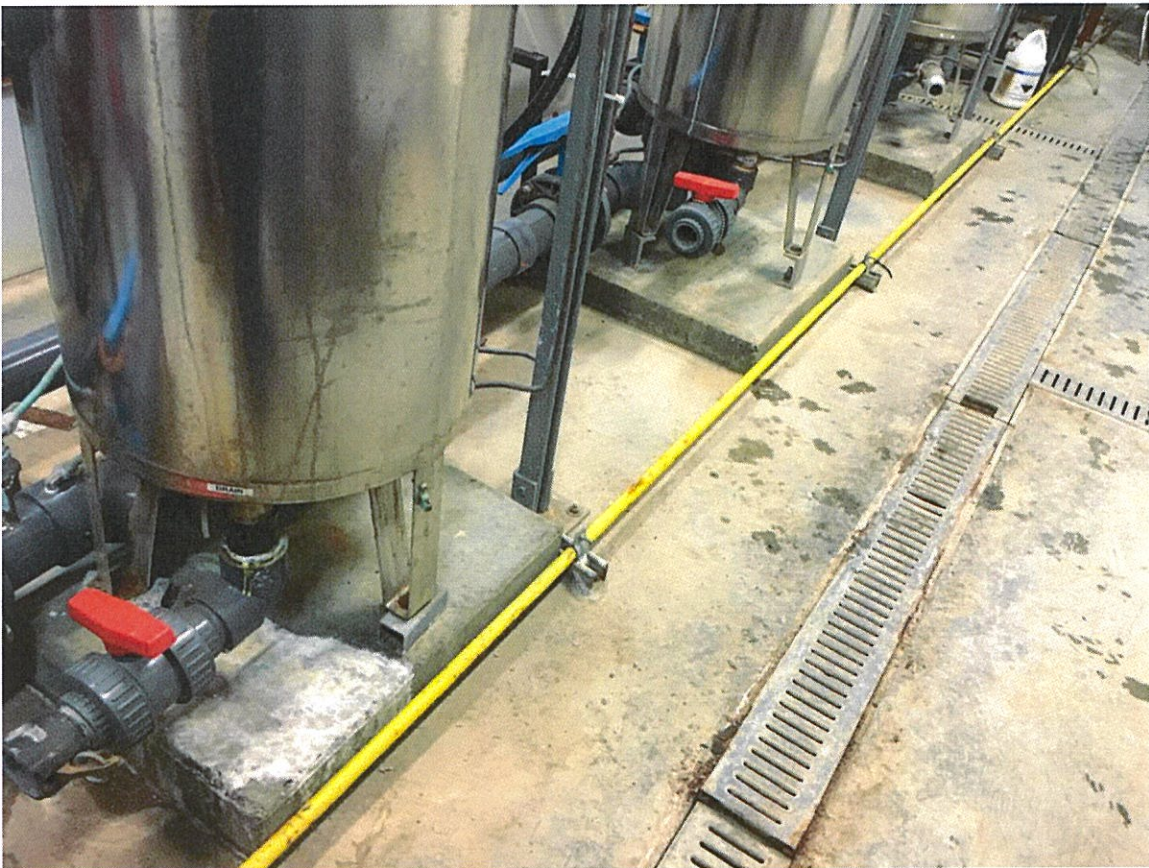
- A stain was noticed on the concrete pad of Cartridge Filter #3 under the nozzle, see figure 2. This indicates that leaking is occurring. This will need to be fixed immediately.

Figure 2: Stain on pad indicating a leak from Cartridge Filter #3.

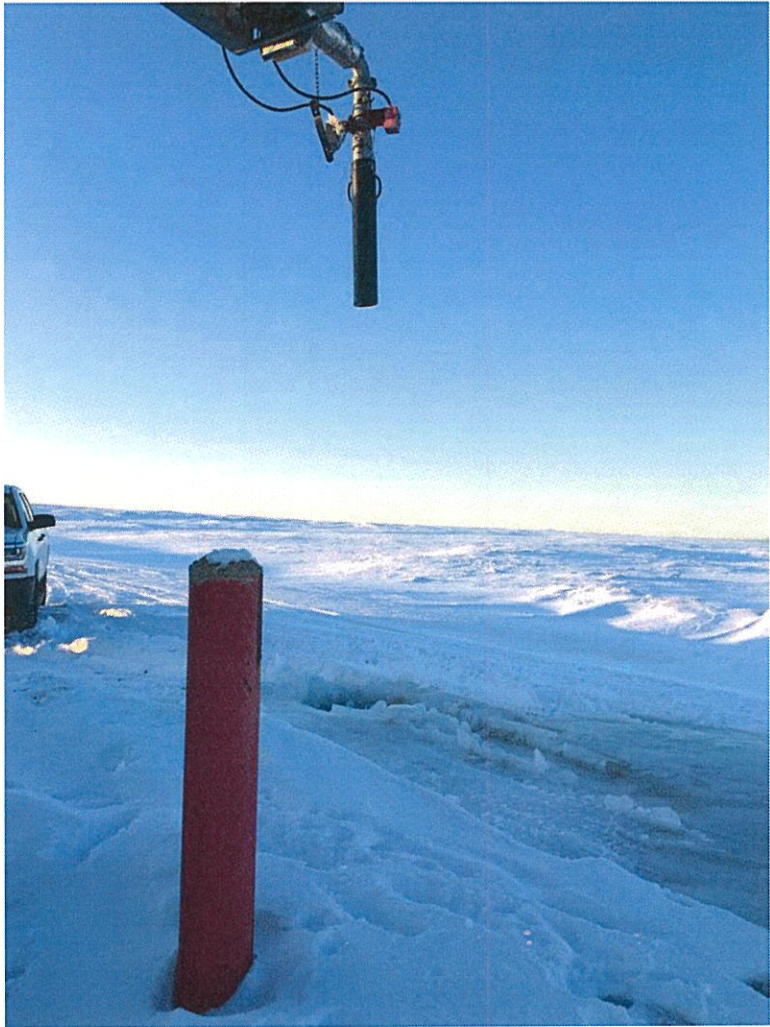
- <sup>3</sup>The pipe which the water truck receives water from was leaking at the time of inspection. There was a large icicle hanging from the water pipe at the time of inspection. The constant leak can be dangerous to employees as this will cause large icicles and ice mounds to form. Foreman John Elanik mentioned that this was resulting from an electrical issue. They are aware of the matter and are waiting on parts to fix the issue. This may become a work hazard and cause erosion of the ground if this problem is not resolved. ENR recognizes that The Hamlet staff are actively working to correct this issue.

Figure 3: Pumping station outlet leaking at time of inspection. Large icicle was knocked off before photo was taken.

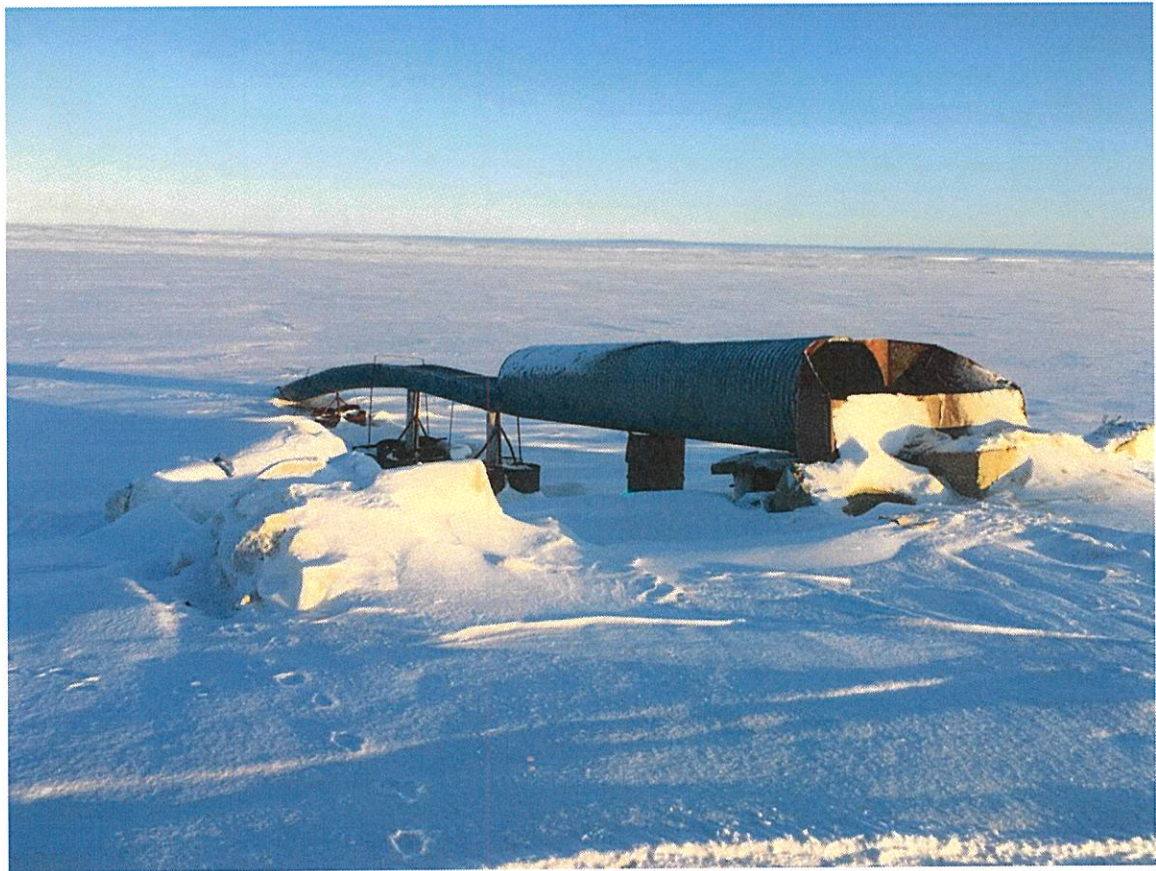
- The receiving end of the chute is in good, stable condition. However, it is noted that one deteriorating 45-gallon drum is holding up the higher portion of the chute, refer to figure 4. This will need to be replaced with a better brace before the drum fails. The bracing on the lower section of the chute appears to be sound and stable.

Figure 4: Sewage pump out. Note drum holding up the upper section.

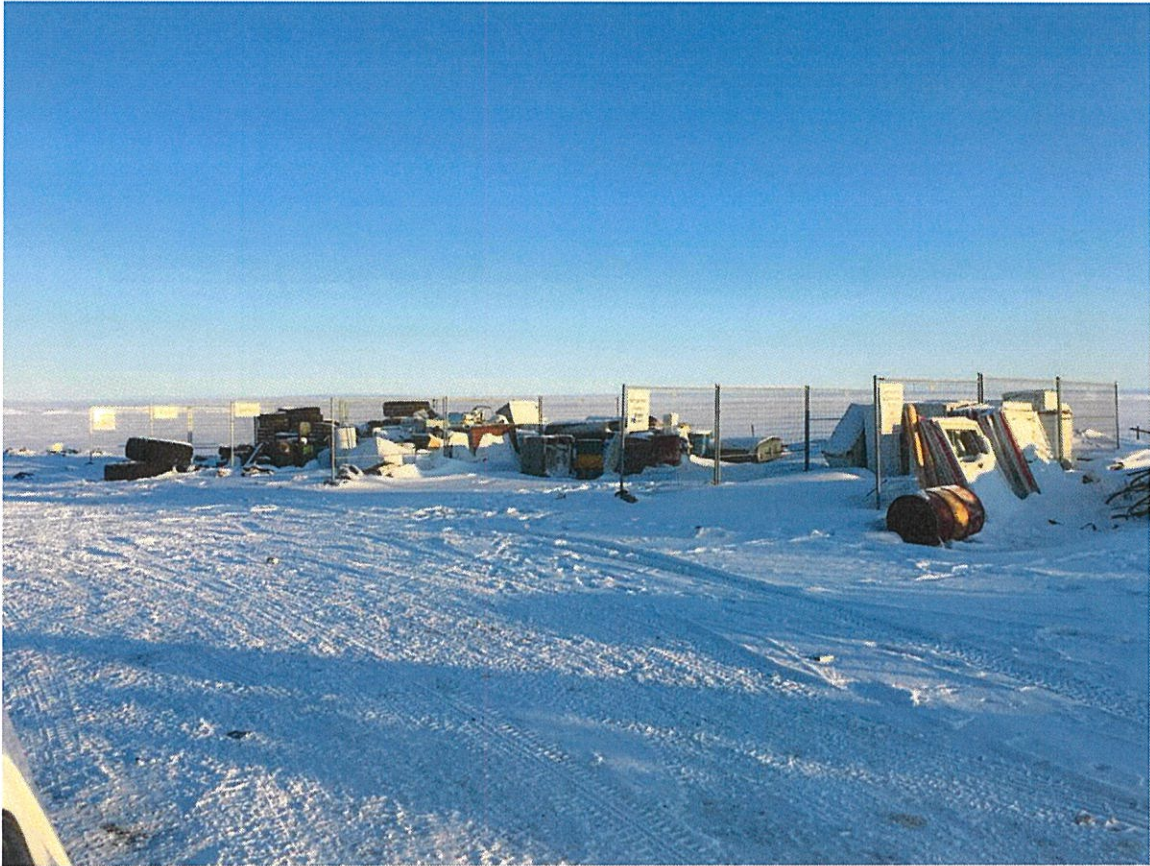
- It is to be recognized and commended that the Hamlet recently underwent a huge organizational clean-up at the landfill. Wastes are segregated into separate piles. Fencing was set up as open cells to store larger items and hazardous materials. This is separated into 6 sections to accept wastes such as batteries, tires, appliances, drums, large appliances, and construction and demolition wastes. It is recommended that The Hamlet speak with construction companies before the completion of a project to discuss and agree on disposal methods for construction and hazardous materials.

Figure 5: Fencing set up as open cells for larger items at landfill.

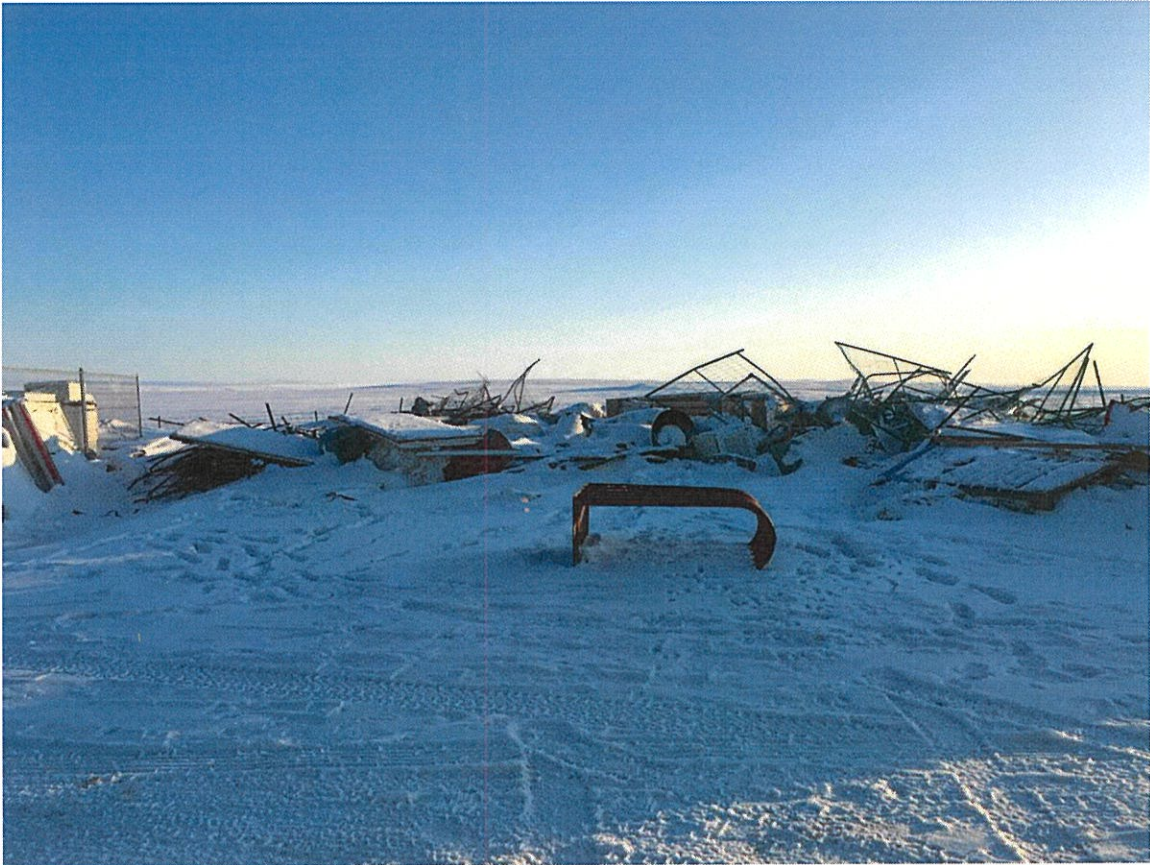
- It is evident that the Hamlet continues to accept construction debris from outside sources.
- Considering the evident gun shooting and arson events that are constantly occurring at the landfill, it is highly recommended that the Hamlet begin considering closing and locking the landfill after hours.

Figure 6: Construction materials left behind by contractors.
