**Re: N7L3-1619 – Modifications to Sewage Lagoon**

HAMLET OF PAULATUK

# **Sewage Lagoon and Solid Waste Assessment**

November 29, 2017

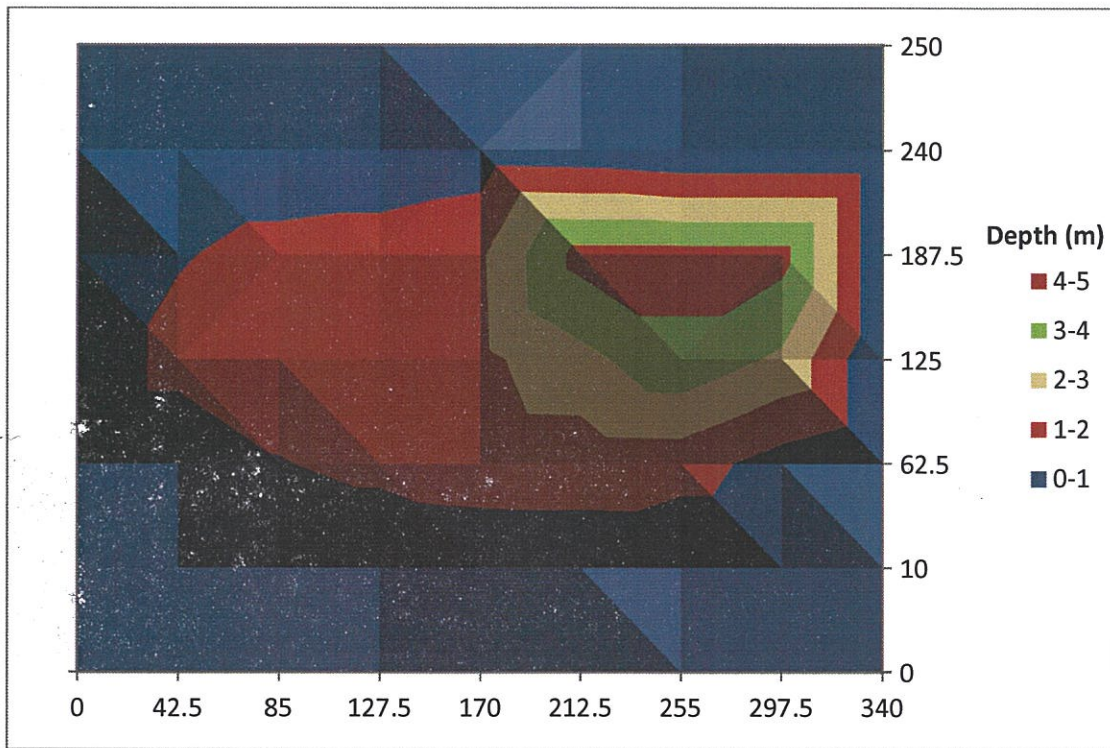
Figure 2: 'Lake A' - Effluent Depth Map

Figure 2 presents a surface map of the effluent depth of 'Lake A'. Figure 3 presents a surface map of the sludge thickness of 'Lake A' Sewage Lagoon. These maps provide a visual representation of the results of the bathymetric survey. The depth/thickness of points between sampling locations is interpolated.

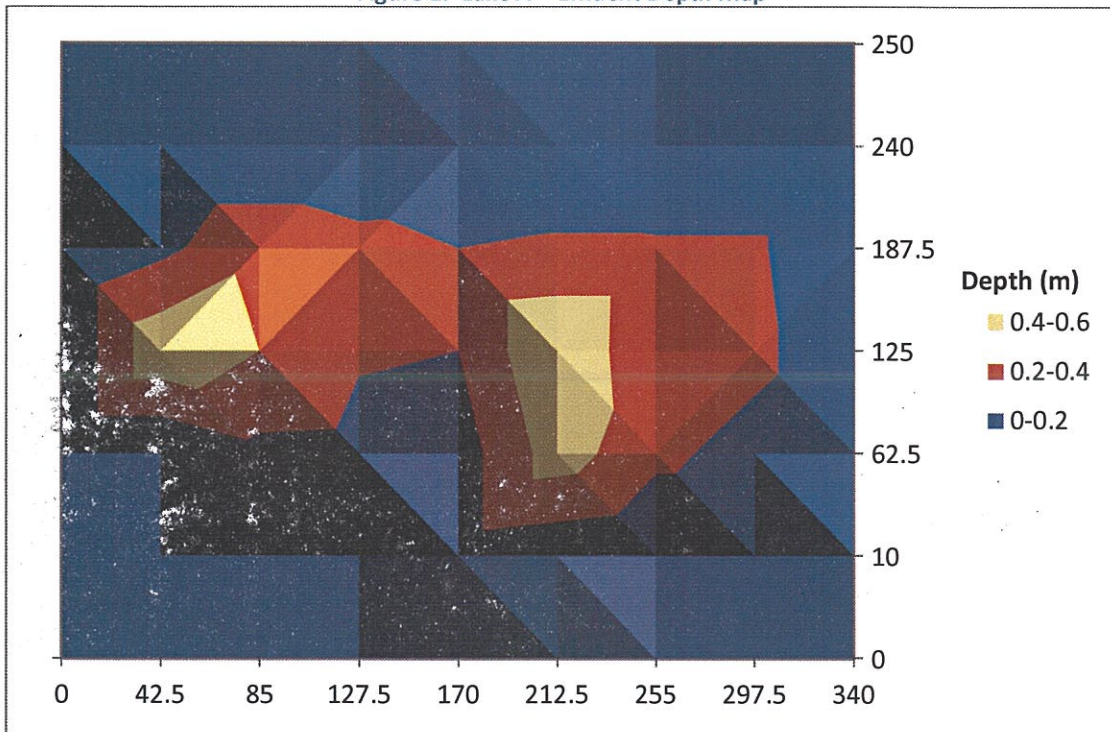
Figure 3: 'Lake A' - Sludge Thickness Map

When the sludge layer thickness reaches 0.5 m from the bottom of the lagoon floor and has reached the bottom of the decant screen structure, it is recommended to assess desludging alternatives (Dillon, 2017a). Given that 'Lake A' has been used as the sewage lagoon since the early 1990s (at most, 27 years to date), and the average depth of sludge is 0.23 m, the lagoon has approximately 30 years of use remaining prior to requiring desludging.

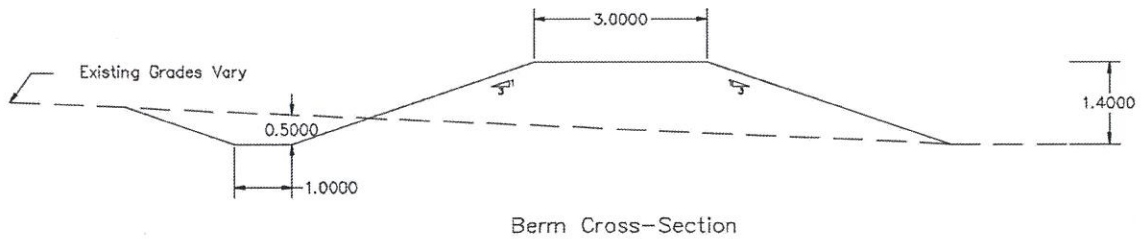
Figure 4: Berm Cross-Section

The approximate drainage area was delineated during the site investigation. A differential topographic survey was conducted to record various locations and elevations between the edge of the lagoon and the edge of the approximate drainage area boundary. Roughly 300 topographic survey shots were taken and used to create contour data and grading profiles. This topographic information was used to estimate the volume of runoff that the berm would aim to divert along with the lagoon volume change that the berm would aim to retain during a 25-year, 24-hour precipitation event. The exterior berm is ideally kept as small as possible while still providing adequate containment and freeboard to prevent overtopping from storm events. Based on an additional freeboard of 750 mm (1 m total), the 25-year return storm rainfall amount of 40 mm, and an assumed lifetime loss of freeboard due to sediment and vegetation accumulation of 10 mm/year over 25 years, it was calculated the berm should have a minimum height of 1.4 m above existing ground.

The berm was designed with a top width of 3 m. This dimension was selected to facilitate the use of construction equipment or other vehicular traffic on top of the berm crest. It was assumed that berm side slopes of 3:1 would be acceptable for the geotechnical stability considerations as well as the construction considerations. Figure 4 below shows a typical cross-section of the proposed lagoon berm. During the site investigation, it was observed that the area currently had problems regarding erosion, sediment transport, and rodent burrowing. To prevent erosion and rodent burrowing, the outside berm slope may be riprapped with stone. Without this stone protection, the berm may not prove sufficient with regard to water restriction as an additional volume of water would be allowed to percolate through the rodent burrows and eroded side material. The poor grading surrounding the edge of the berm would require the use of a collection ditch to convey the diverted surface runoff around and away from the lagoon.

A drainage ditch was included in the berm cross-section for two primary purposes. Firstly, the ditch is a means to direct and move surface runoff away from the berm and the lagoon. If there was no drainage ditch, there would be significant standing water and ponding surrounding the berm due to various depressions in the natural topography along with the generally poor natural grading of the area. Secondly, the ditch facilitates the use of reused 'cut' material to lessen the amount of 'fill' material that would otherwise need to be hauled in from off site. The reused material was estimated to be half the cost of material brought in, with unit prices of \$30/m<sup>3</sup> and \$60/m<sup>3</sup> respectively.

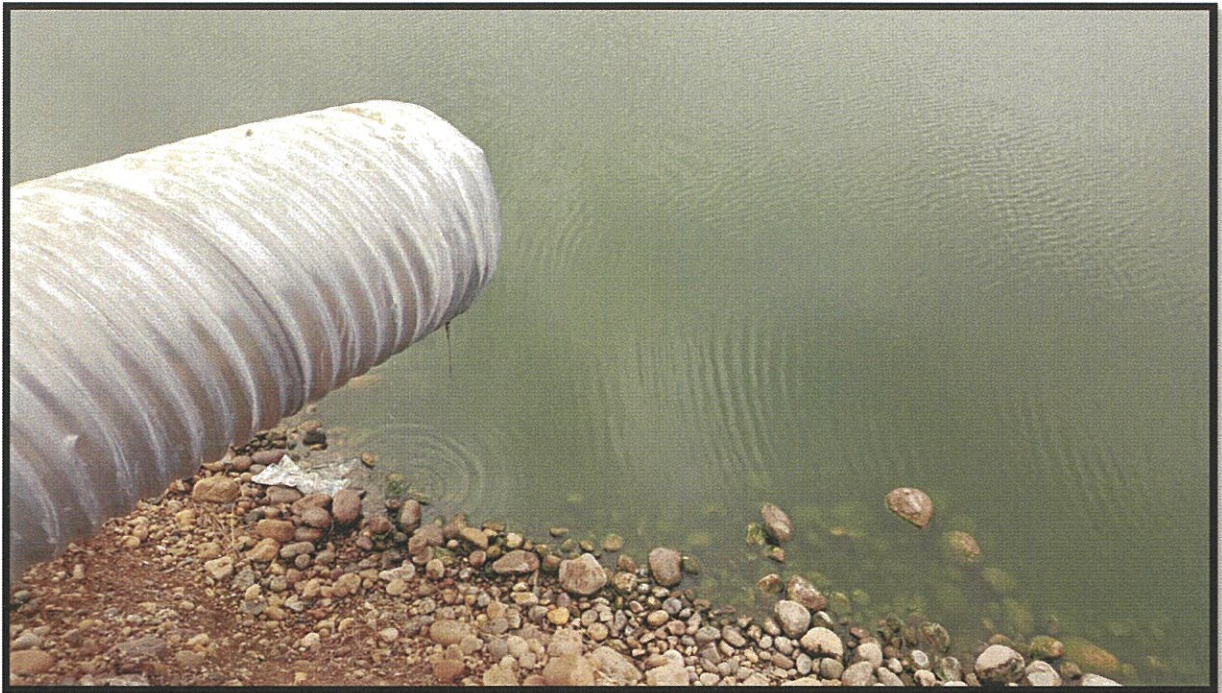
The discharge chute of the sewage disposal facility is located at the northeast corner of 'Lake A'. The end of the discharge chute is 700 mm above the lagoon surface. Riprap is present under the discharge point to reduce erosion (see Photo 1). The majority of the lagoon perimeter is sandy and vegetated. There was no significant algal growth at the surface of the lagoon. There was no signage observed indicating that the facility is an active sewage lagoon site. Wildlife including sandhill cranes and ducks were noted in and near 'Lake A' and the wetland. A black bear was observed in the vicinity of the sewage lagoon discharge chute.

Photo 1: Sewage Lagoon Discharge Chute Outlet

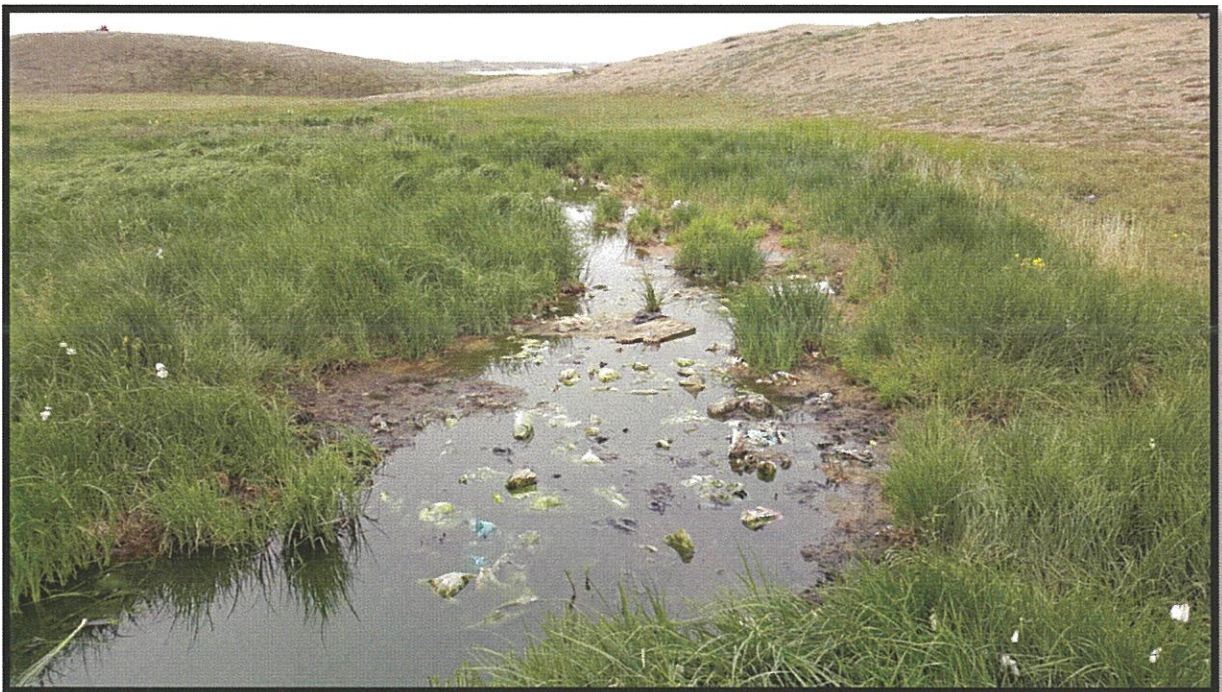
There is significant windblown litter accumulating at the discharge point from the lagoon to the wetland (see Photo 2). A well-used ATV trail crosses the wetland, and a visible sheen was noted on the water (see Photo 3), approximately 20 m east of the shore of Darnley Bay. Some litter is present at the discharge point from the wetland to Darnley Bay (see Photo 4). There is continuous low flow from the wetland into Darnley Bay.

Photo 2: Accumulated Litter at SNP Station 1619-2, Outlet of Lagoon to Wetland

Accumulation of litter along the banks of the lagoon	Windblown litter from the solid waste disposal facilities is entering the lagoon	Begin application of cover material to waste disposed of in landfill cells on a regular basis; and conduct litter cleanup in accordance with the water licence requirements (twice annually)
SNP results from sewage lagoon stations are not within the effluent criteria established by the IWB	Stations 1619-2, 1619-3, and 1619-4 results do not meet the pH and TSS effluent criteria values	Continuous natural decanting at the active sewage lagoon should cease, and manual decanting should occur annually in the fall to allow for longer treatment over summer months

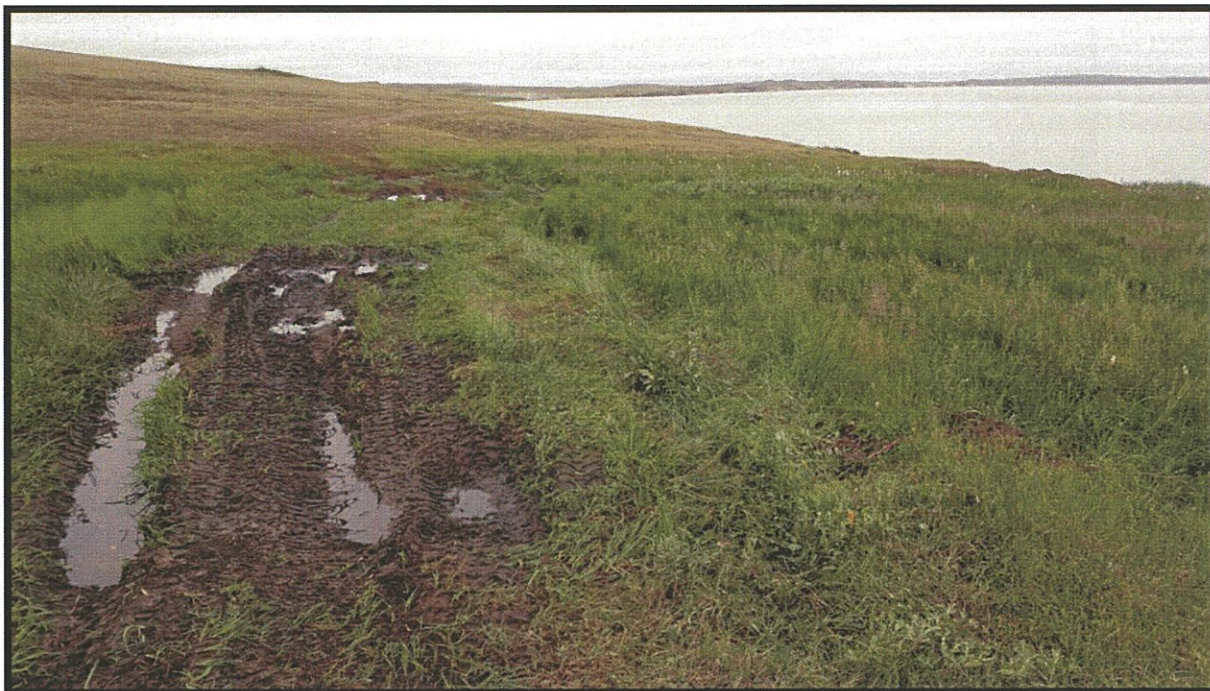
Photo 3: ATV Path Across Wetland, Looking South

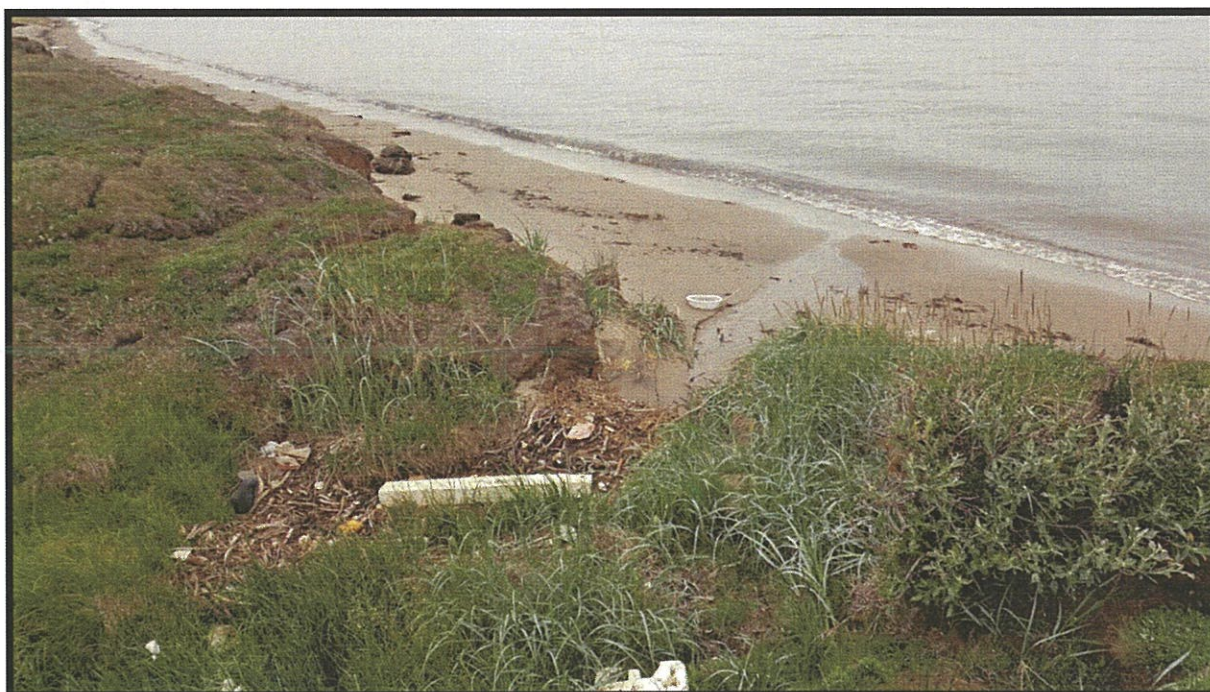
Photo 4: Accumulated Litter at Outlet of Wetland to Darnley Bay

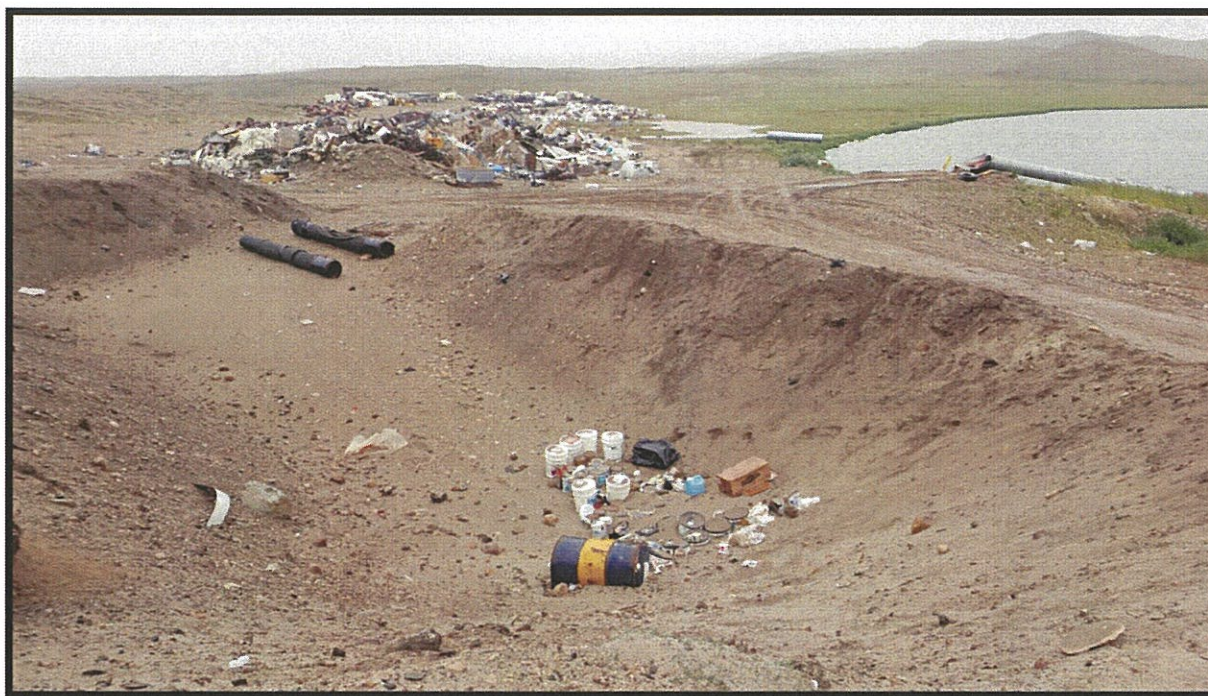
To the east of the municipal cell, running parallel lengthwise to the road is an additional cell with minor amount of hazardous materials. Two rolls of geotextile material approximately 5 m in length are also located in this cell (see Photo 5).

Photo 5: Geotextile Rolls and Hazardous Waste in Bermed Area, East of Active Cells

The bermed area currently containing minor amounts of hazardous waste (Photo 5) and geotextile rolls could be repurposed to yield a new municipal or Northern Store waste cell. The construction and use of an appropriate hazardous waste area or the storage of these hazardous wastes at the Hamlet maintenance garage would result in this cell being available for other wastes. The current dimensions of the cell would yield an estimated 220 m<sup>3</sup> of landfilling capacity. It is recommended that the geotextile rolls be stored in a safe location as they may be of use for future construction or improvement work at the site.

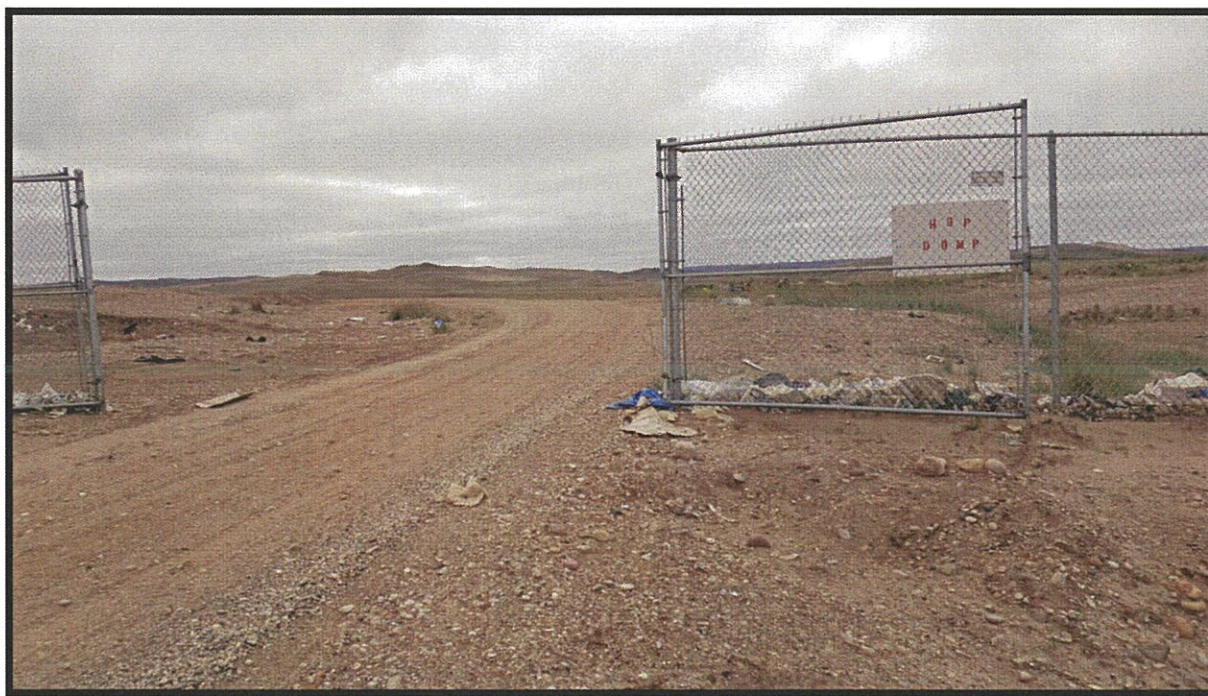
The only signage observed at the landfill was the name sign adjacent to the gate (see Photo 6). Fencing was observed to be falling over and in general disrepair (see Photo 7). Significant windblown litter was noted outside of the solid waste facility to the north, down to Old Water Lake (see Photo 8).

Photo 6: Access Road to Solid Waste Disposal Facility, Only Signage at the Facilities

In accordance with the water licence N7L3-1619 Part B, Item 5, signage clearly indicating where different waste streams should be deposited is required at the waste disposal facility. It was noted by the Hamlet foreman that the Hamlet is in possession of signage supplied by MACA that can be installed, however reinforcing of the signs with plywood is necessary as the signs are Plexiglas. Vandalism of the signs (shooting) has been an issue in the past.

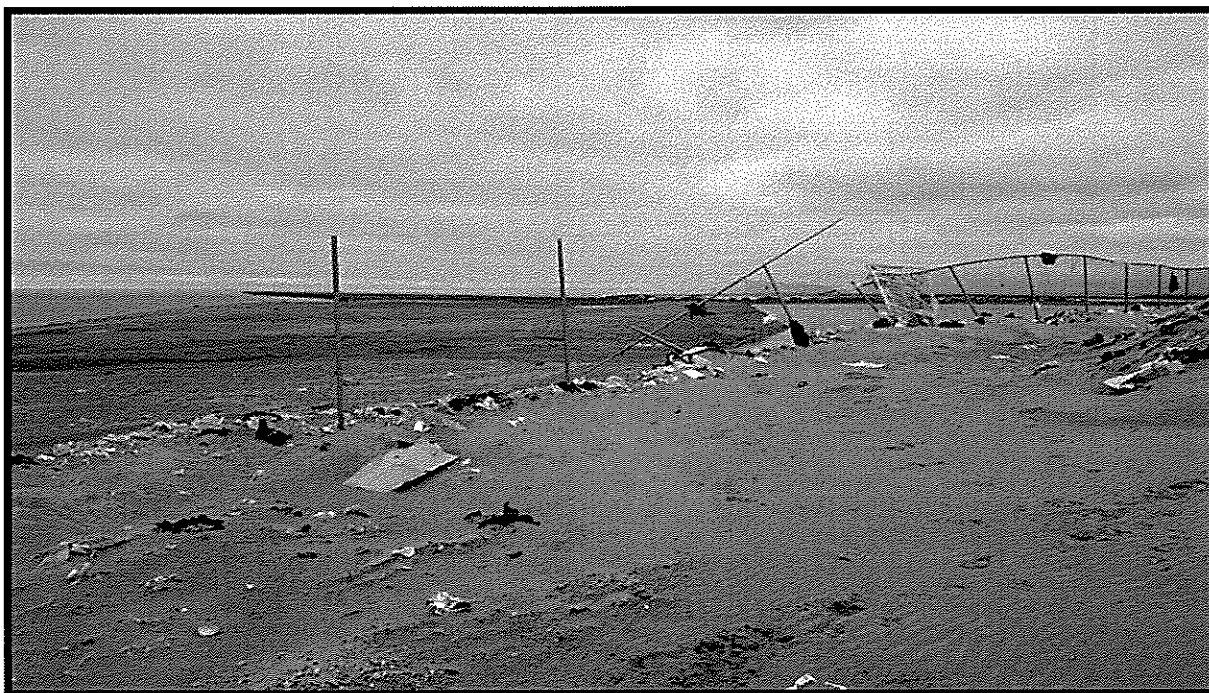
Photo 7: Downed Fence East of the Access Road, Looking North

The Hamlet experiences strong south winds. The fencing along the northern perimeter of the facility is intended to prevent windblown litter from the landfill site from spreading. The northwest fencing has been installed in concrete, and is upright and in good condition. The northeast fencing has been installed in sand, and has fallen over and is in disrepair. The Hamlet is required to maintain fencing around the facility in accordance with Part B, Item 8, of the water licence, to prevent the spread of windblown litter. The Hamlet has indicated that the repair of the solid waste facility fencing is in progress. Hamlet is required to collect windblown litter in the facility and surrounding lands twice annually, in the spring and fall, in accordance with Part D, Item 20, of the water licence.

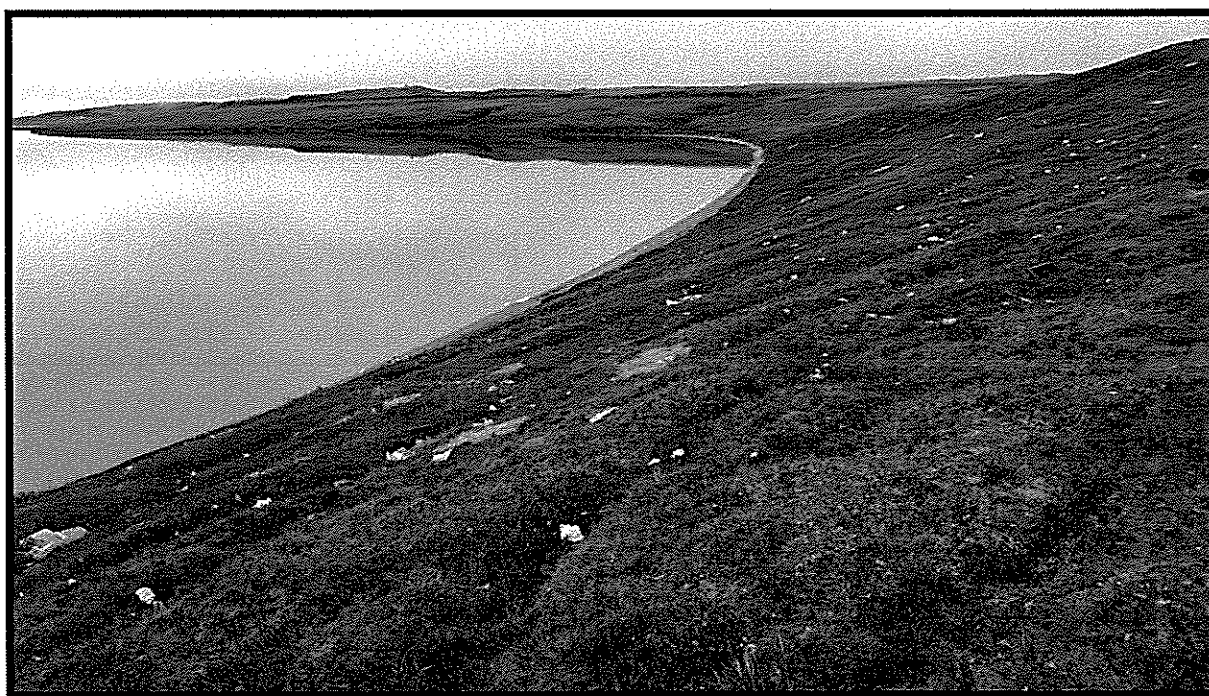
Photo 8: Accumulated Litter North of Solid Waste Disposal Facility, at Shore of Old Water Lake, Approximate Location of SNP Station 1619-6

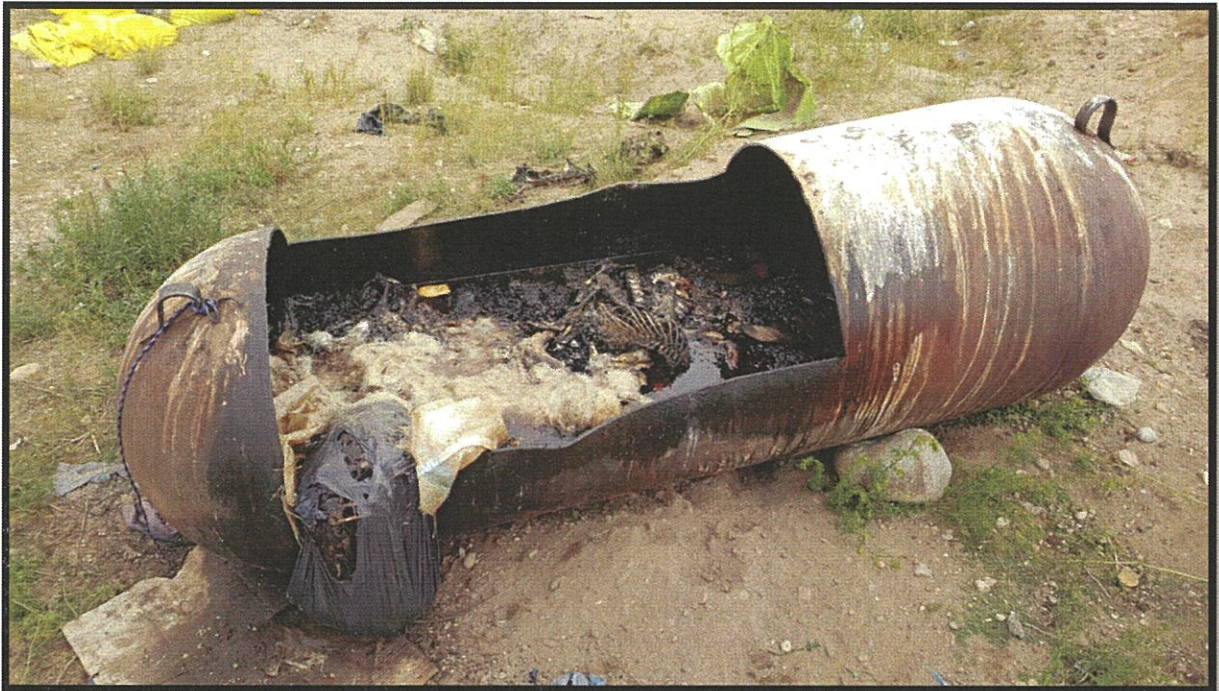
Animal carcasses are incinerated in the designated incineration drum (see Photo 9), and are then buried in the carcass pit and covered. Inspection of the facility revealed animal carcasses found outside of the designated bin, not properly buried. Additionally as noted in Photo 9, the incineration drum is partially filled with water and other waste, and incinerated carcasses have been left in the drum and not managed properly.

Photo 9: Animal Carcass Burning Pit

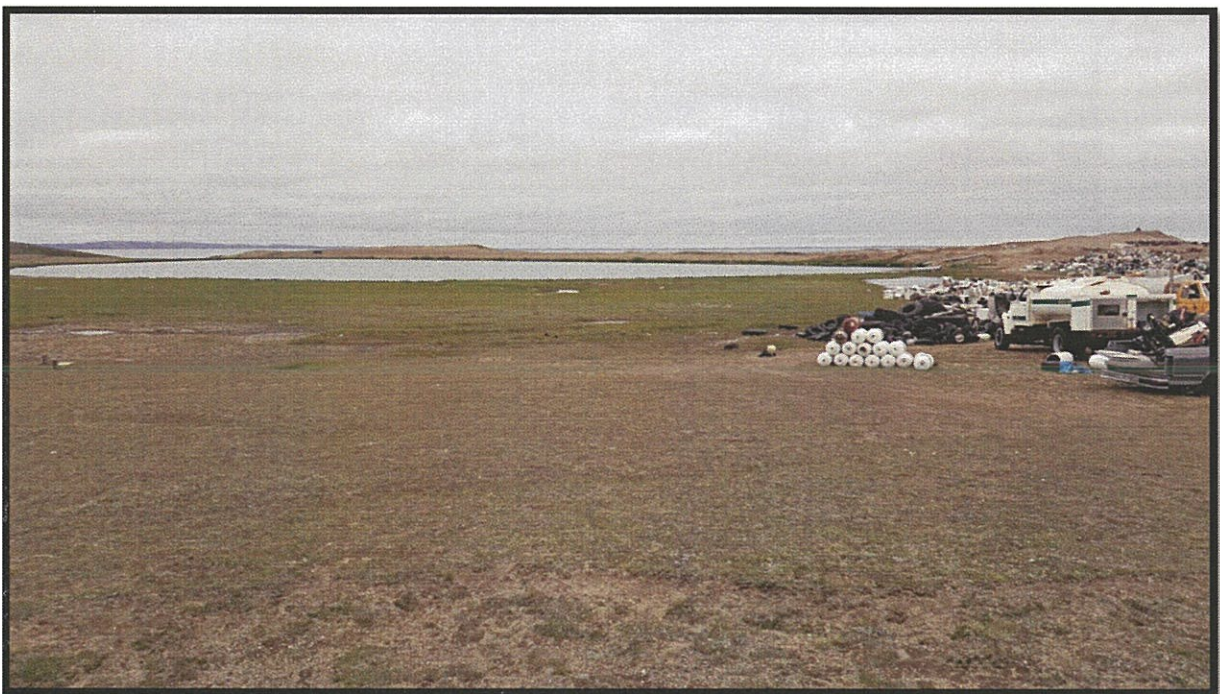
At the southeast extremity of the facility, propane tanks were noted as being stored on their side (Photo 10). Most household type propane cylinders are designed to be used, stored, and transported in an upright position. Propane tanks not designed for horizontal use may pose an extreme danger if stored horizontally and not upright. See the *Solid Waste Disposal Facilities Operation and Maintenance Plan* for more information.

Photo 10: East End of Solid Waste Disposal Facility, Looking West to 'Lake A'
