An inspection of the Imperial Oil Resources Water Licence N7L1-1836 (expiry on March 30, 2020) was conducted on July 27, 2016. Specifically, the Water Licence was inspected to ensure that the terms and conditions were met. Enclosed is a copy of the Inspection Report (8 pages) for your review and records.

INDUSTRIAL WATER USE INSPECTION REPORT

LICENCE #:	N7L1-1836	EXPIRY DATE:	March 31, 2020
LICENCEE:	Imperial Oil Resources	PREVIOUS INSPECTION:	July 31, 2013 (INAC)
COMPANY REP:	Tobiah Newton, Project Manager	INSPECTION DATE:	July 27, 2016

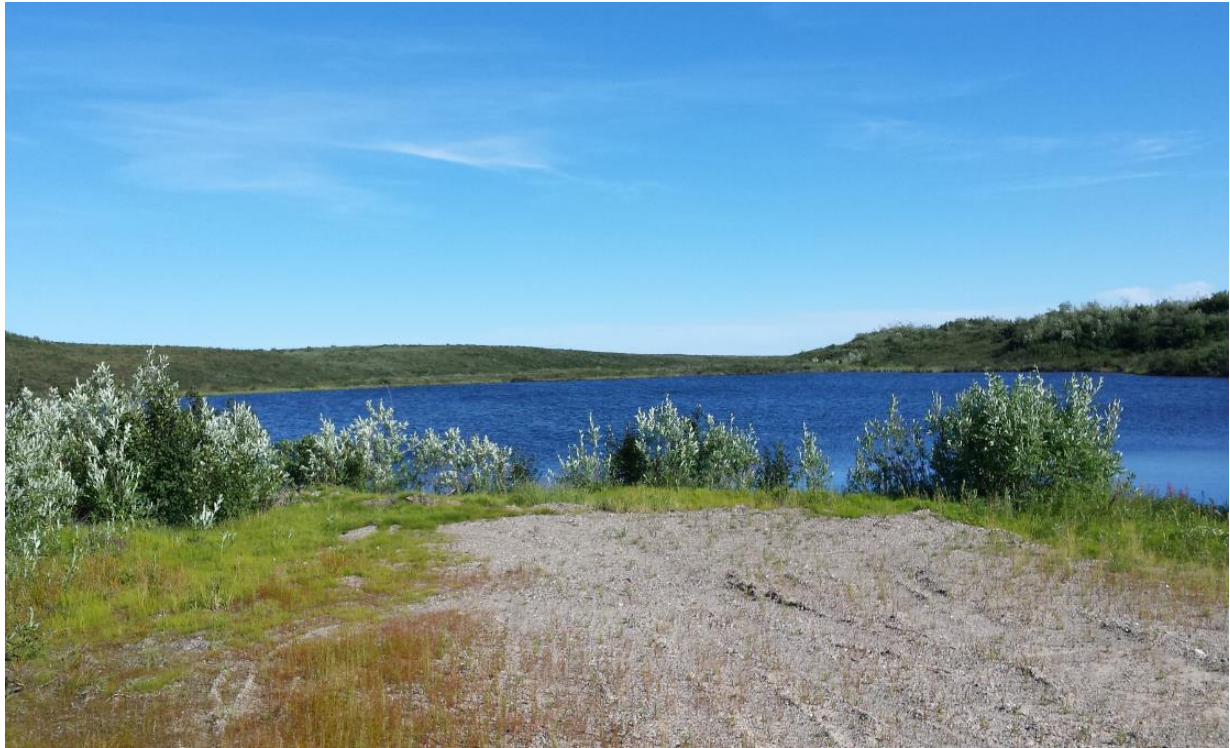
Figure 1

- No concerns to report with regards to water use. The old water source was inspected and no issues could be observed around it (Figure 1). The access road towards the lake and the gravel pad on the south end of the lake are still in place and pose no threat to the water source. The substrate on the south side of the lake was natural looking and no environmental issues could be observed. There were many signs of wildlife using the water source and the area was well vegetated and appeared to be undisturbed.

Old water source.

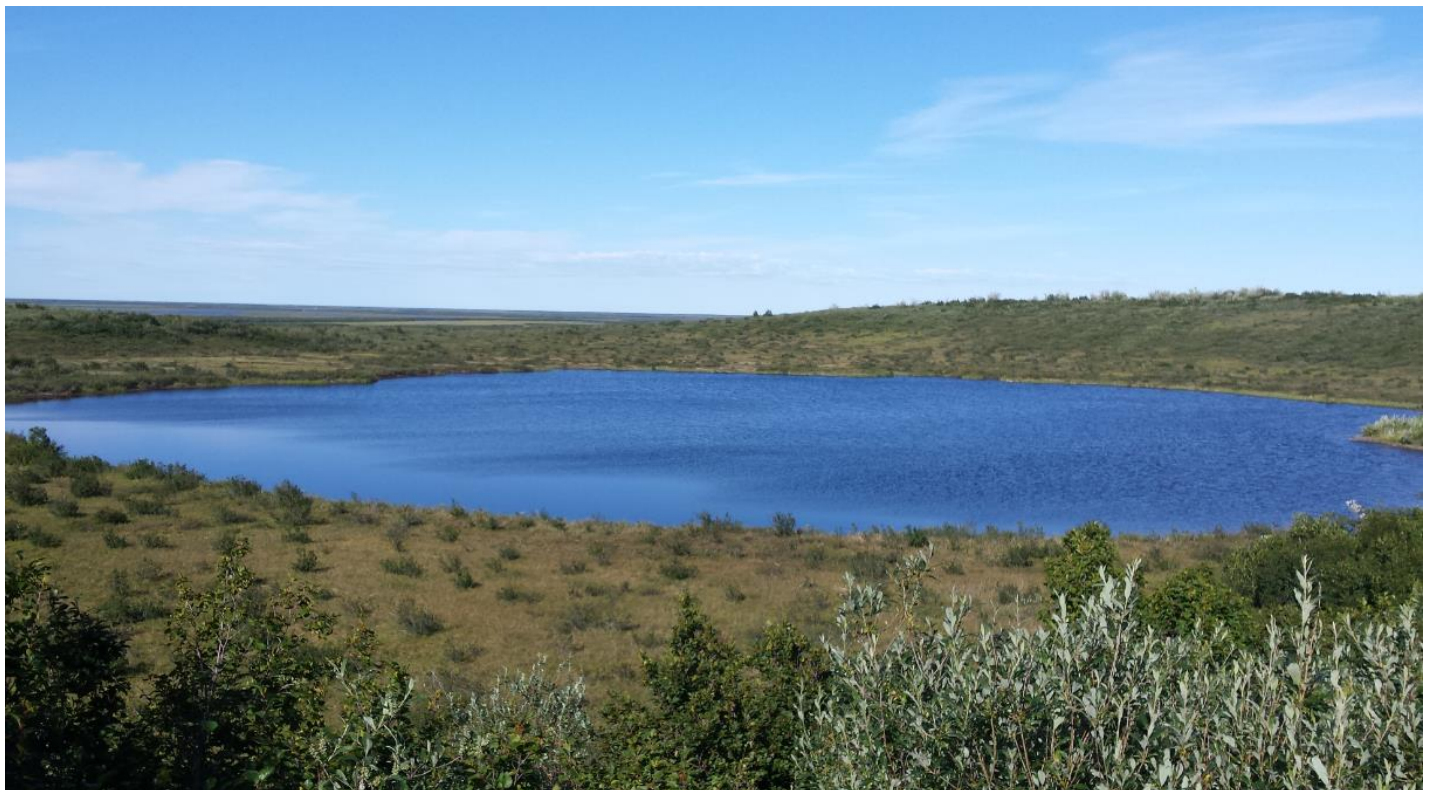
Figure 2

- The old DEW Line site sewage lagoon and the Imperial Oil Resource (Figure 2) lagoon appeared to be in acceptable condition (e.g. smell, coloration banks). The freeboard level stood well above the 1 meter limit as per the Water Licence. The sewage lagoon banks were fully vegetated and discharging naturally into nearby wetlands northwest of the lagoons and towards the Mackenzie River.
- There were no erosion, run-off or leakage concerns at the time of the inspection.
- It is understood that the sewage lagoon has not been used for some time.

Imperial Oil Resources sewage lagoon.

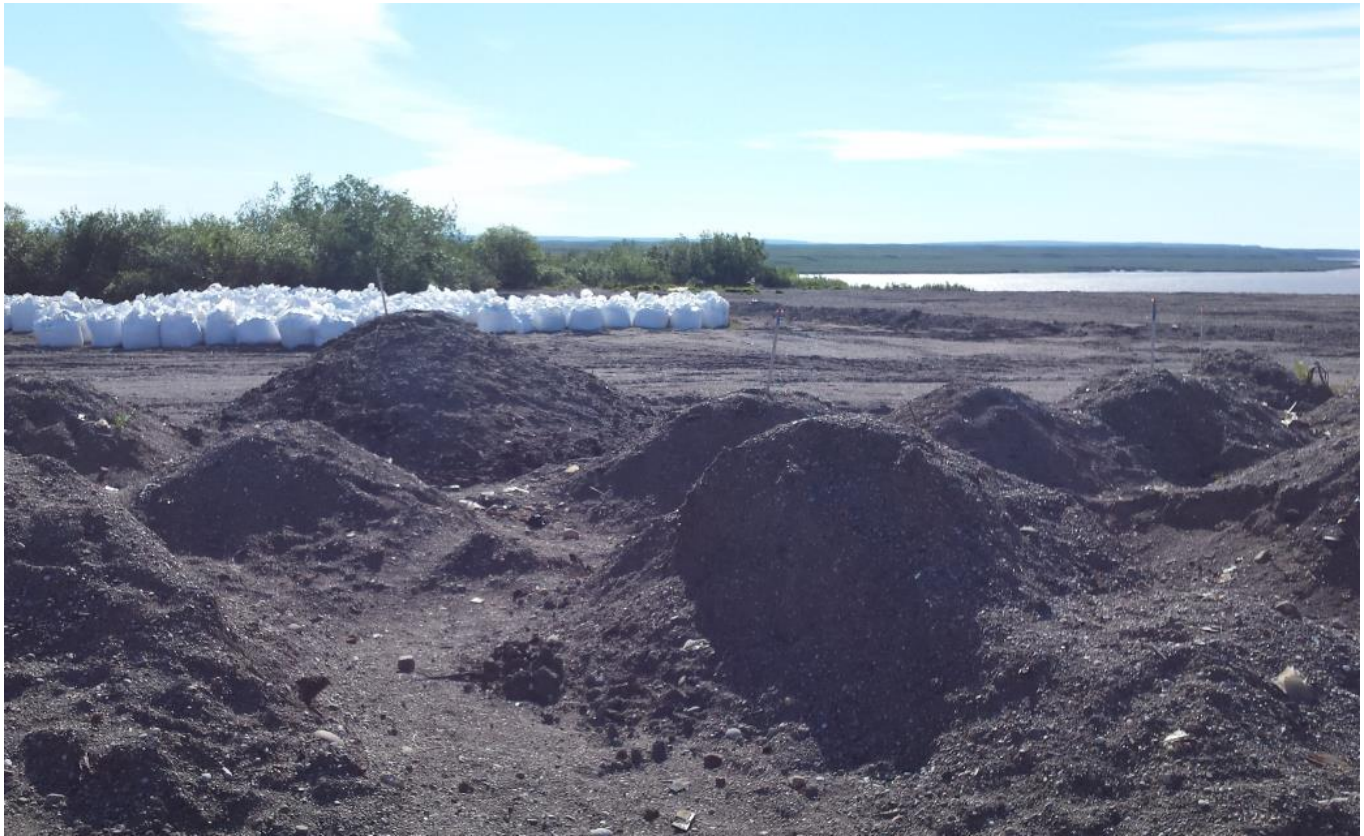
Figure 3

Earthpiles and soil bags.

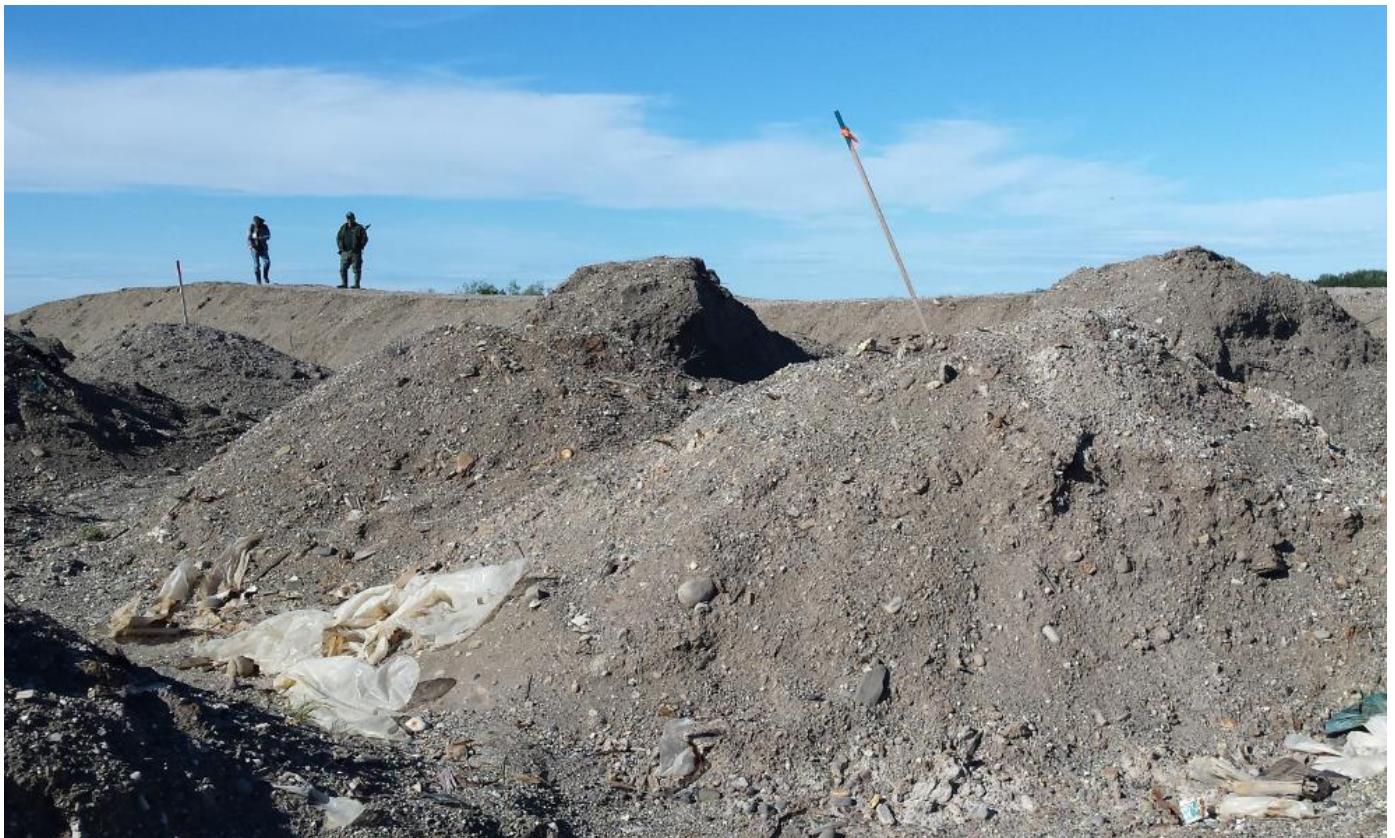
Figure 4

Earthpiles and berm.

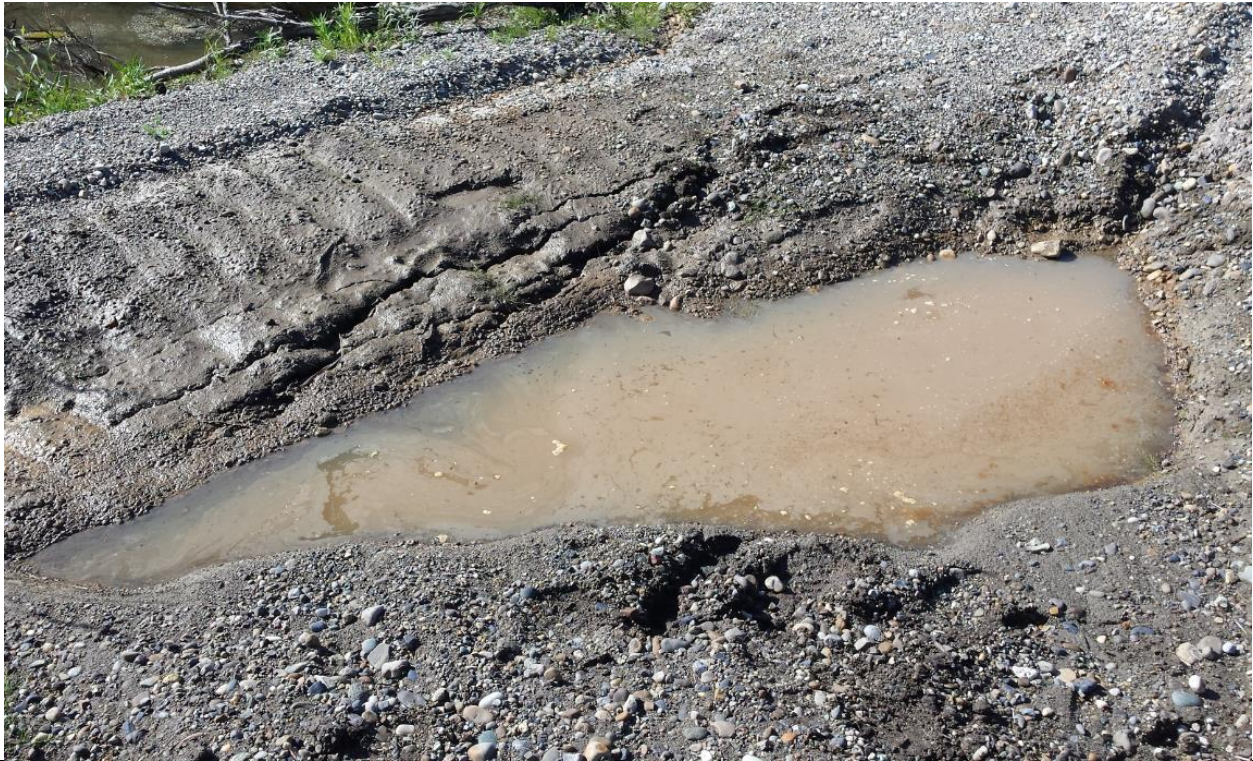
Figure 5

- ²There appeared to be an oily sheen at Area A, southwest of the site (Figure 5). It smelled faintly of hydrocarbons and should be further assessed by the Licensee once there are crews on the ground.

Oily sheen at Area A.

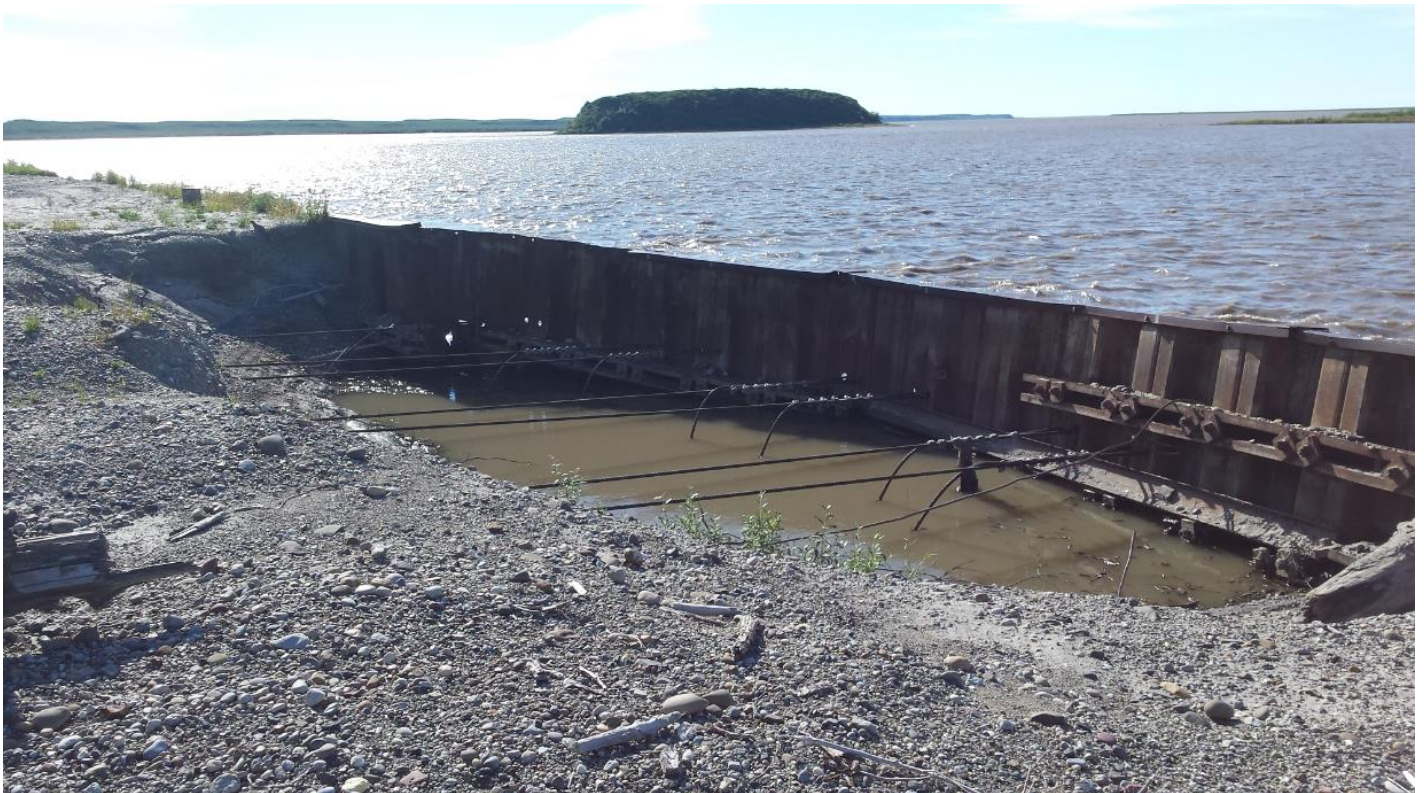
Figure 6

- At the time of the inspection, no work had been done at Area H (Barge Dock). The dock is eroded in some areas and discharging sediments and materials into the Mackenzie River (Figure 6). Overall condition and stability of the dock should be closely monitored until its final removal.

Erosion and sedimentation from the dock at Area H.

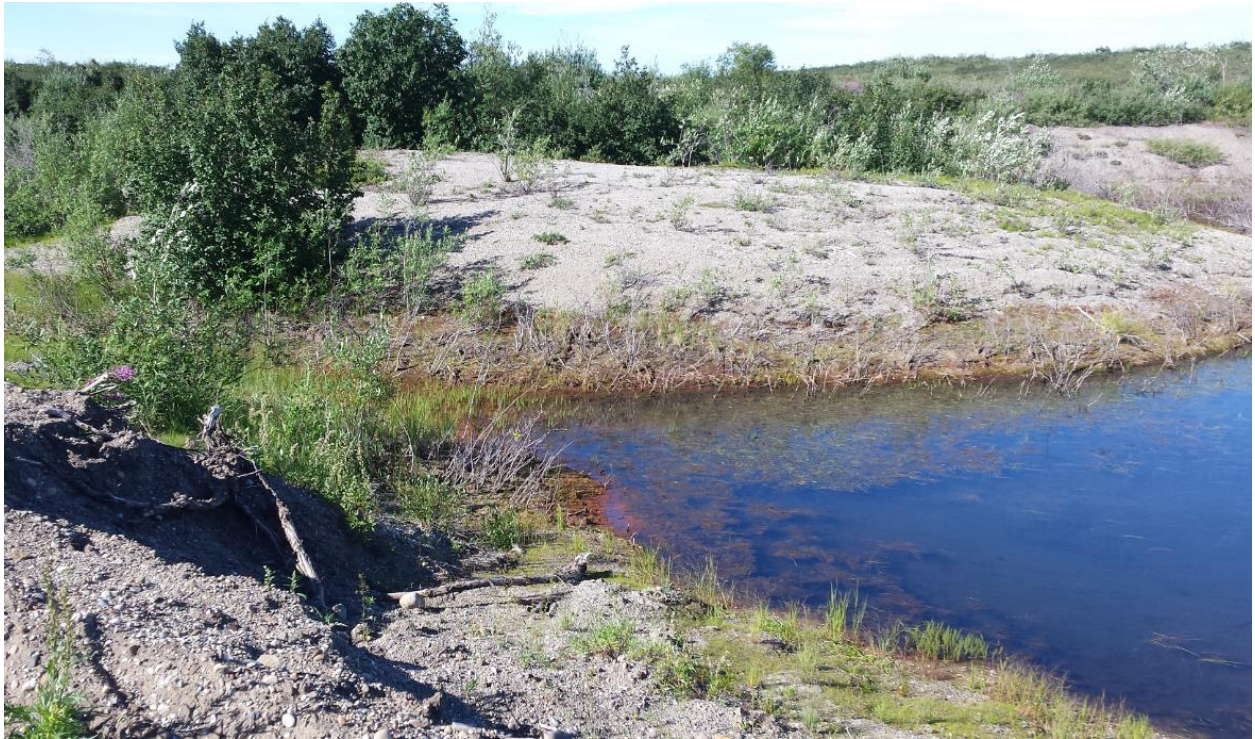
Figure 7

- Overall the remediation work that has been ongoing at Areas A, B, D and F appear to be holding, i.e. no major erosion and sediment issues could be identified, as well as run-off escaping the sites. There is some ponding along Area F however they were well vegetated and inhabited by wildlife (Figure 7). Some ponding was also observed inside Area F. In addition, the northwest corner of Area F should be further assessed and monitored by the Licensee as there appears to be some disturbed soil outside of the former borrow, uphill from the natural lake north of the old water source.

One of the many ponds around Area F.

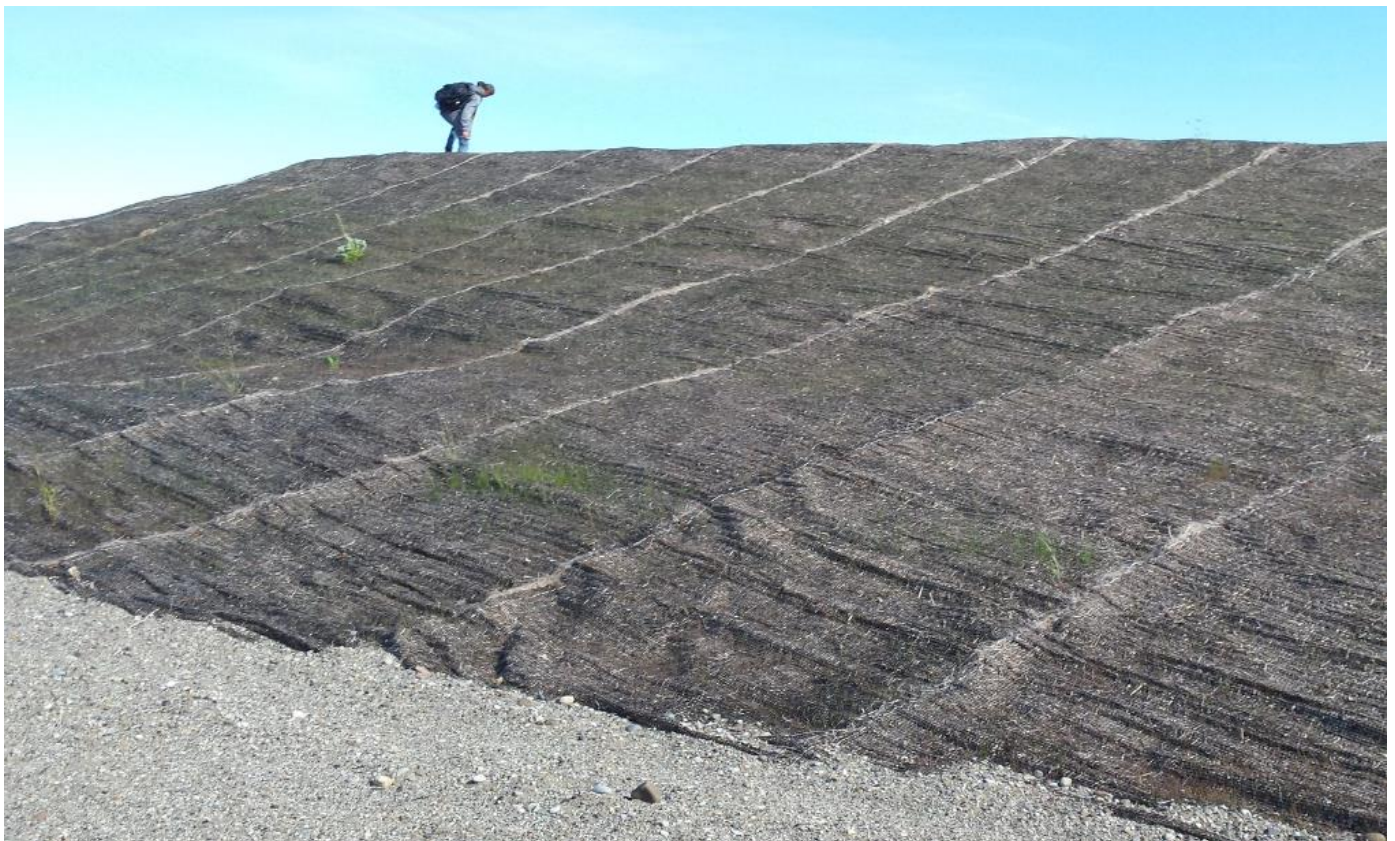
Figure 8

- The erosion and sediment control (ESC) best management practices in place at Areas A and B appeared to be effective and still in good condition. Some revegetation is occurring, mostly downhill (Figure 8). Revegetation and stability/condition of the ESC measures in place will have to be closely monitored through the years given the elevation of the site and the strong exposure to weathering.

Area B, ESC measures and light revegetation taking place.
