An inspection of the Shell Canada Energy Water Licence N7L1-1834 (expiry on July 17, 2017) was conducted on August 15, 2016. Specifically, the Water Licence was inspected to ensure that the terms and conditions were met. Enclosed is a copy of the inspection report (7 pages) for your review and records.

LICENCE #:	N7L1-1834	EXPIRY DATE:	July 17, 2017
LICENCEE:	Shell Canada Energy	PREVIOUS INSPECTION:	July 31, 2014 (GWNT Lands)
COMPANY REP:	Randall Warren, Manager, DAR and Drilling Waste	INSPECTION DATE:	August 15, 2016

INDUSTRIAL WATER USE INSPECTION REPORT

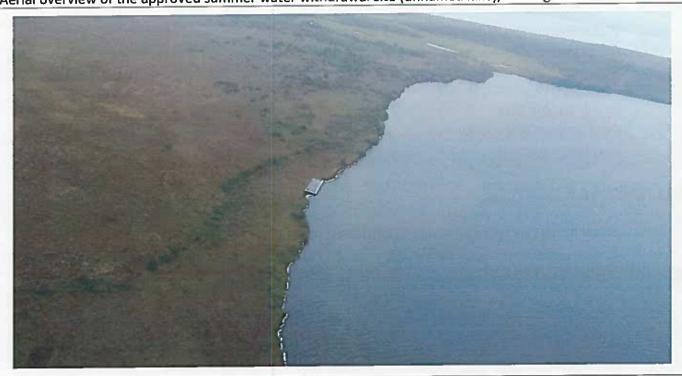
- It is understood that drinking water was barged in from the Town of Inuvik. All other water used for domestic purposes was obtained from the Mackenzie River in the winter and the unnamed lake to the north of camp facilities in the summer.
- An aerial inspection of the summer water withdrawal site was conducted and no environmental concerns were identified. The area appeared to be clean and undisturbed (Figure 1). No equipment was left on site at the time of the inspection.
- All tanks on the camp barge appeared to be in good working condition and the supervisors on site did not report experiencing any issues with the equipment (Figure 2).

Figure 1
Aerial overview of the approved summer water withdrawal site (unnamed lake), looking west.

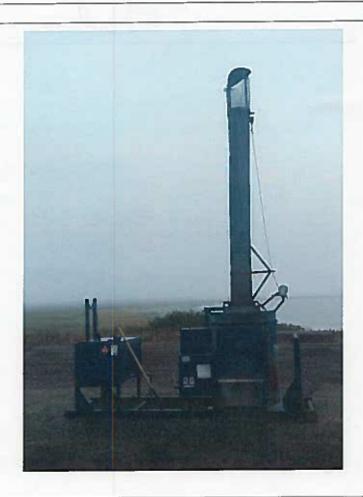
- There were no issues or concerns identified with regards to solid waste disposal.
- During camp operations, organic wastes are incinerated on site using the approved incinerator
 which appeared to be in good working condition (Figure 3). All other non-hazardous wastes that
 are not incinerated on site are stored for shipment to the Inuvik landfill.

Figure 2 Incinerator.

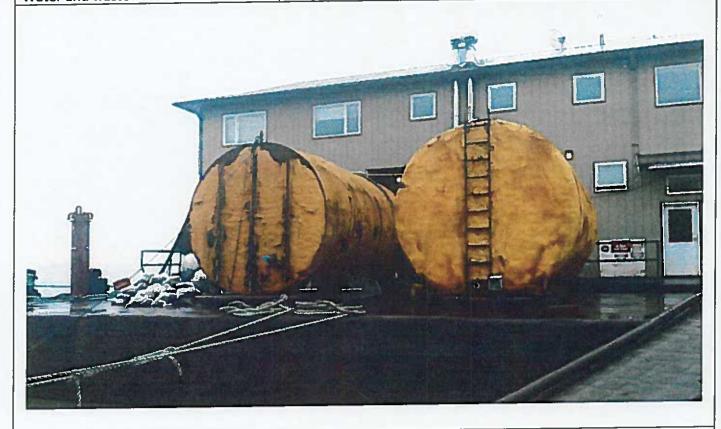
Figure 3

Water and wastewater tanks on the camp barge.

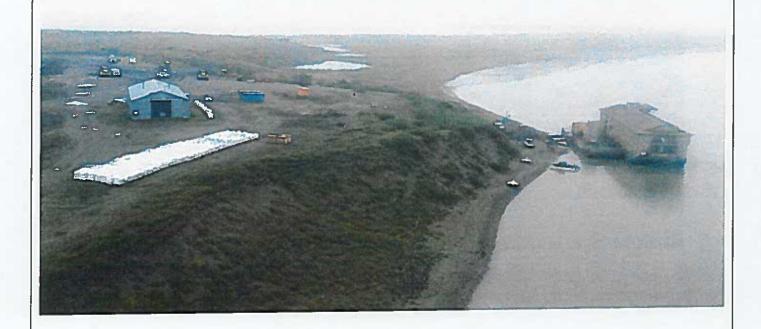
Figure 4

- As of the time of the inspection, the structures that remained on site were a fuel trailer, a storage shed, an emergency shelter and the airstrip (Figure 4). A camp barge was docked at the existing barge landing site. There were temporary rig mats installed at the dock to protect the river shore and allow for loading and unloading of the barge (Figure 5). All fuel tanks on the barge appeared to be in good working condition (Figure 6).

Aerial overview of the Camp Farewell remaining structures (air strip is missing), looking south.

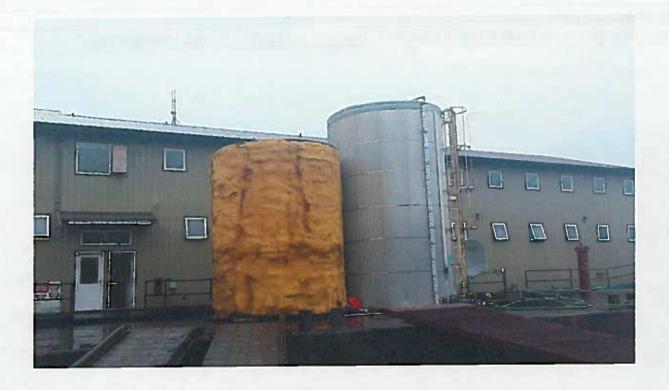
Figure 6
Fuel tanks on the camp barge.

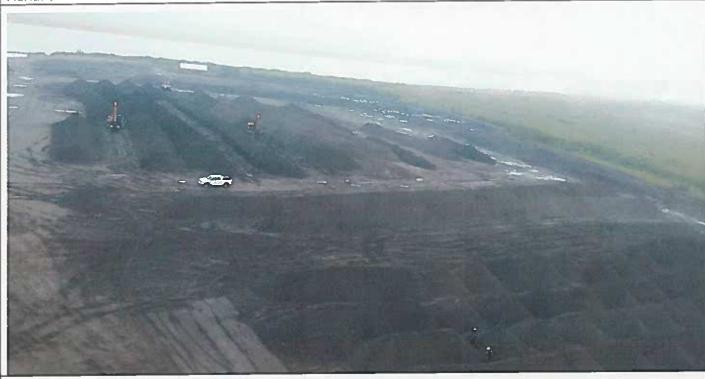
- At the time of the inspection, there were a numerous windrows of contaminated soil in the process of being remediated (Figure 7). There were also numerous bags of polyurethane layering which was in the process of being recovered (Figure 8).

Figure 7
Aerial overview of the windrows of contaminated soil being remediated, looking southwest.

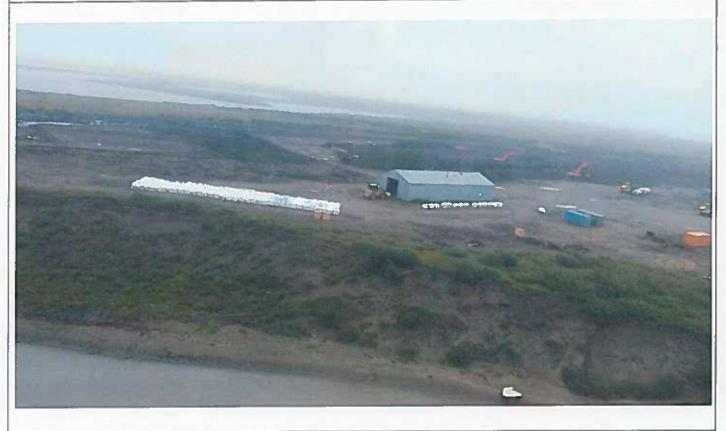
Figure 8

Aerial overview of the bulk bags of polyurethane layering recovered from the subsurface on site, looking northeast.
