An inspection of the Municipal Water Supply and Waste Disposal Facilities was conducted on August 25, 2016. Enclosed is a copy of the Municipal Water Licence inspection report.

MUNICIPAL WATER USE INSPECTION REPORT

LICENCE #s:	G99L3-003 and N3L3-0570	EXPIRY DATES:	November 30, 2019
LICENCEE:	Hamlet of Aklavik	PREVIOUS INSPECTION:	August 26, 2011 (AANDC)
COMPANY REP:	Fred Behrens, SAO	INSPECTION DATE:	August 25, 2016

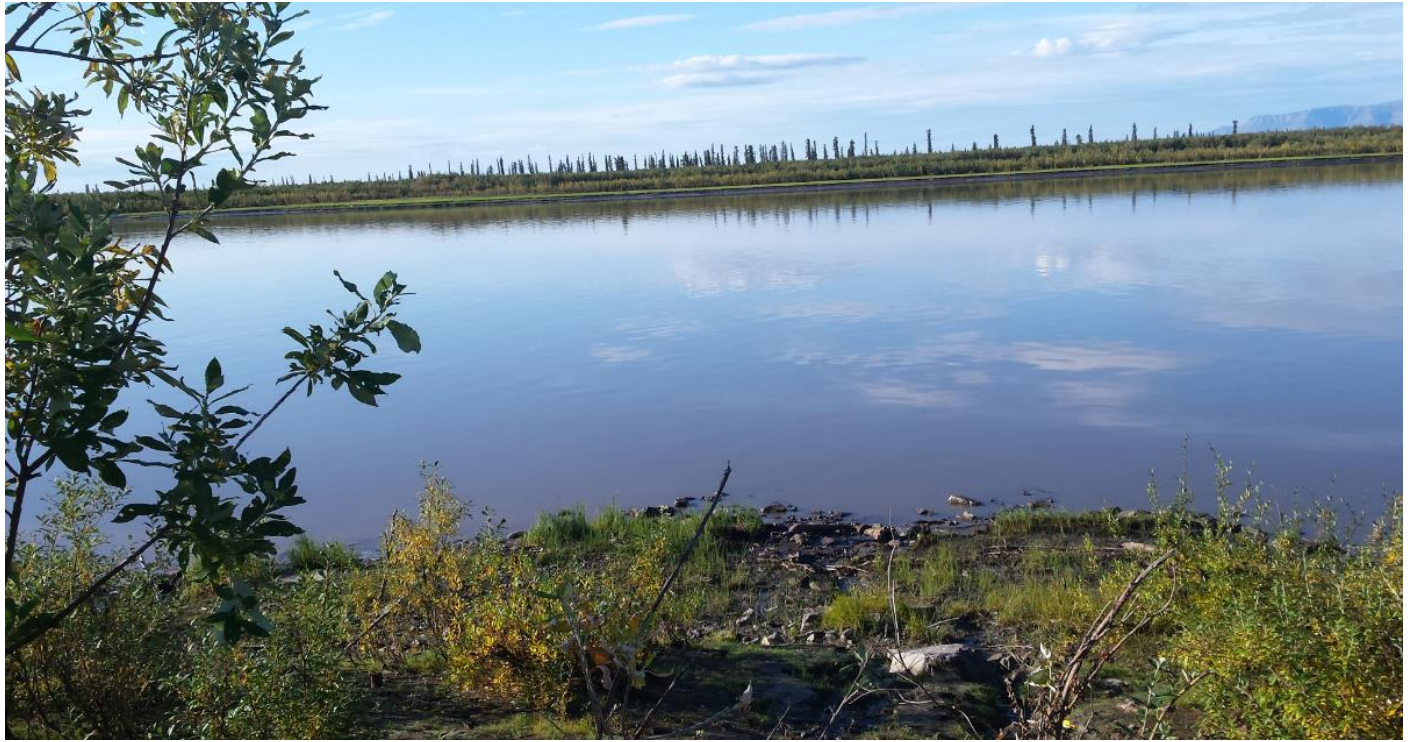
Figure 1

- The water intake site, located behind the Water Treatment Plant (WTP) and drawing from the Peel Channel of the Mackenzie River, was clean looking with no litter nearby (Figure 1). Human activity around the water supply is constant however it has not affected water quality in recent years.
- The water intake pipe is fully submerged and does not enter into contact with any vessels/motorized vehicles operating around the WTP.
- From a source water protection standpoint, it would be a best management practice to berm all medium to large fuel storage tanks near the water intake area.

Water Supply: Mackenzie River, Peel Channel. Overview of the Water Intake area, behind the WTP.

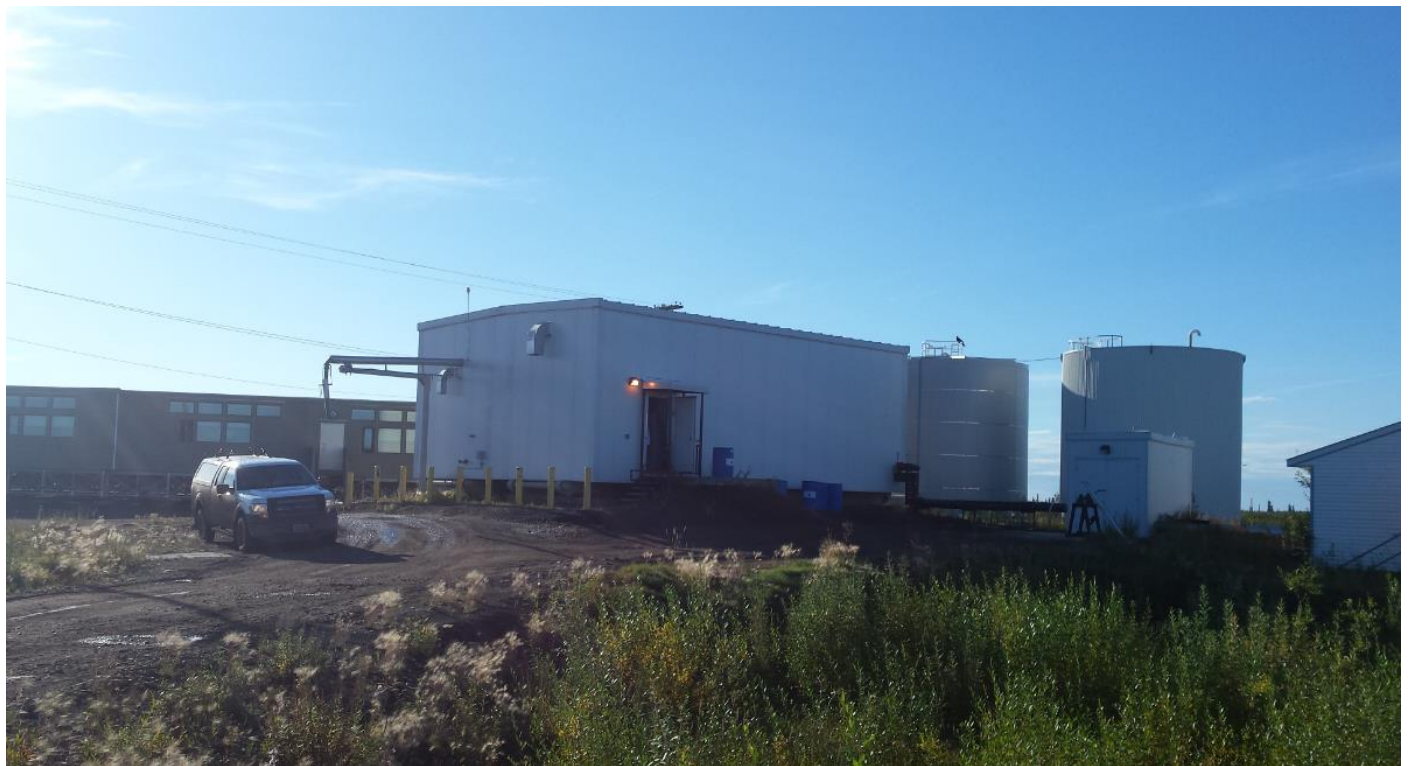
Figure 2

Water Treatment Plant: Overview.

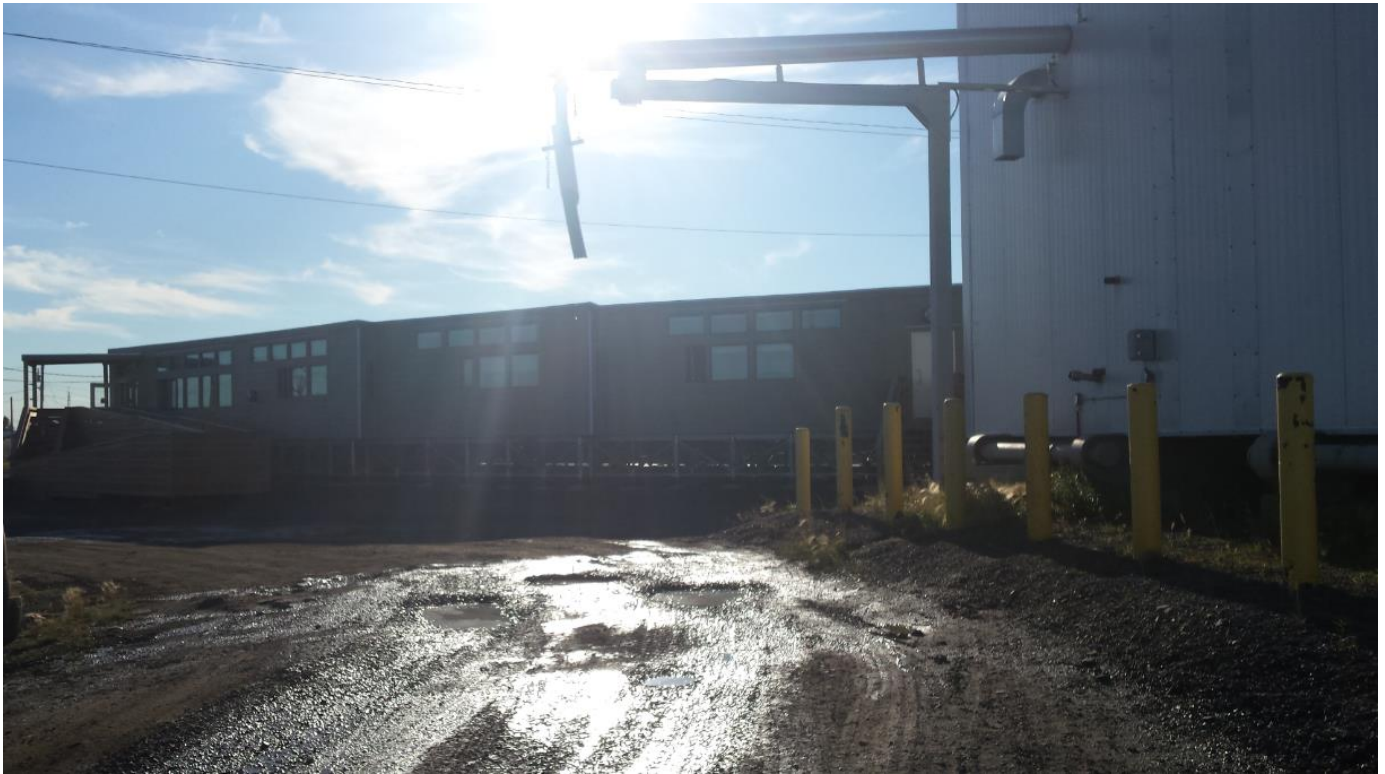
Figure 3

- The Water Treatment Plant (WTP) appeared to be in overall good condition (Figure 2). Protective pilings in front of the WTP were in good condition, however some rutting/ponding was identified at the truckfill station (Figure 3). This should be backfilled regularly to prevent ponding as part of regular access road maintenance.

Water Treatment Plant: Truckfill pad.

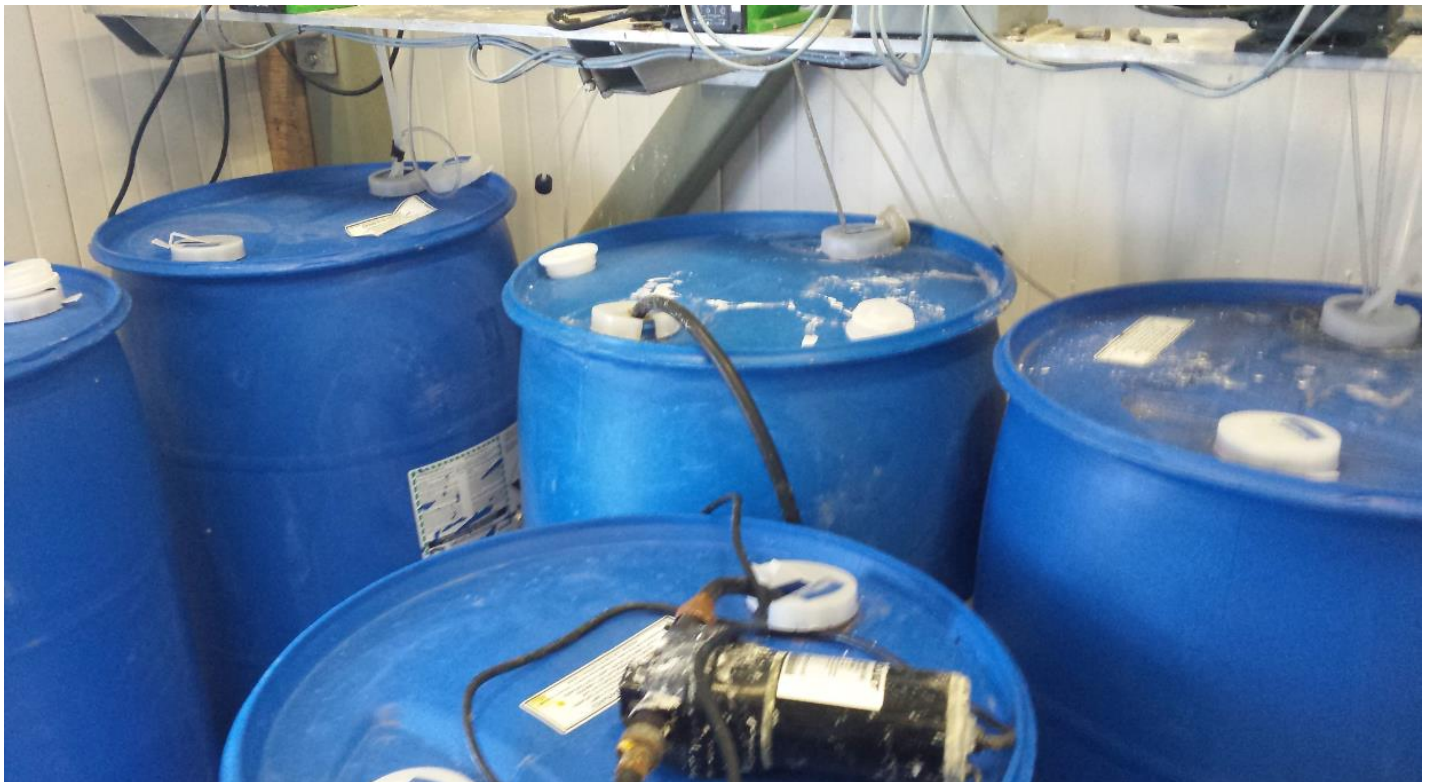
Figure 4

Water Treatment Plant: Chlorine barrels.

- Daily logs and record keeping requirements were being met. The overall condition of the WTP was clean and tidy.
- Please ensure that all chlorine barrels are labeled and dated properly upon receipt, and that empty chlorine containers are disposed of properly (Figure 4).

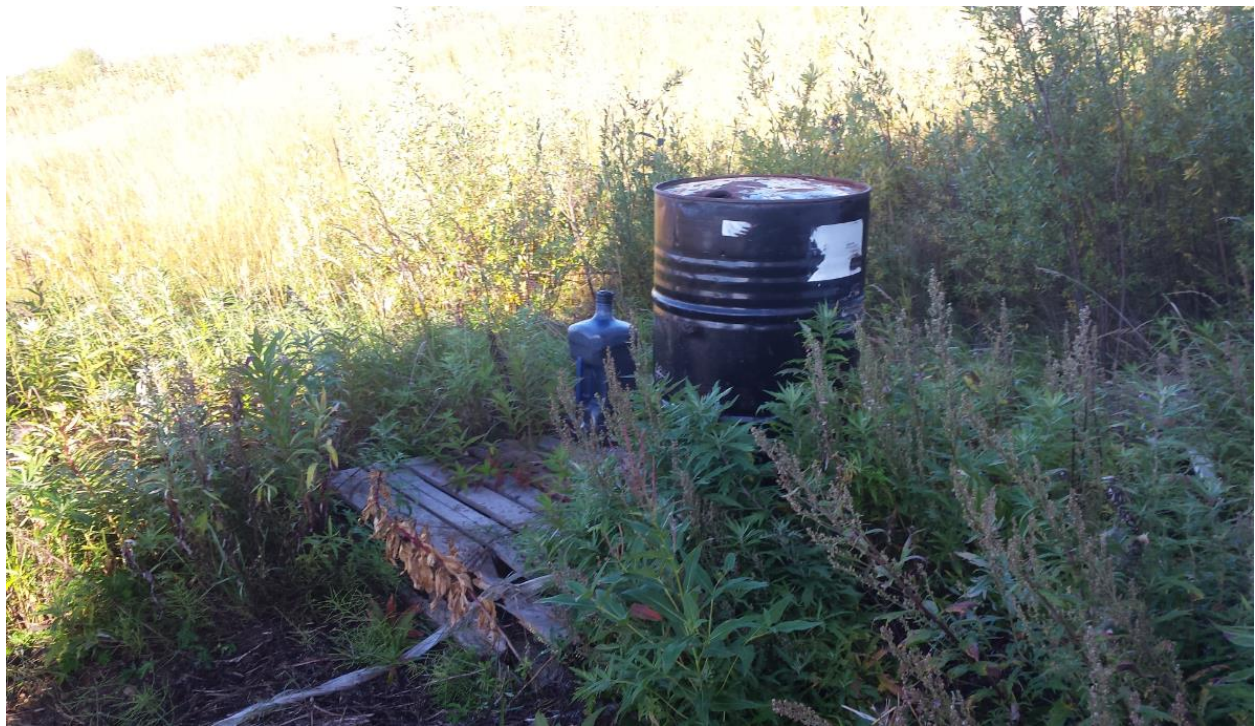
Figure 5

- There were some litter/wastes around the WTP site. Two unsealed containers likely containing waste oil were identified close to the WTP and the water intake site, without secondary containment. Both containers should be consolidated into a more secure container and stored somewhere dry and with secondary containment (e.g. Hamlet garage).

Water Treatment Plant: Unidentified wastes outside of the WTP, unsealed and without secondary containment.

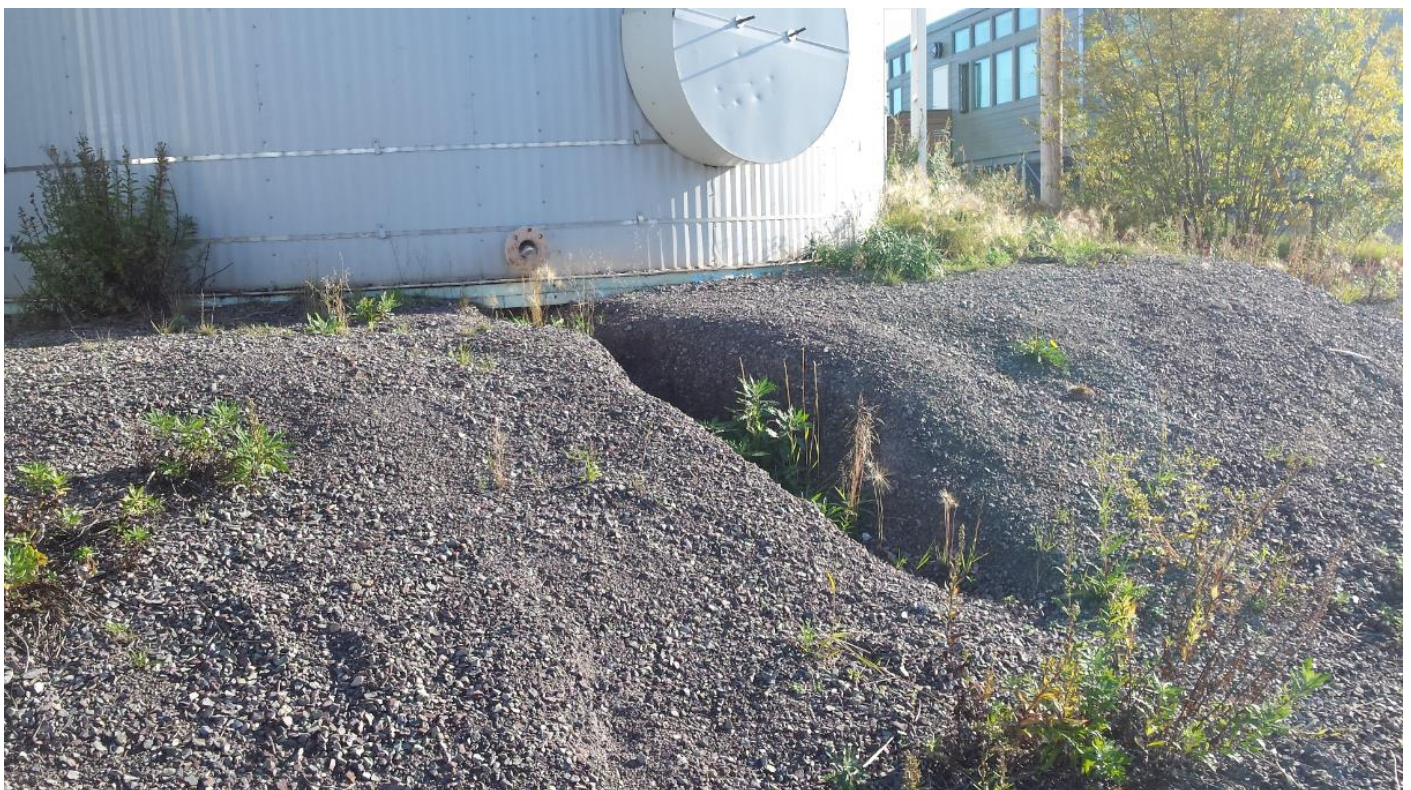
Figure 6

- A large erosion channel was identified behind one of the two main water storage tanks (Figure 6). Please ensure that the erosion is monitored and that Water Treatment Operators are monitoring the WTP regularly for signs of erosion and subsidence. Before the erosion channel is backfilled, the source of erosion should be identified and promptly dealt with (i.e. redirecting drainage in the area as needed).

Water Treatment Plant: Large erosion channel identified behind one of the main water storage tanks.

- The large erosion channel identified behind one of the two main water storage tanks at the WTP should be dealt with promptly.

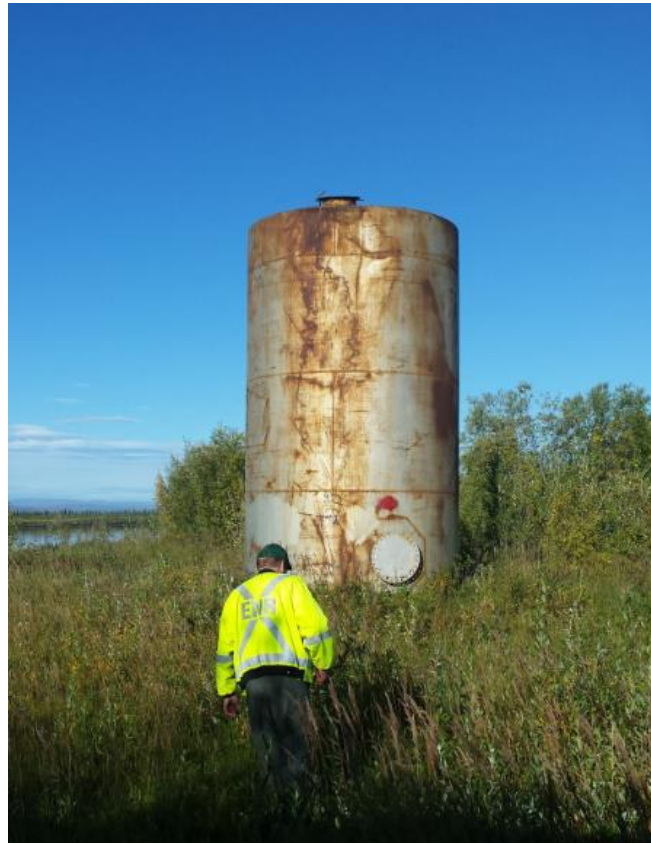
Figure 7

- There is an old large storage tank adjacent to the WTP (Figure 7). Hamlet staff reported that the tank used to store dust suppressant oil and that it has not been used in years. The perimeter surrounding the tank was inspected and some oil/spilled materials were identified on the ground. It appeared that the tank was no longer in use; as such the Hamlet should identify the owner and request that the tank be decommissioned and the site tested for hydrocarbon contamination. ENR Inuvik Region can be of assistance as needed.

Water Treatment Plant: Old storage tank near the site.

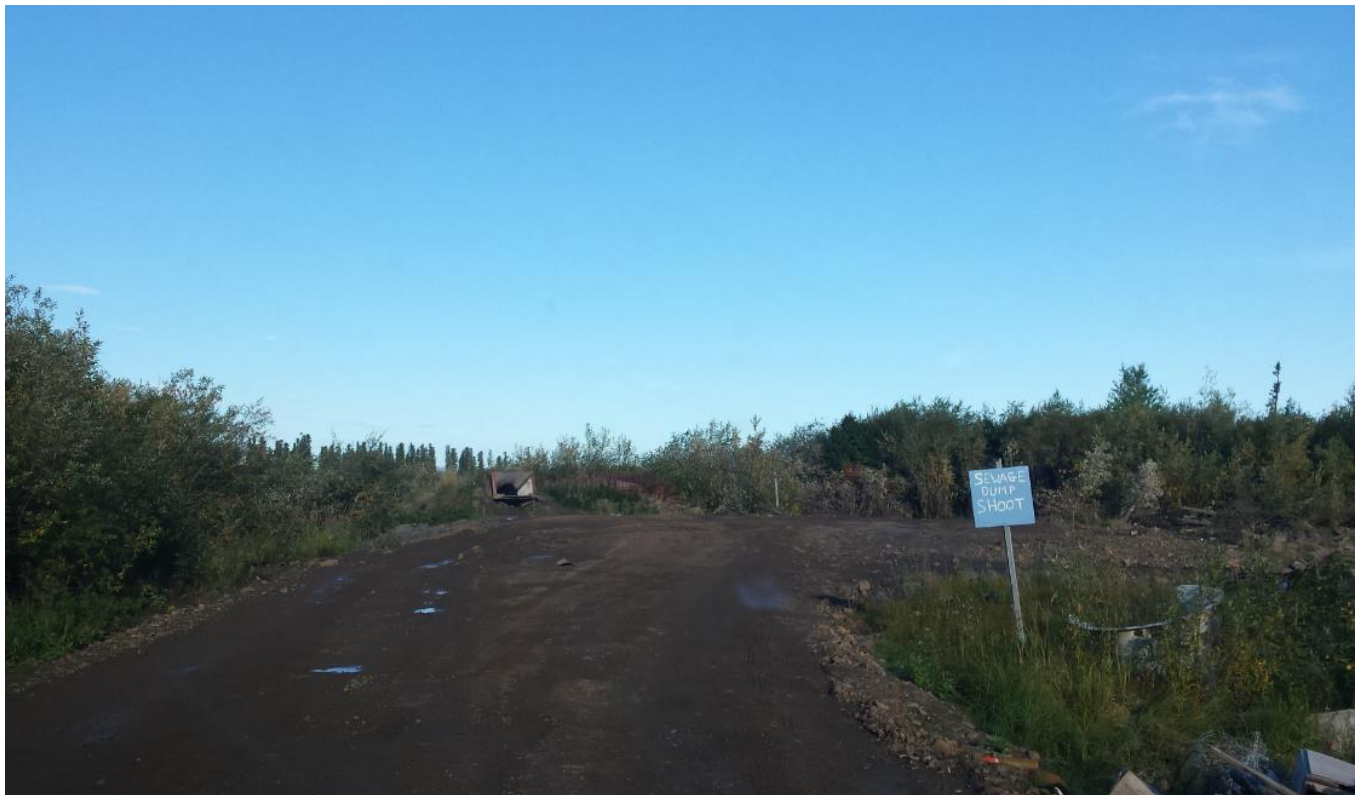
Figure 8

- The overall condition of the Sewage Disposal Facility (SDF) was satisfactory. The single discharge chute was in good working condition and the truck discharge pad did not show any sign of erosion, ponding or subsidence (Figure 8).
- Colour and smell were adequate and sewage lagoon appeared to be performing well.
- Freeboard level appeared to be adequate (e.g. >1 meter length). Maintaining adequate freeboard level has not been an issue in recent years according to Hamlet staff. One issue that was mentioned however, is when a flooding event occurs and flushes out the sewage lagoon into the surrounding environmental without proper natural filtration. This is a difficult challenge given the flooding history in the Hamlet. The Hamlet should prepare for such event and have capacity and

Sewage Disposal Facility: Overview of the access road, discharge pad and signage.

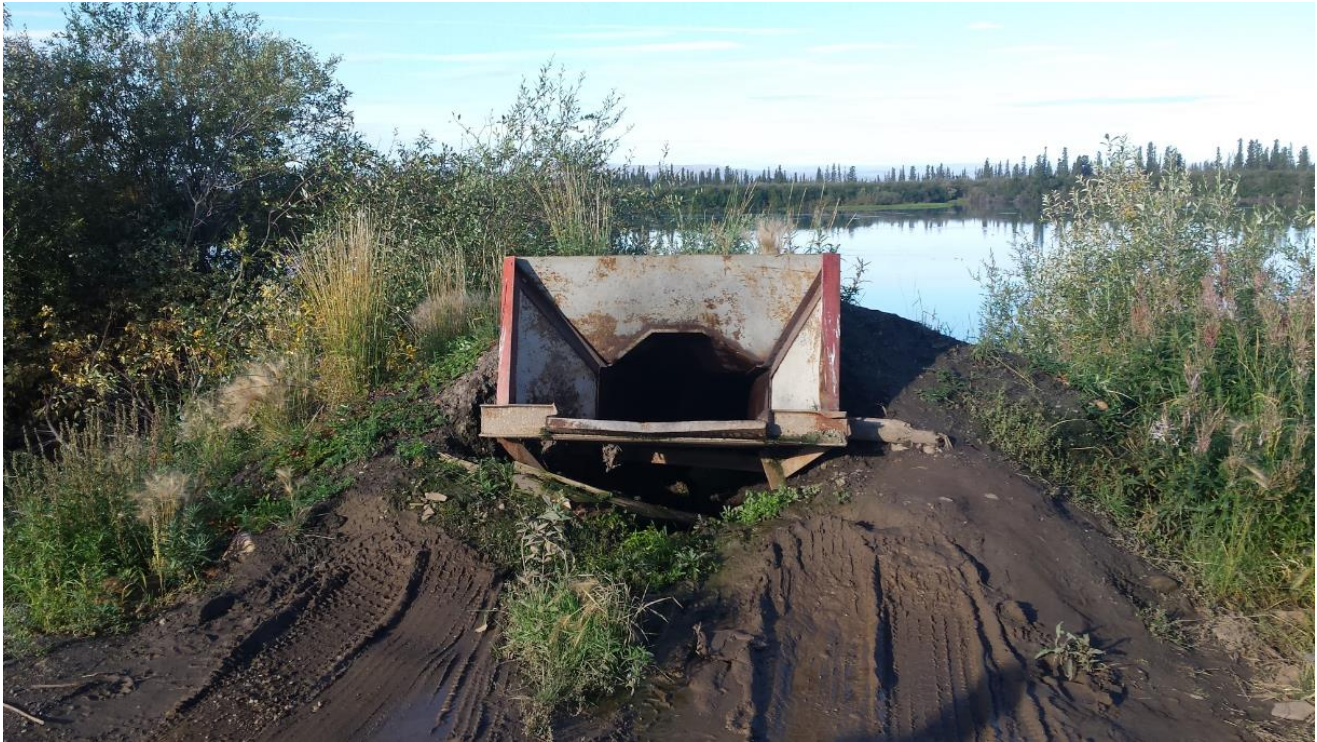
Figure 9

- Overall, the discharge chute appeared to be performing well, however no catchment basin is being used underneath the discharge chute inlet. There were signs of erosion as a result (Figure 9). The hole/subsidence underneath the discharge chute should be backfilled and a catchment basin should be placed underneath to capture any spilled sewage at the time of discharge.

Sewage Disposal Facility: Discharge chute inlet.

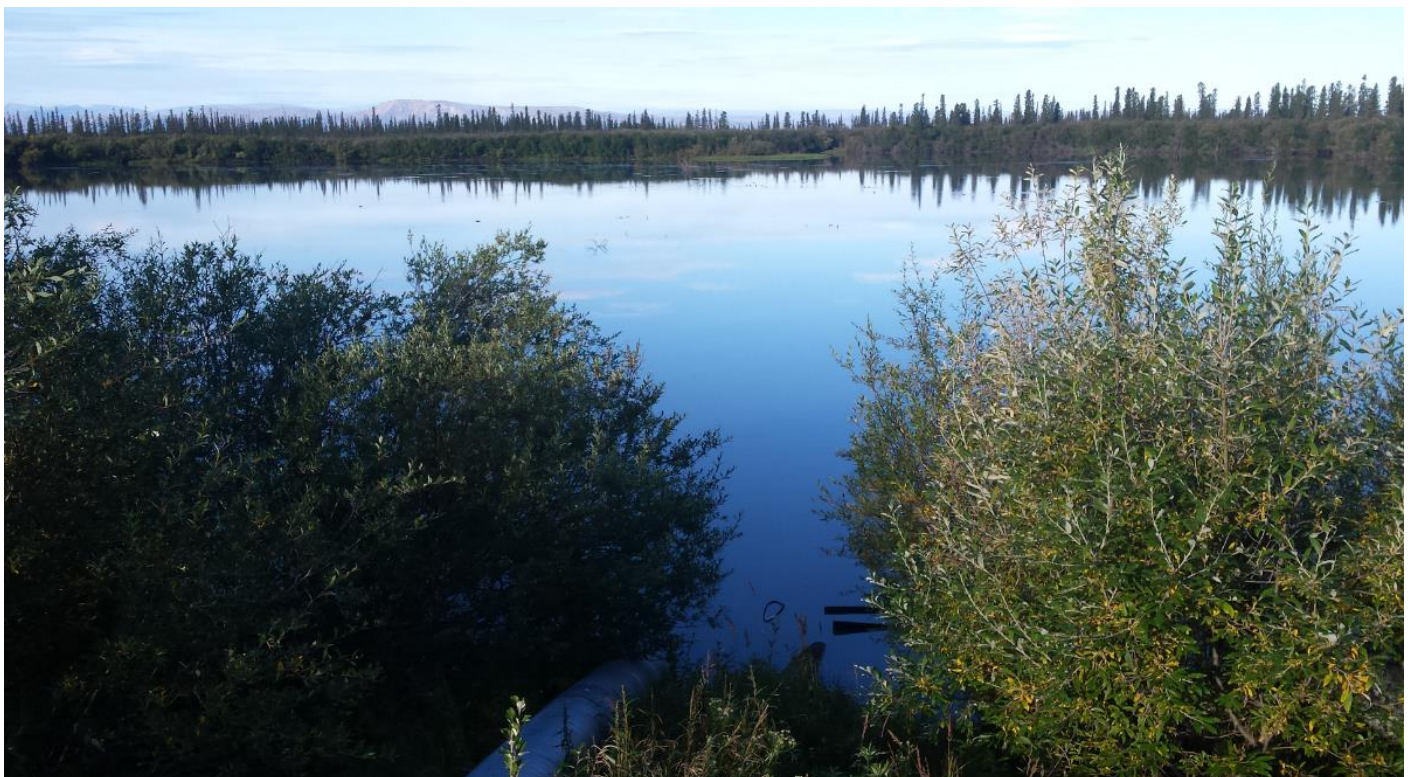
Figure 10

- No litter/debris was identified on the surface and around the sewage lagoon (Figure 10). There were wastes nearby from the landfill however they were contained and far enough from the sewage lagoon and the discharge pad. Good and clear signage was also identified.

Sewage Disposal Facility: Discharge chute outlet area.

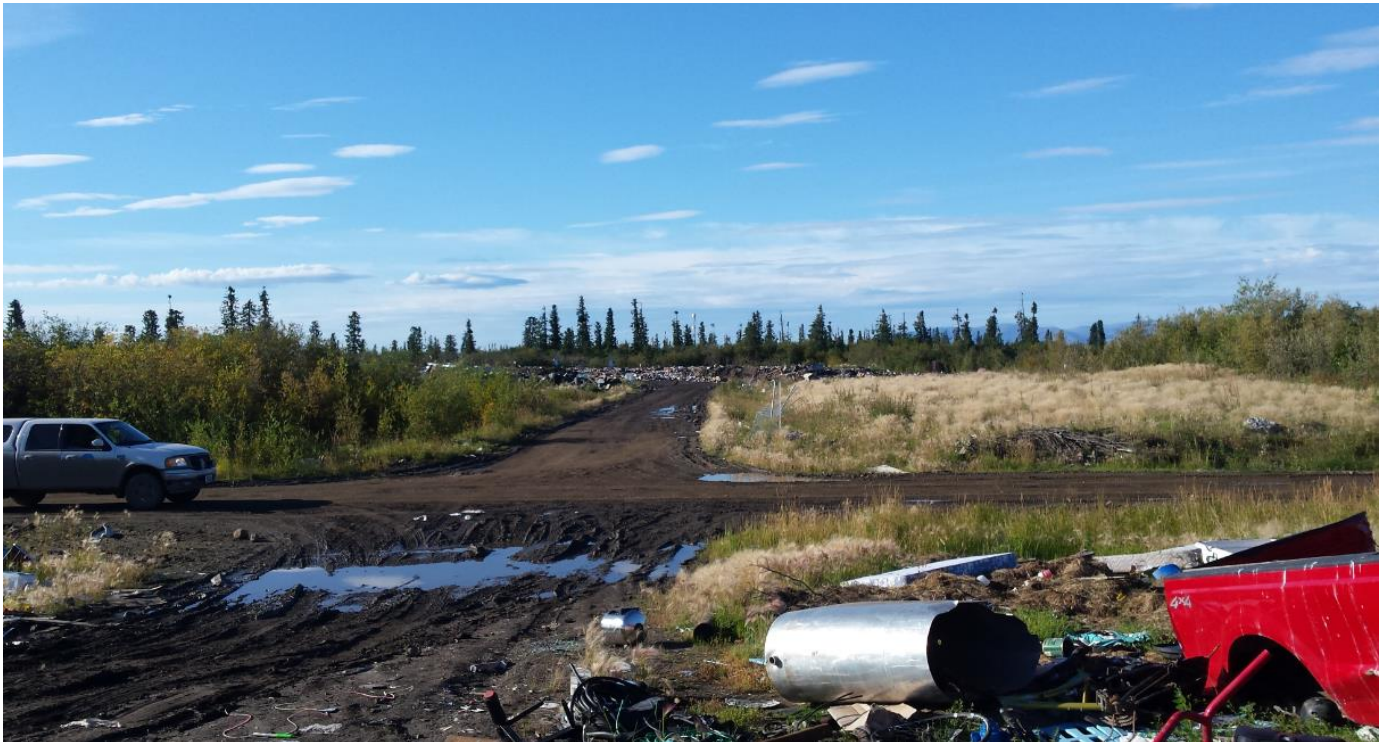
Figure 11

Solid Waste Disposal Facility: Overview of the general wastes area, from the bulk wastes area.

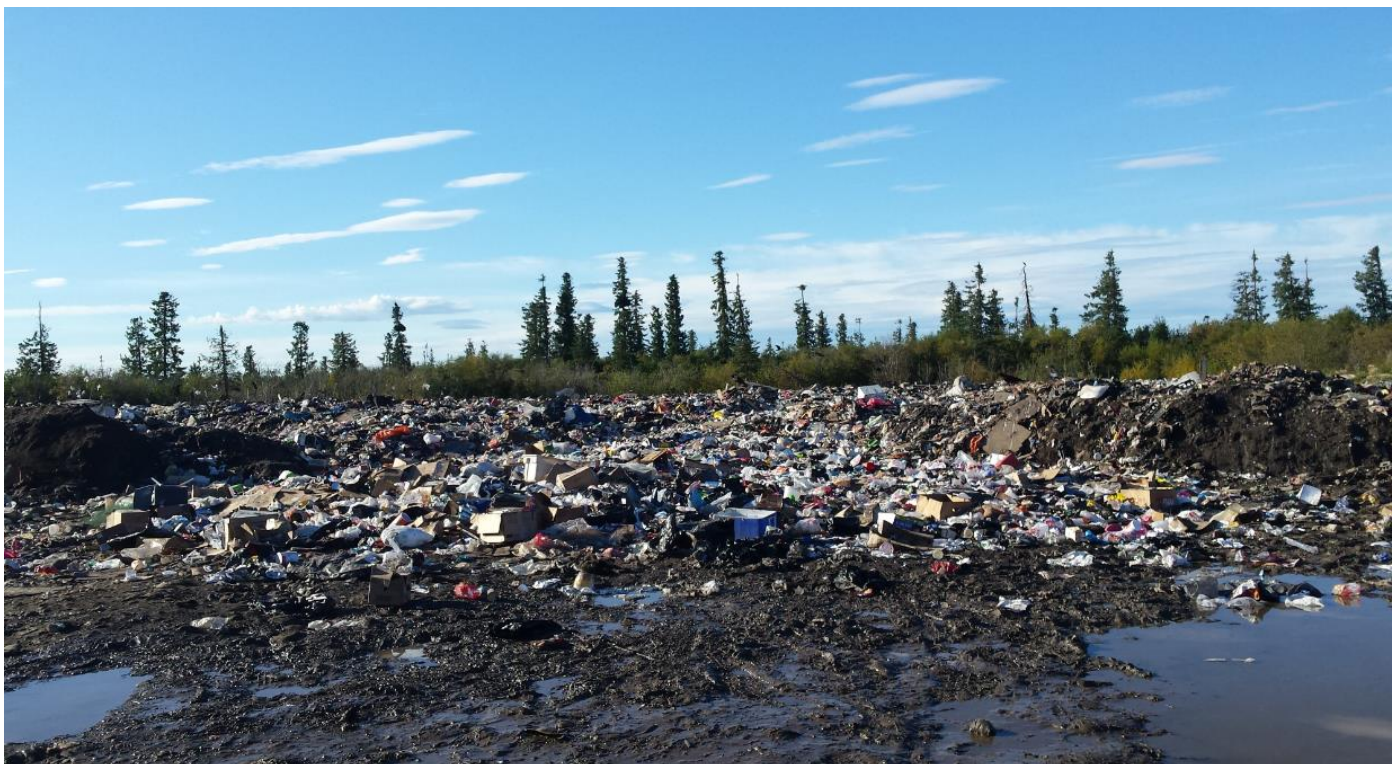
Figure 12

- The Solid Waste Disposal Facility (SWDF) is separated in 2 areas: general household wastes and bulk wastes (Figure 12).
- Household wastes were not being compacted/capped (Figure 13). There was significant ponding however no run-off was observed around the perimeter.

Solid Waste Disposal Facility: Household wastes.

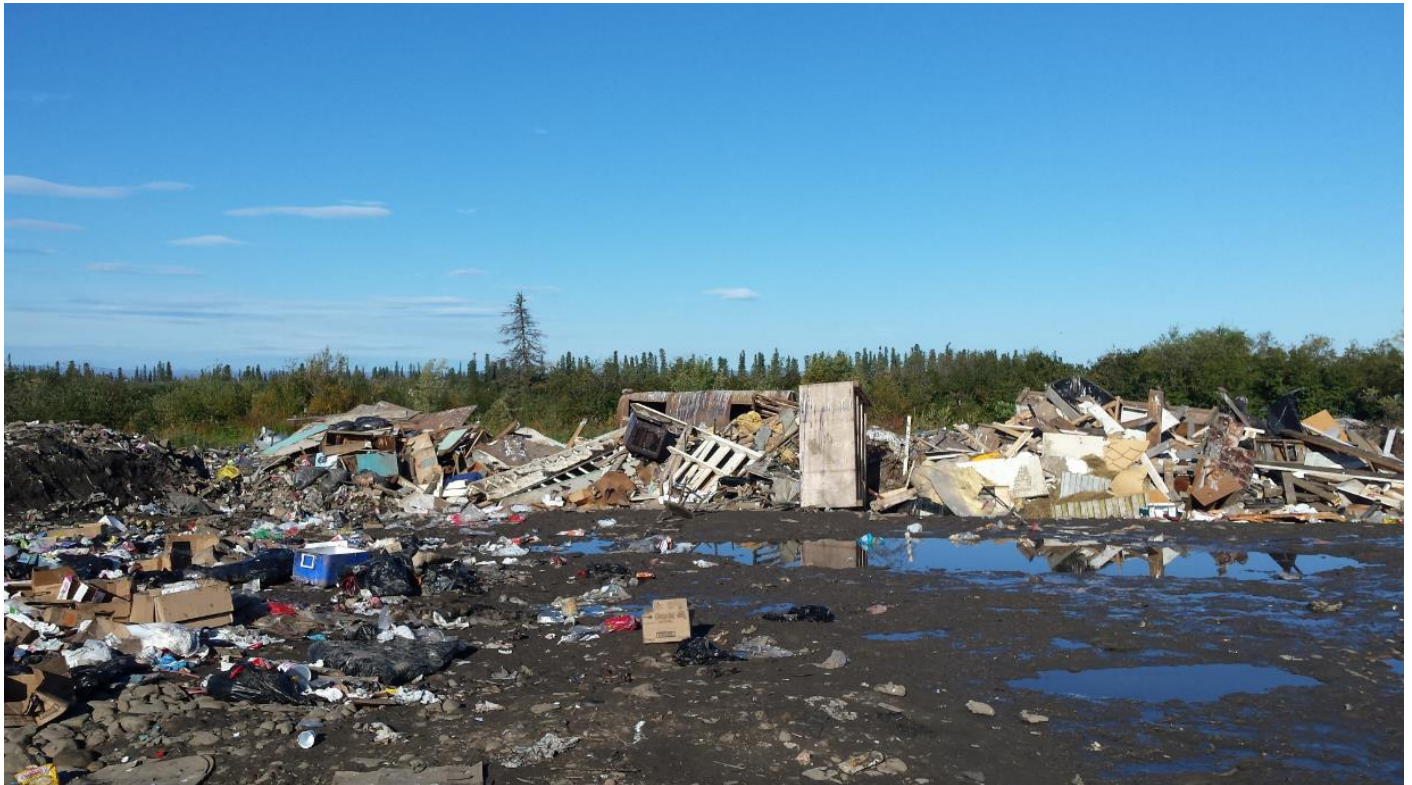
Figure 13

- At the household wastes site, there was a significant pile of clean wood debris and other authorized products which can be burned. The piled materials were blocking the designated burn pit (Figure 14). It is recommended that the Hamlet endeavor to reduce the pile of burnable products as soon as possible to ensure the burn pit remains accessible and to maximize the life expectancy of the SWDF.

Solid Waste Disposal Facility: Overview of burn pit and stockpiled products that are authorized for burning.

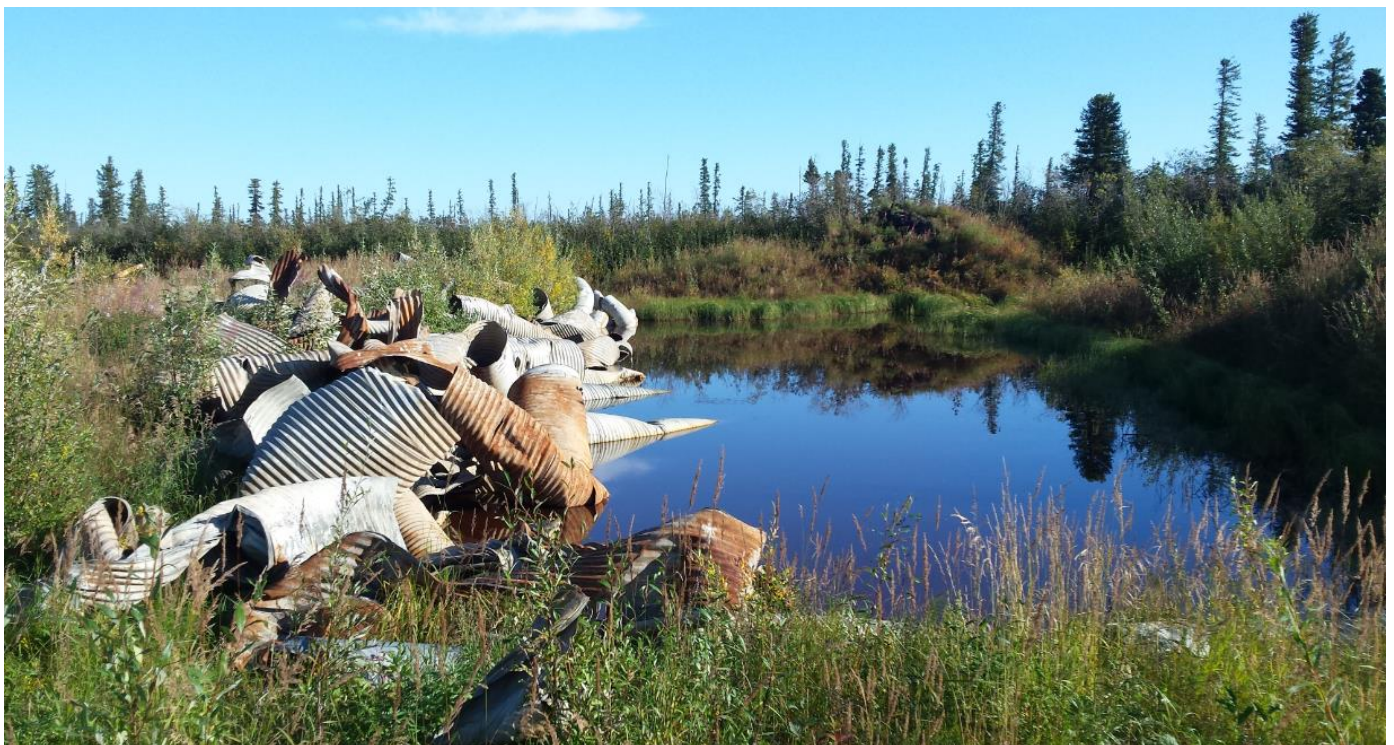
Figure 14

- Overall, the condition of the SWDF could be largely improved if better segregation and consolidation of wastes was done.
- Near the bulk wastes area, there remained a large flooded cell (Figure 14). In the last Water Licence inspection report from the Department of Aboriginal Affairs and Northern Development Canada, it was reported that vehicles were pulled from the water and that sheen and oil were no

longer present. At the time of the inspection, a large amount of used culverts were partly submerged in the cell. These should be removed from the water and relocated to the bulk waste area. No sheen/oil was identified in the flooded cell.

Solid Waste Disposal Facility: Old culverts submerged near the bulk wastes area.

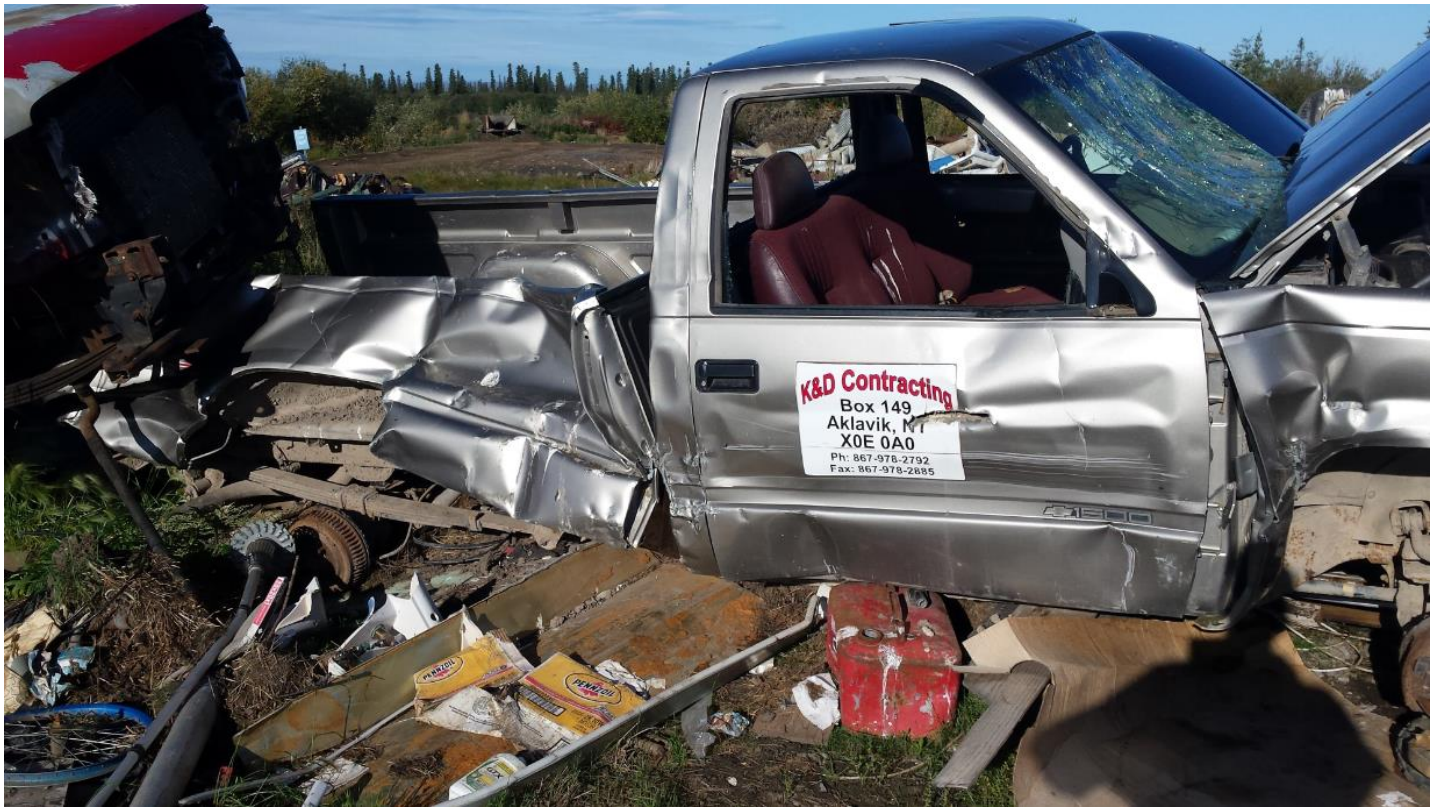
Figure 15

- At the time of the inspection, the Hamlet did not enforce any access control at the SWDF. It was evident that the Industrial, Commercial and Institutional (ICI) sectors use the SWDF regularly to dispose of bulk wastes and hazardous wastes (Figure 15). It would be a best management practice for the Hamlet to request, through correspondence and/or bylaw for example, that ICI sectors compensate the Hamlet for accepting such wastes as the SWDF was near capacity.

Solid Waste Disposal Facility: Industrial, commercial and institutional wastes.

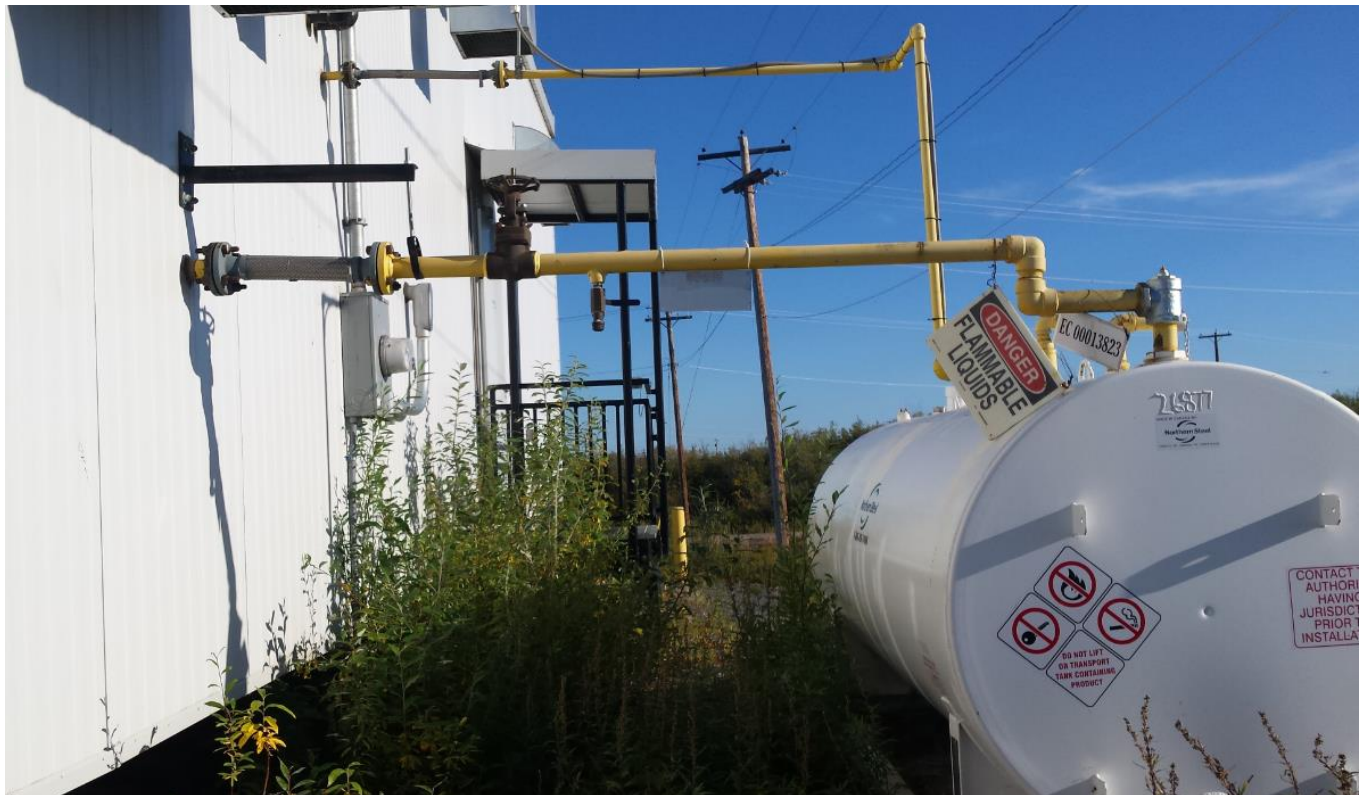
Figure 16

- Two above-ground fuel storage tanks were identified around the WTP. One was a 10,000L double walled tank connected to the WTP (Figure 16), and the other was a 1,000L tank connected to the storage shed adjacent to the WTP (Figure 17). It does not appear that the 1,000L tank is double-walled.

- The 10,000L tank appeared to be in good condition overall. No sign of leakage was observed. There were no protective pilings around the tank and no berm in place. The fuel supply line was equipped with a flex pipe which seemed to be fully stretched. Upon review of the last Water Licence inspection, it appears that the flex pipe has not shifted in recent years, which would indicate that there has not been shifting of the ground impacting the WTP and the fuel tank in recent years.

Water Treatment Plant: Large fuel tank and fixtures.

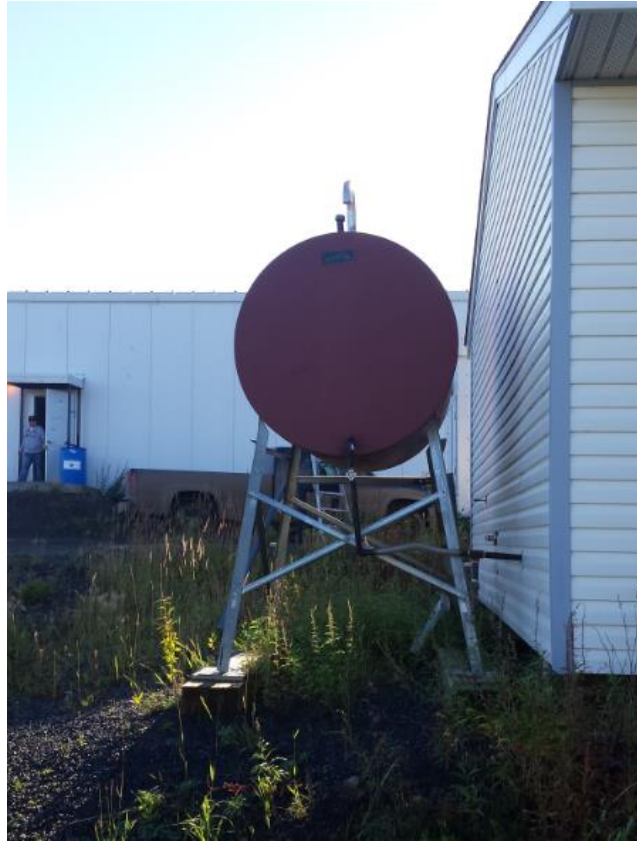
Figure 17

- The 1,000L tank appeared to be in good condition overall. No sign of leakage was identified at the time of the inspection. It is likely that this tank is not double-walled. As such, it would be a best management practice to provide for secondary containment around the tank as it poses a significant risk to the water supply. Upon review of the 2011 Water Licence inspection report, it appears that the flex pipe has not moved in recent years, which would again indicate that there has not been any significant shifting of the ground in recent years.

Water Treatment Plant: Large fuel tank by the storage shed.

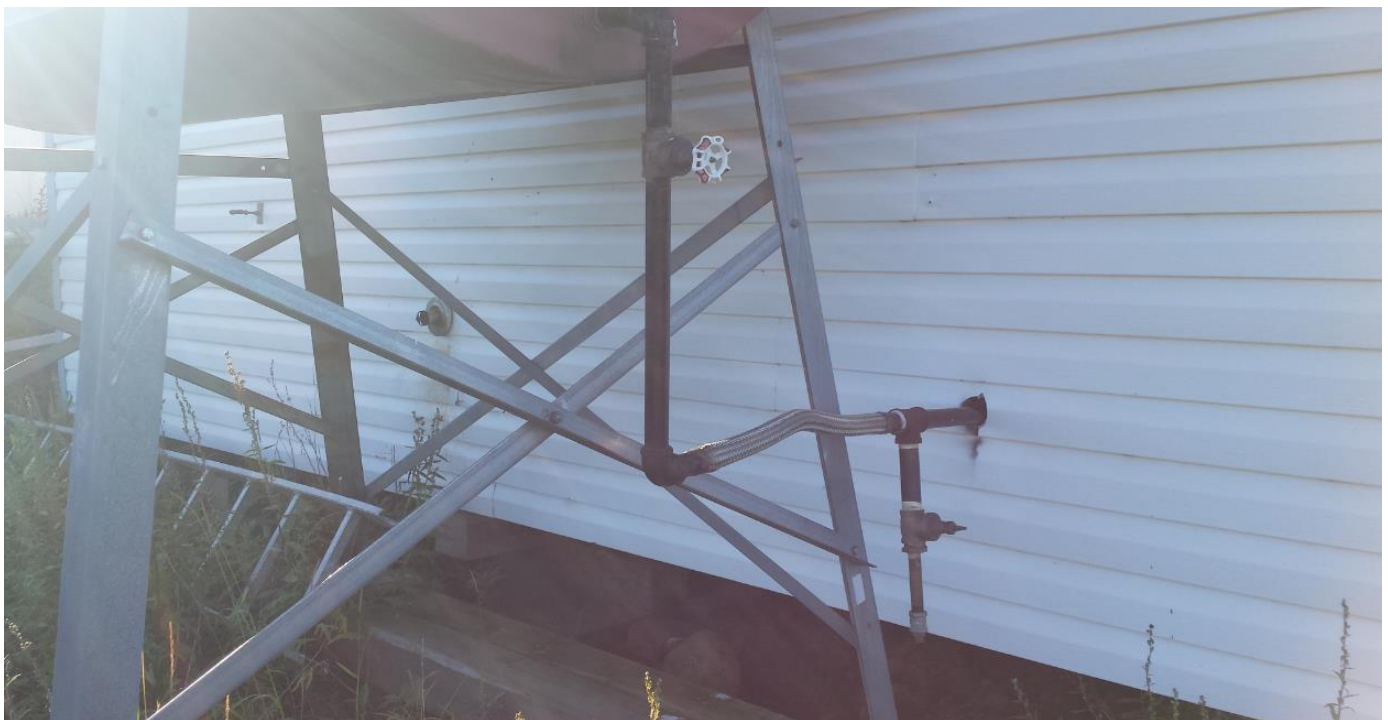
Figure 18

Water Treatment Plant: Large fuel tank by the storage shed and flex pipe.
