File Number N5L1-1843
Type of Operation CLASS B - INDUSTRIAL
Location: Gunghi Creek

«INSP_TYPE» WATER USE INSPECTION REPORT

LICENCE #:	N5L1-1843	EXPIRY DATE:	January 31, 2025
LICENCEE:	GNWT Infrastructure	PREVIOUS INSPECTION:	New
COMPANY REP:	David B. MacDonald	INSPECTION DATE:	January 18, 2021

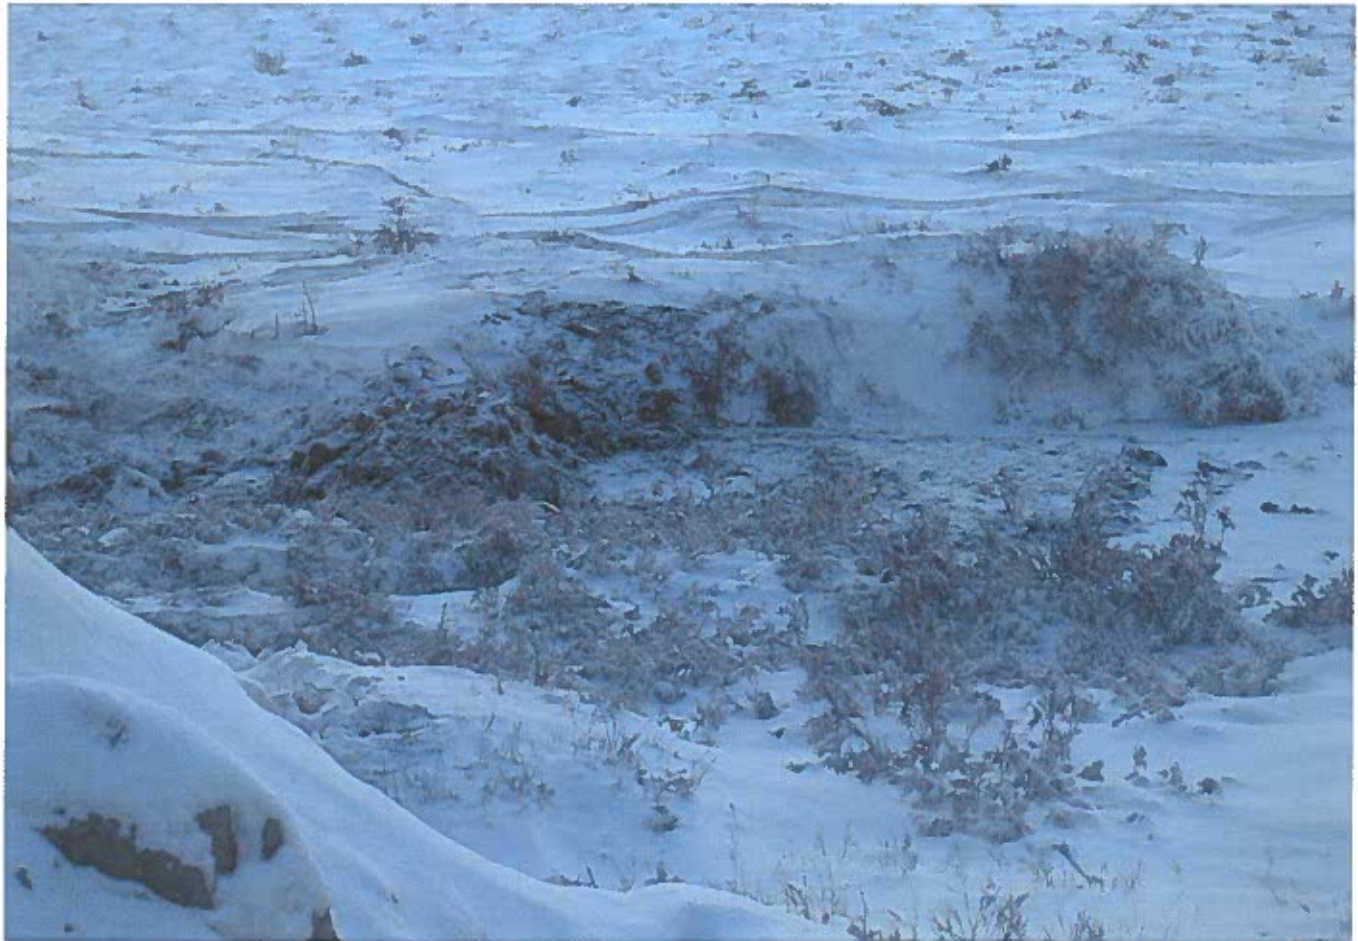
Figure 1

Up stream from work area

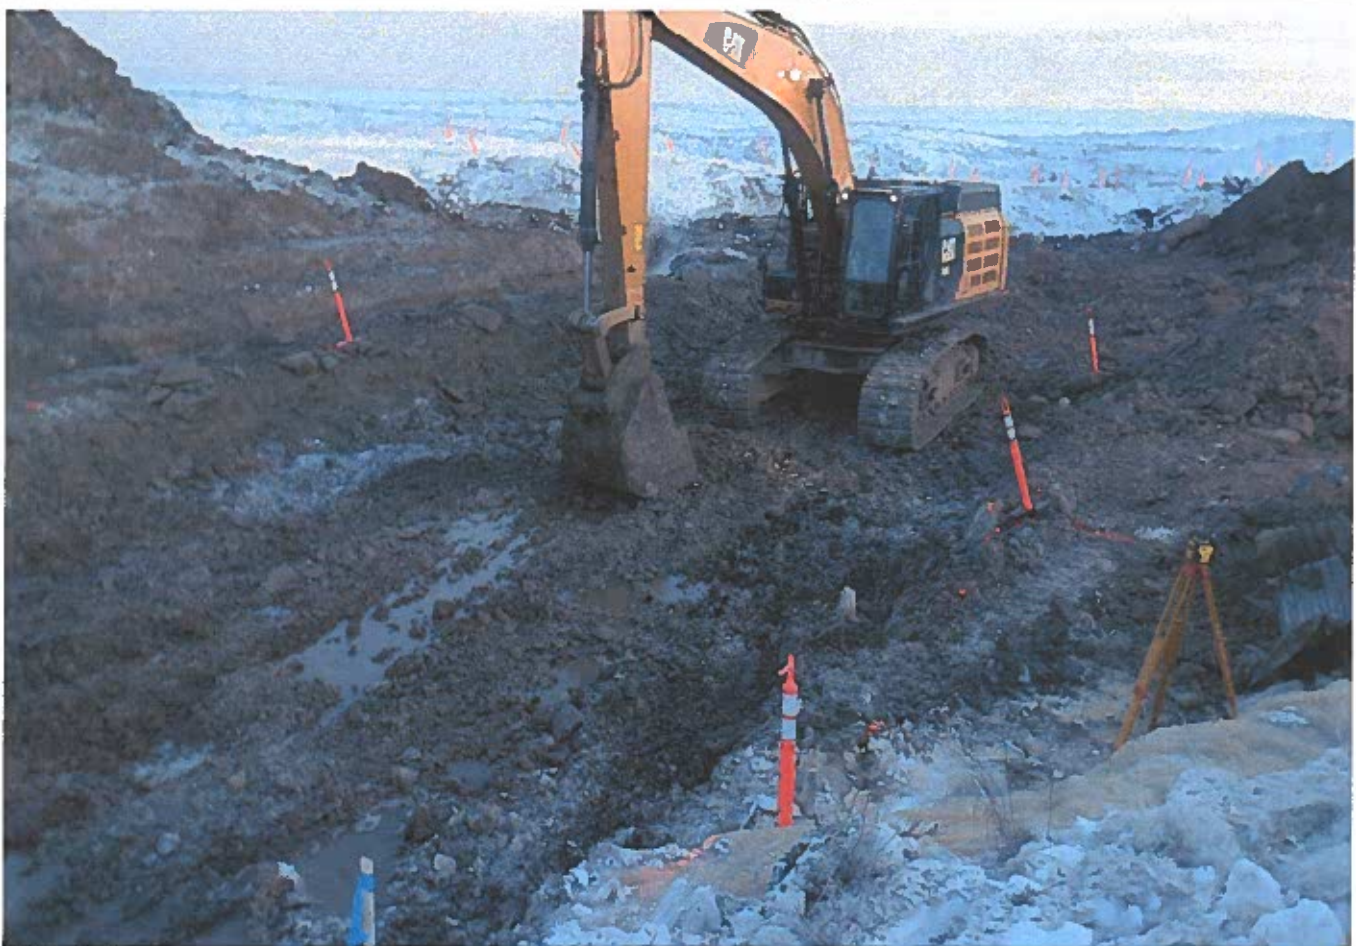
Figure 2

Mid section of work area

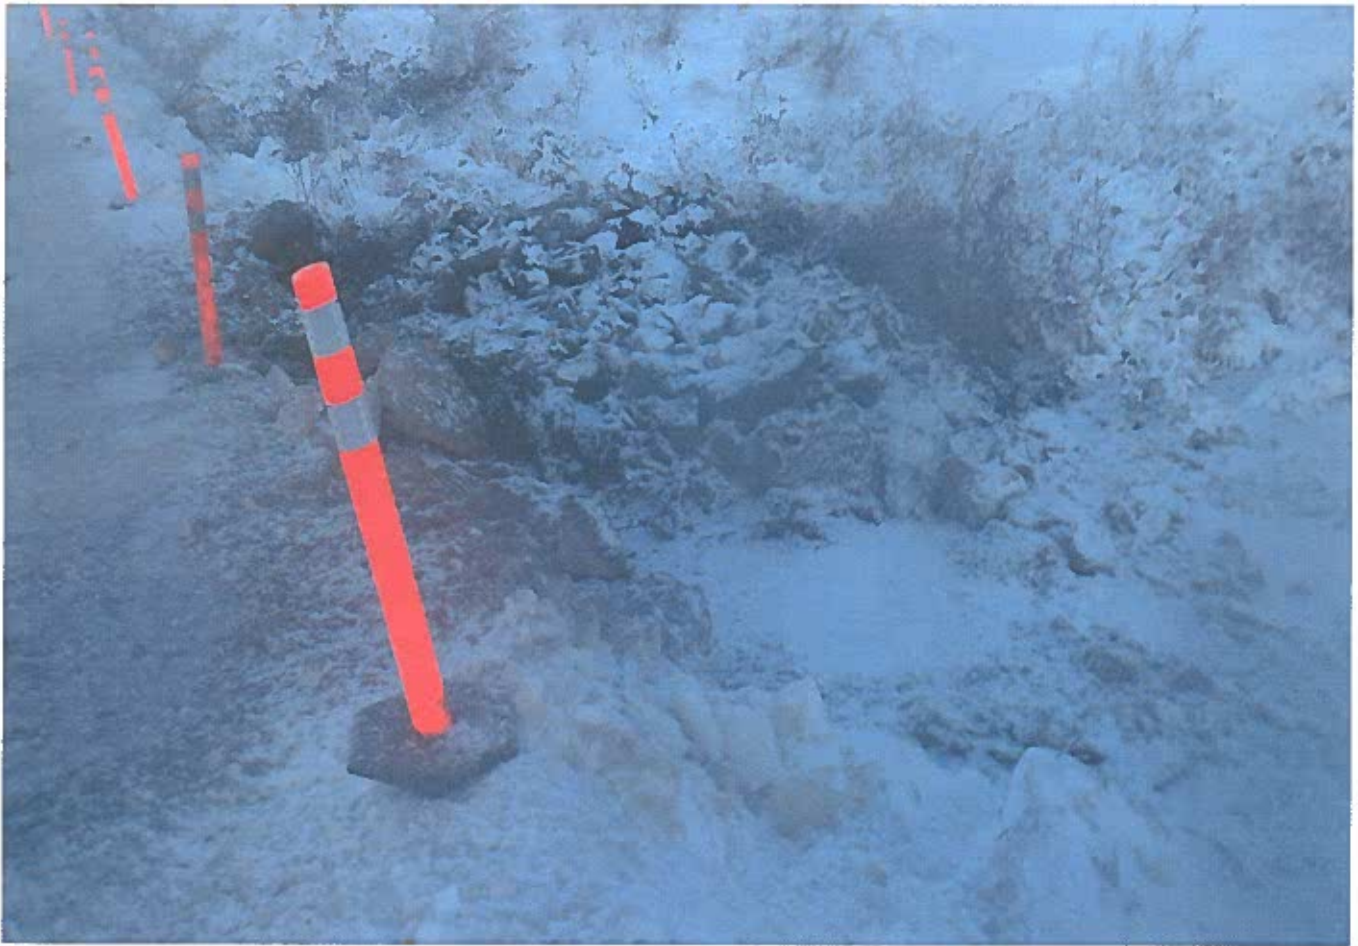
Figure 7

Down stream of ice bridge.

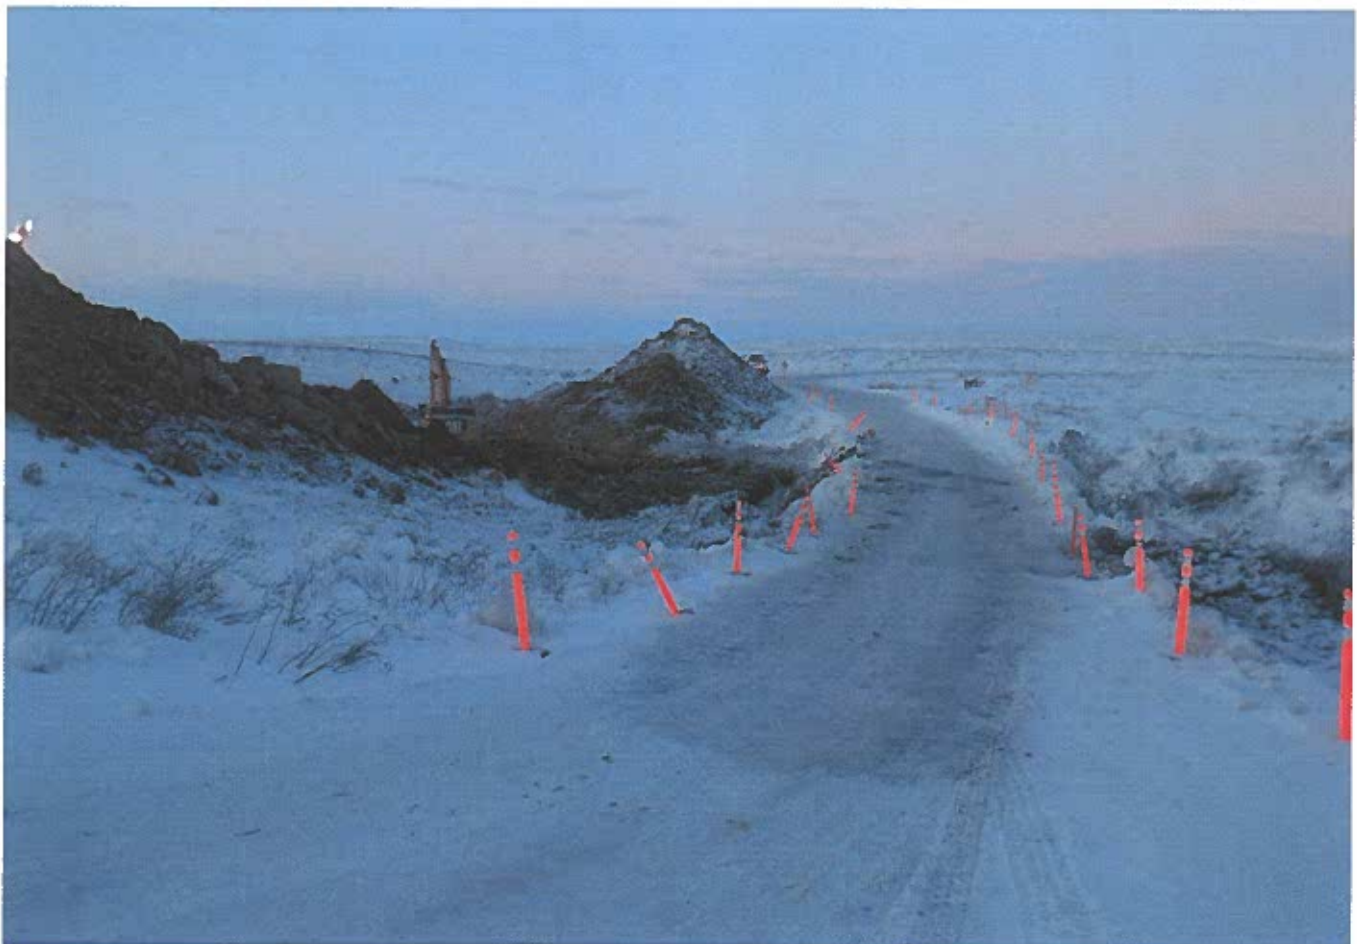
Figure 8

facing north
