File Number	N7L3-1531
Type of Operation	CLASS B - MUNICIPAL
Location	Sachs Harbour

An inspection of the above noted operation was conducted on September 15, 2021 by Regional Environmental Assessment Coordinator, Alicia McRae. Enclosed is a copy of the Municipal Water Use Inspection Report.

MUNICIPAL WATER USE INSPECTION REPORT

LICENCE #:	N7L3-1531	EXPIRY DATE:	November 20, 2022
LICENCEE:	Hamlet of Sachs Harbour	PREVIOUS INSPECTION:	October 17, 2019
COMPANY REP:	Betty Haogak, SAO	INSPECTION DATE:	September 15, 2021

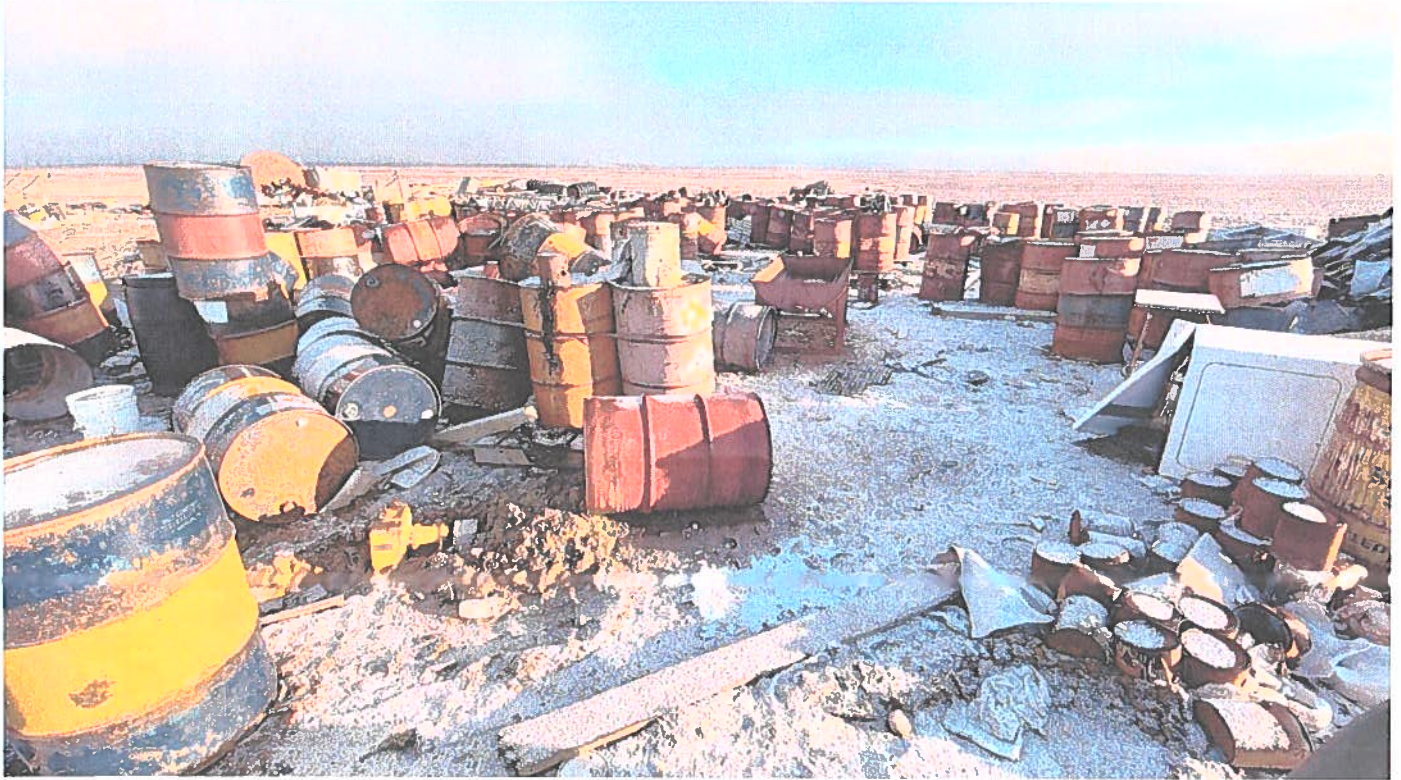
- A large storage area containing 45-gallon drums is staged at the lower half of the landfill. Some drums are upright, some are lying on their sides. A large majority of the drums checked during the inspection still had contents remaining inside. All these drums will need to be addressed appropriately and immediately to reduce the possibility of the contents of these drums spilling and contaminating the receiving environment. This issue was also noted in the 2019 inspection report. All drums need to be emptied prior acceptance at the landfill. Please refer to ENR's [Drum Disposal Protocol for Municipal Landfills](#) document for further information.

Figure 1: Large storage area of fuel drums, oil pails and paint cans at the landfill. Most still have contents inside.

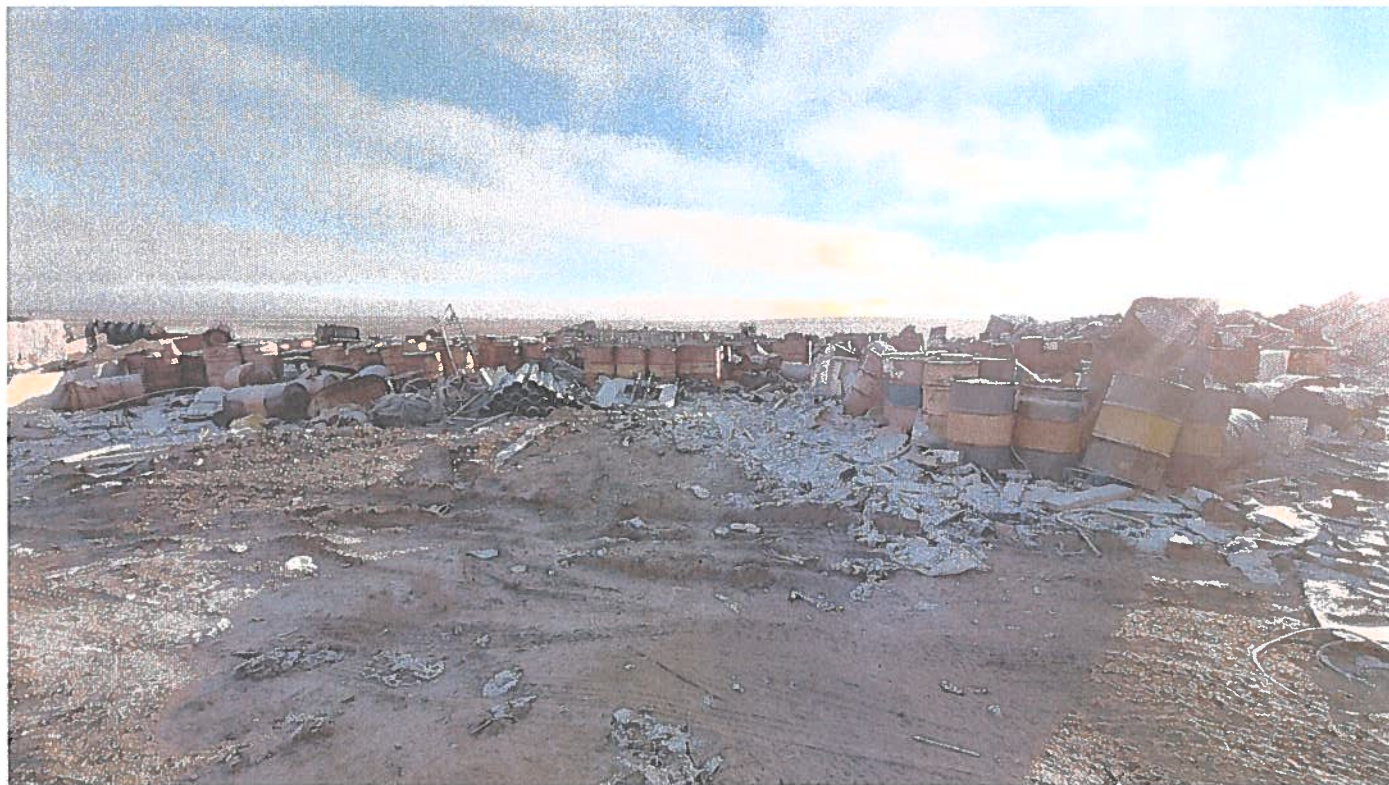
Figure 2: More drum waste behind pile shown in Figure 1.

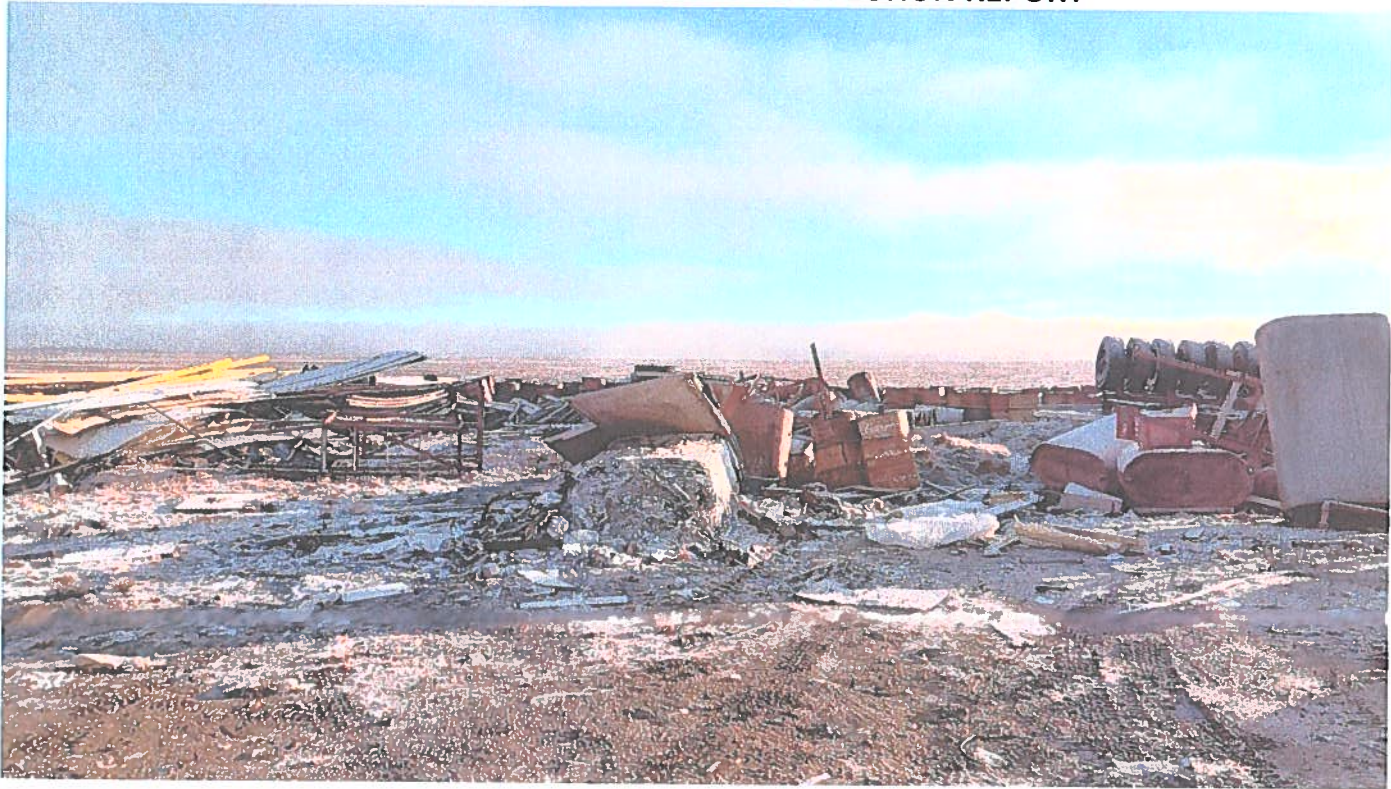
- It is evident that the Hamlet continues to accept construction debris from outside sources. The construction/demolition waste pile is larger than it was in 2019. If this is not addressed, the pile will begin to encroach on other waste segregation areas, take up valuable space and be costly to remove.

Figure 3: Construction waste at the NE corner of the landfill.

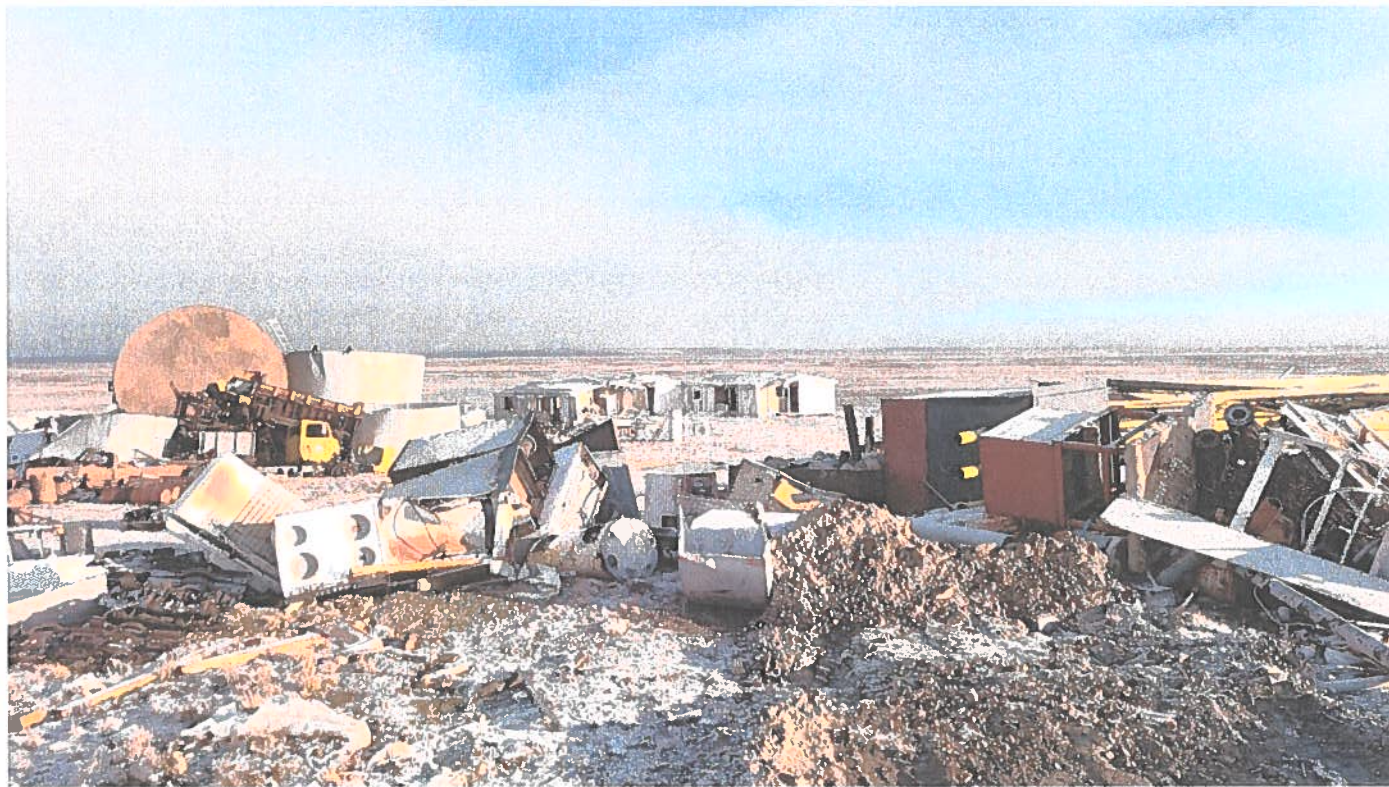
Figure 4: Three partially demolished homes at the far North corner of the landfill.

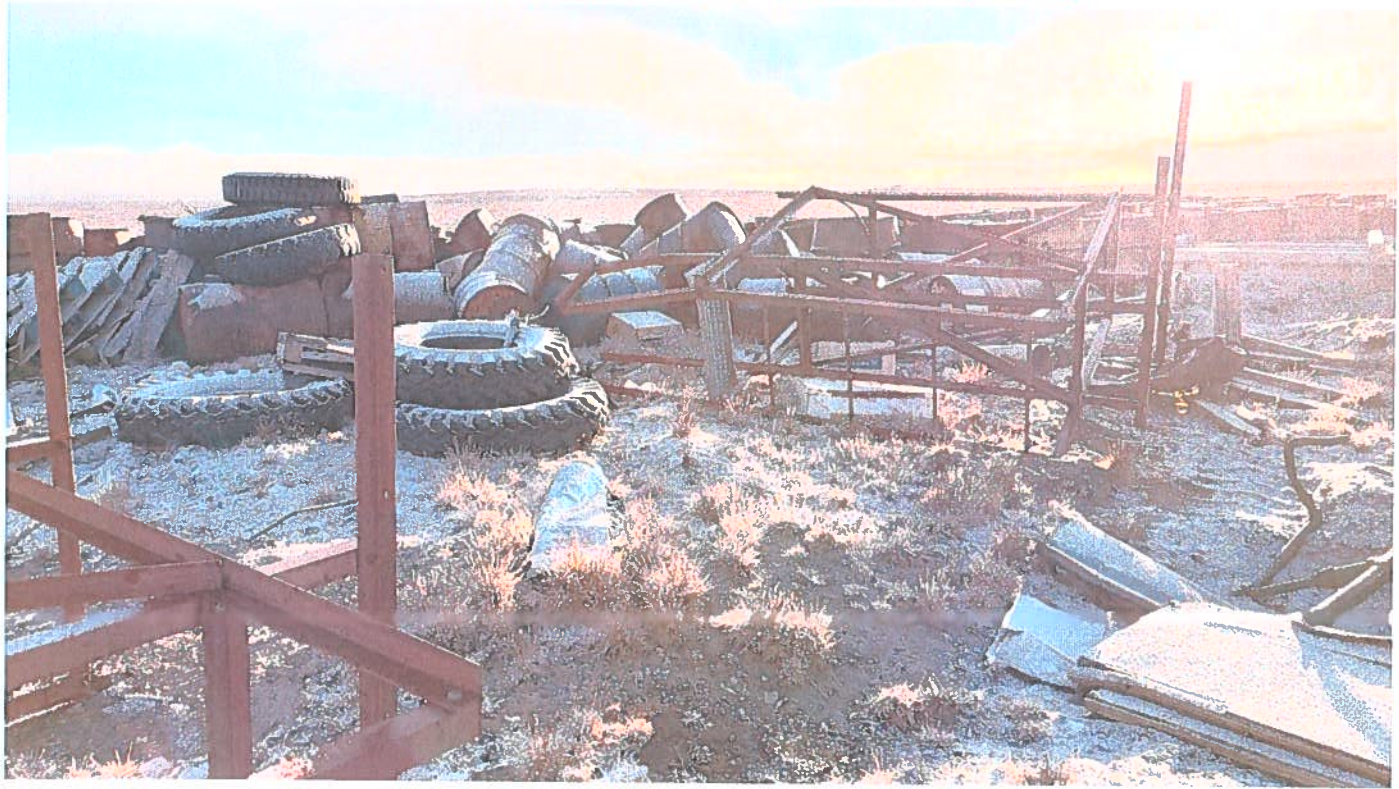
Figure 5: Fuel tank stands scattered among used tires, pallets and used fuel drums.

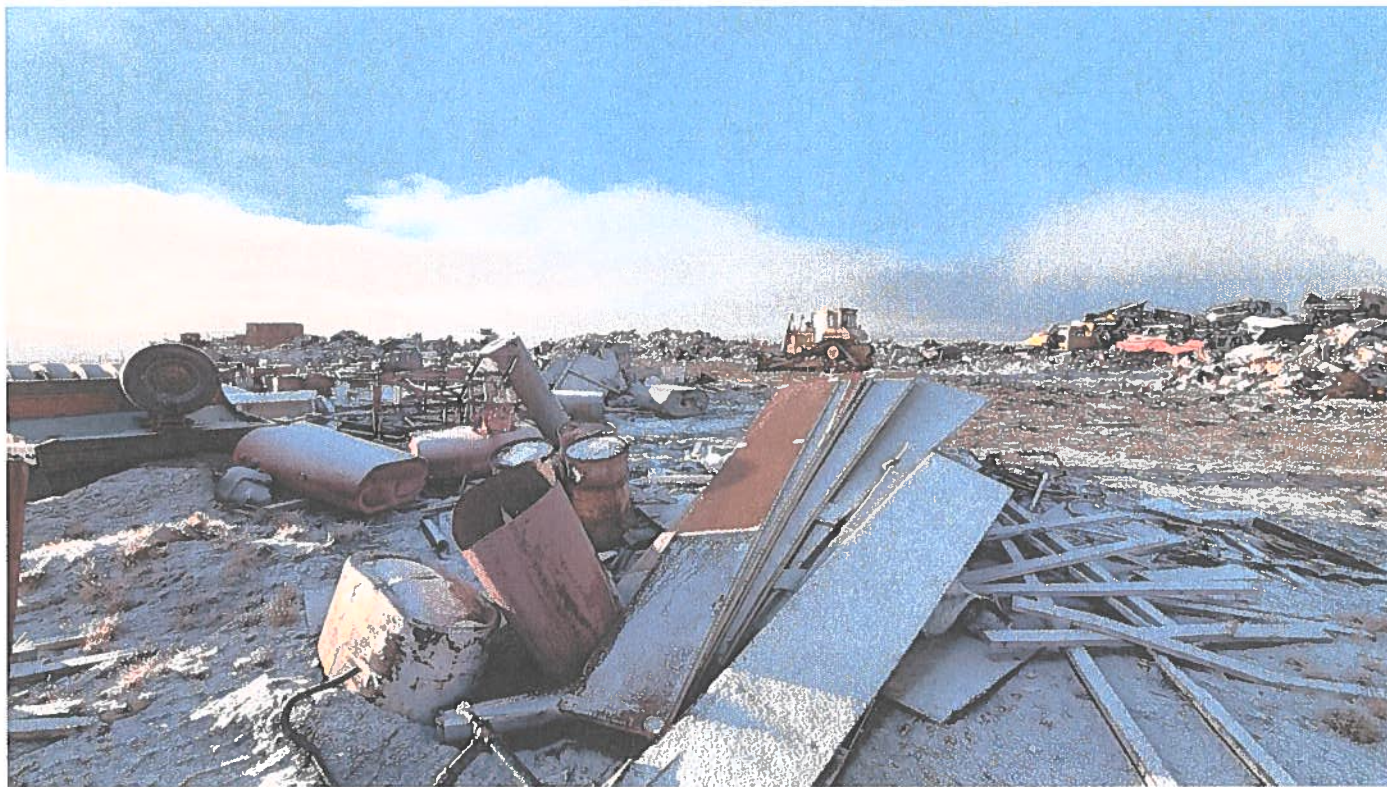
Figure 6: Standing at the North end of the Solid Waste Disposal Facility, facing towards the entrance behind the white van in the distance.

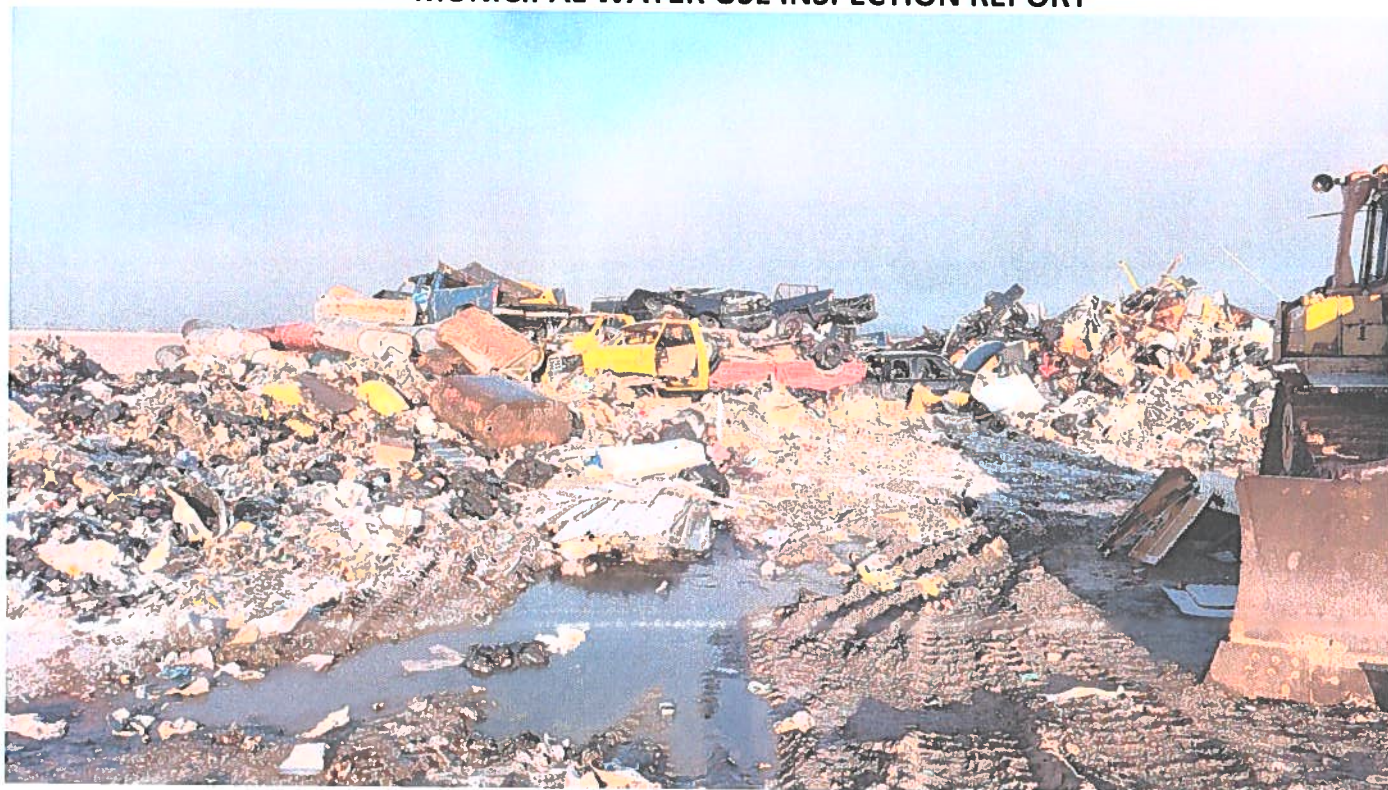
Figure 7: The vehicle section of the landfill surrounded by general garbage. Most vehicles were crushed in the past under previous management.

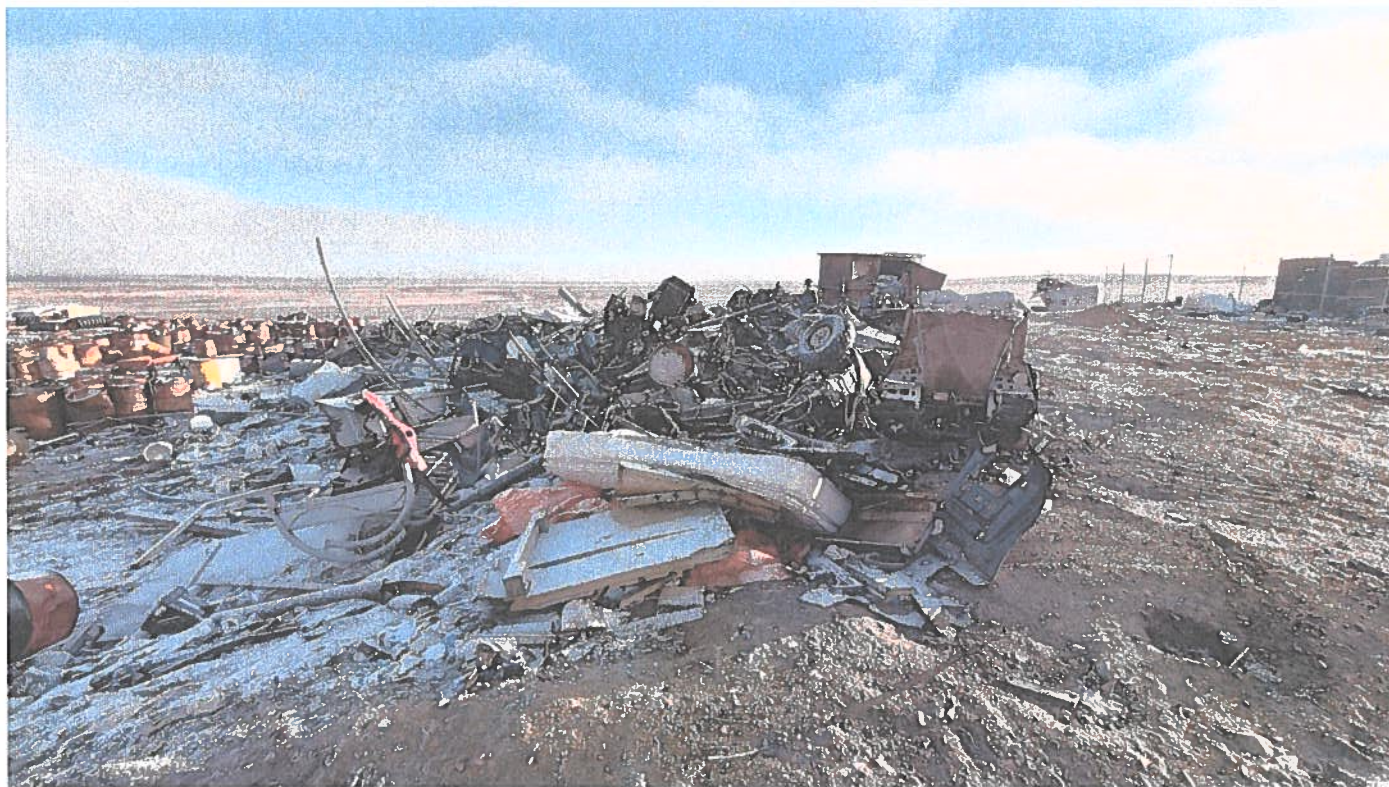
Figure 8: A pile of mixed metals.

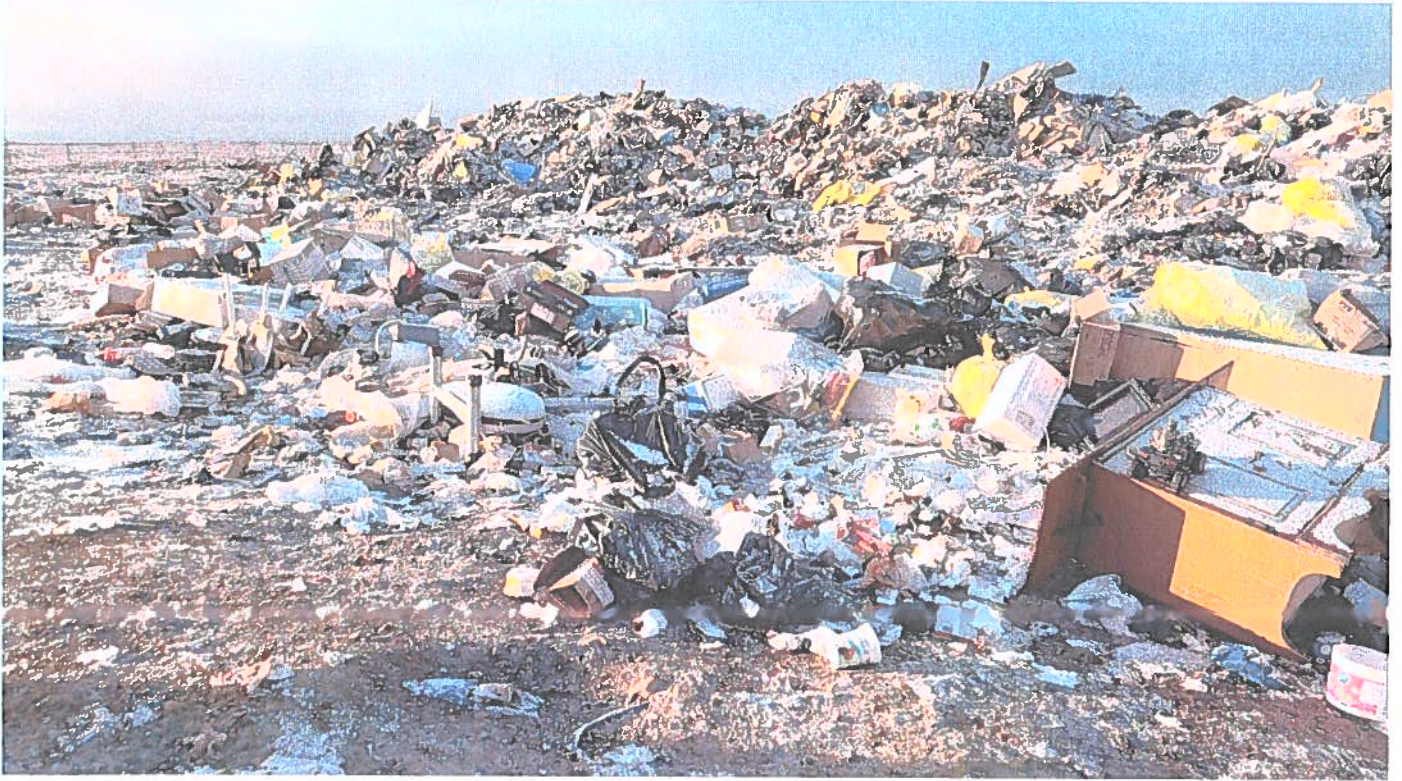
- Household waste is not covered frequently and as a result there is windblown debris across the site. As per Part D, Item 17 of the license, the Hamlet is required to collect any windblown debris.

Figure 9: Pile of general, household waste from community members. The pile looks larger than it was during the 2019 water license inspection.

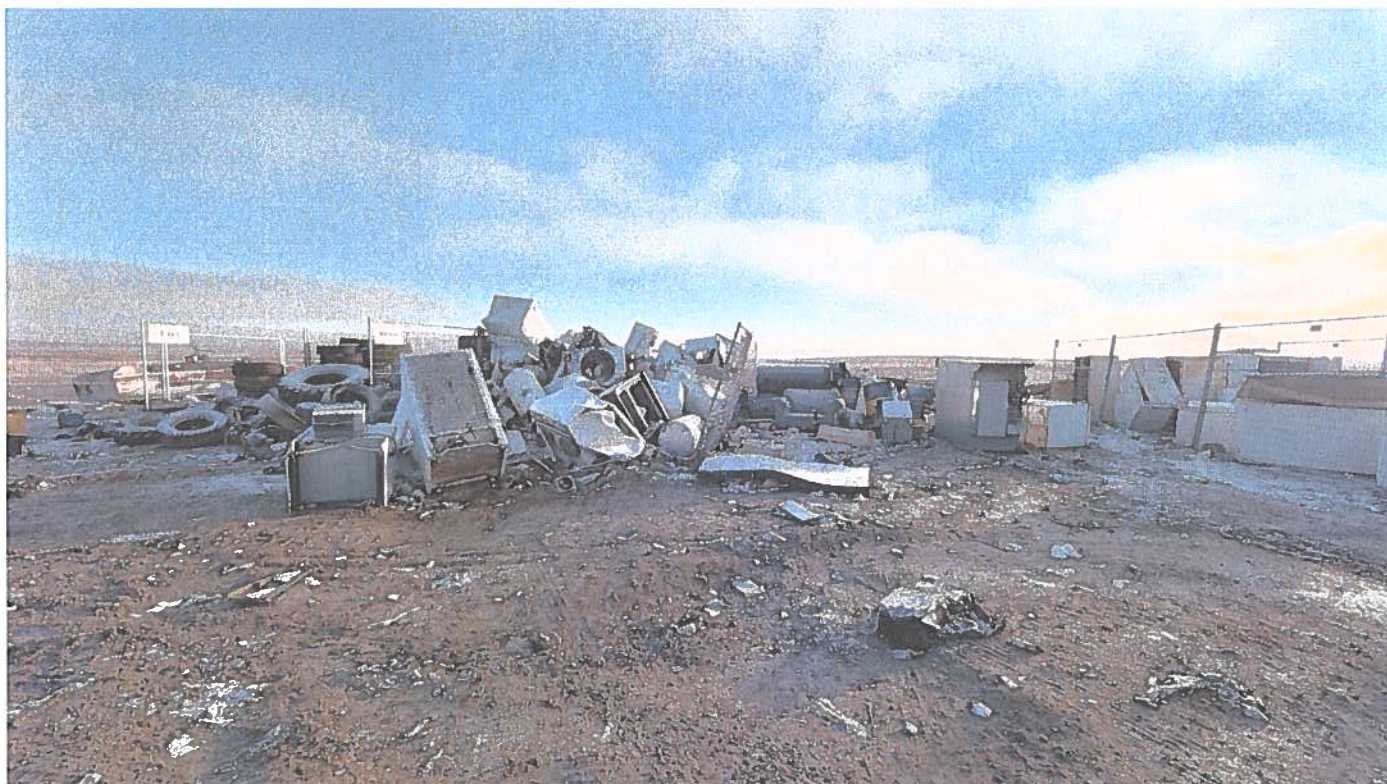
Figure 10: Segregated areas for large wastes, such as tires, appliances, and such. These sections need work to be more organized. This section of the landfill looks more unorganized than it did in 2019.

- Better segregation of waste streams and appropriate signage is required at all areas of the Landfill.
- Household waste is not covered frequently and as a result there is copious windblown debris across the site. As per Part D, Item 17 of the license, the Hamlet is required to collect any windblown debris.

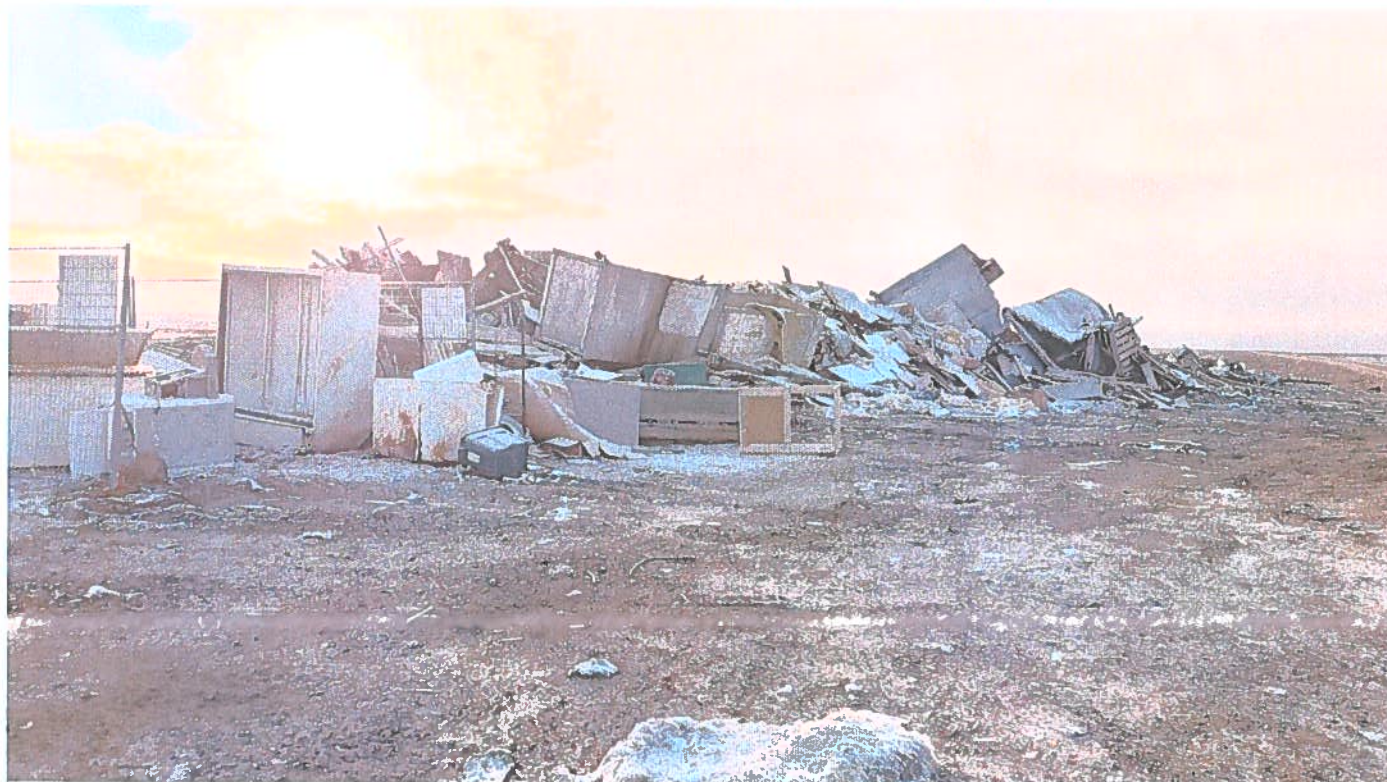
Figure 11: Construction wastes being dumped at the entrance of the landfill facility. This pile is larger and less organized than it was in 2019.

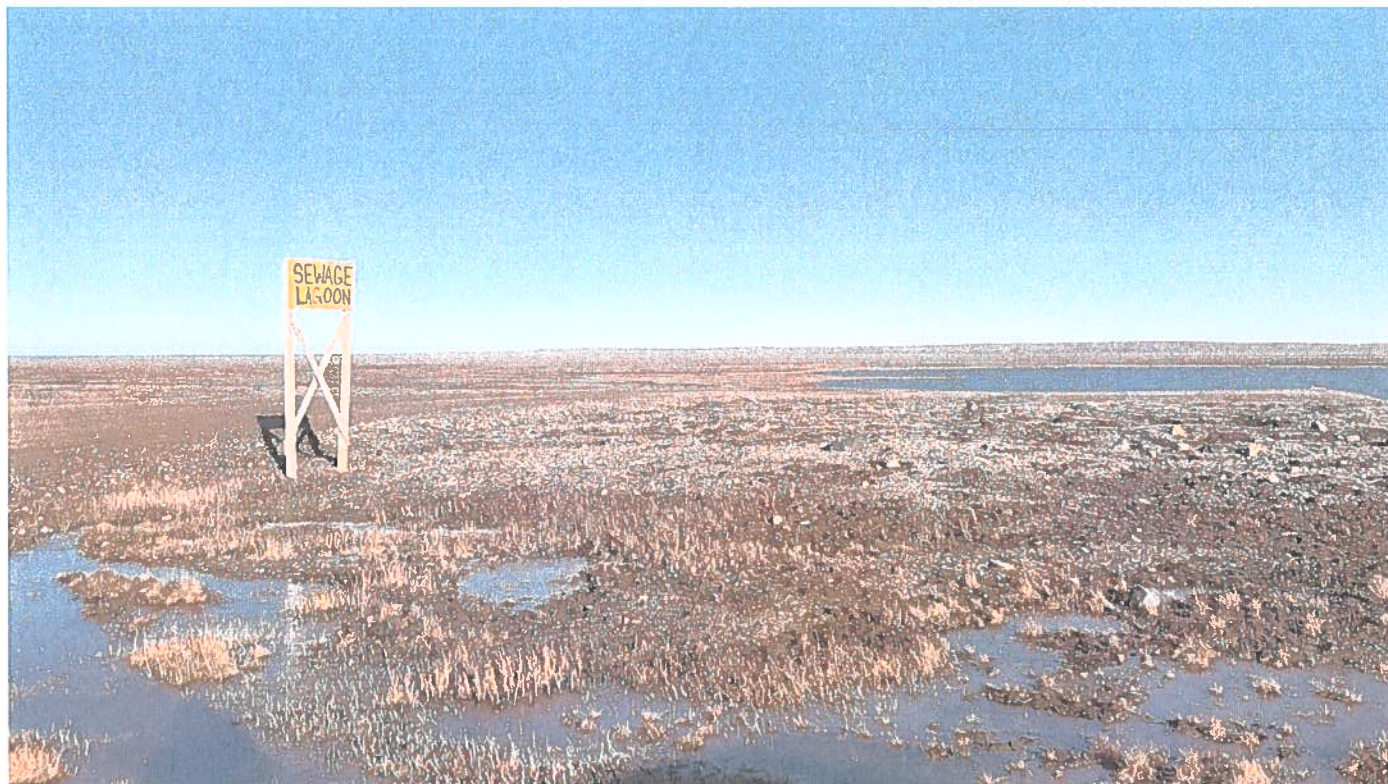
Figure 12: Sign for the Sewage Lagoon, with the lagoon in the back.

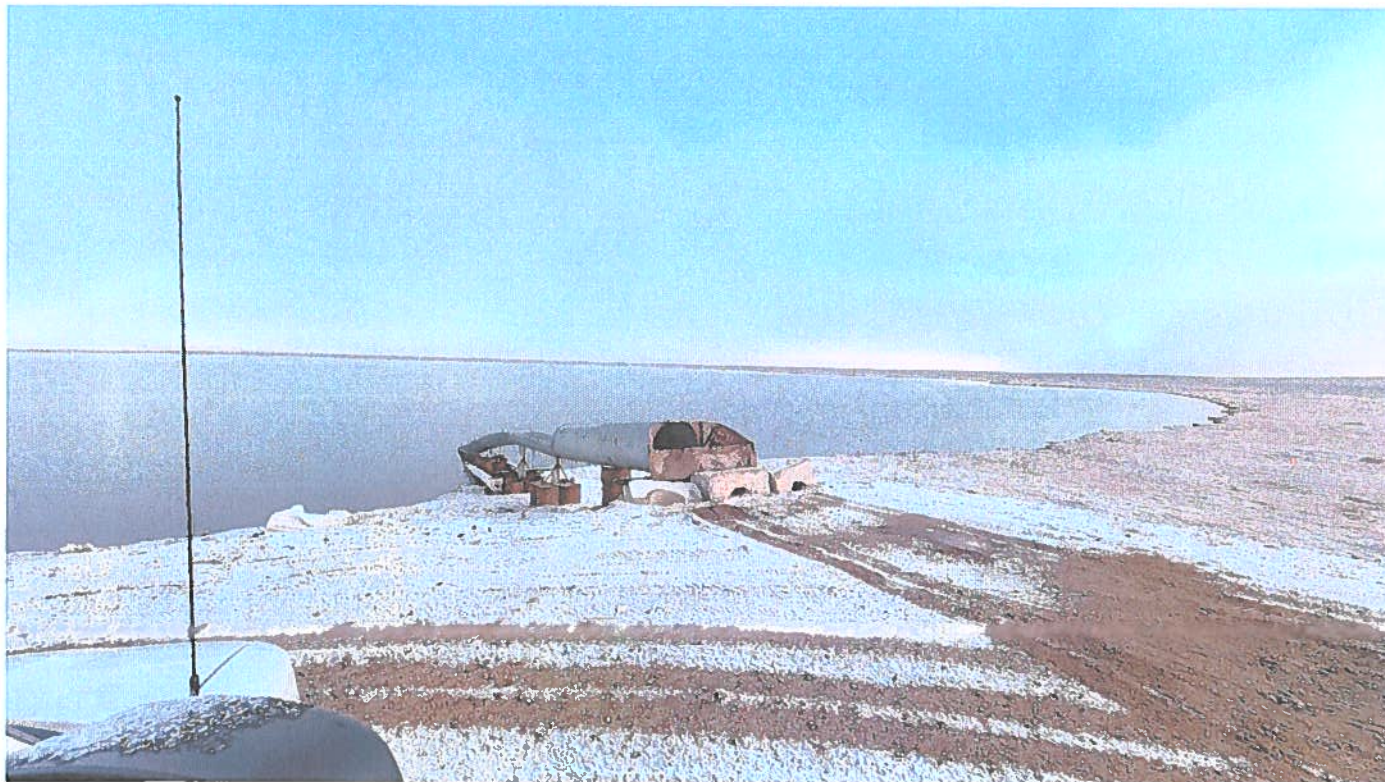
- The sewage lake appears to be in good working condition with no discoloration, strong odors or floating materials observed.
- There were no signs of erosion issues along the access road, or near the sewage chute.
- In the 2019 inspection report it was noted that one deteriorating 45-gallon drum is holding up the higher portion of the chute. This issue is still present as no maintenance work has been done to the receiving chute. This drum will need to be replaced with a proper brace. The bracing on the lower section of the chute appears to be sound and stable. SAO, Betty Haogak agreed that this issue should be addressed before anything fails.
- A large cement block is placed directly in front of the chute to prevent the sewage truck driver from backing into the chute. There are no signs of damage to the chute, or blocks.

Figure 13: Sewage Lagoon facility. The whole area appears to be clean, free of garbage and free of human activity. The receiving chute is in the same condition that it was in, in 2019, with the deteriorating 45-gal drum holding up the upper section of the chute.

- Please address any outstanding maintenance issues mentioned above (i.e., SDF chute, and sign maintenance).

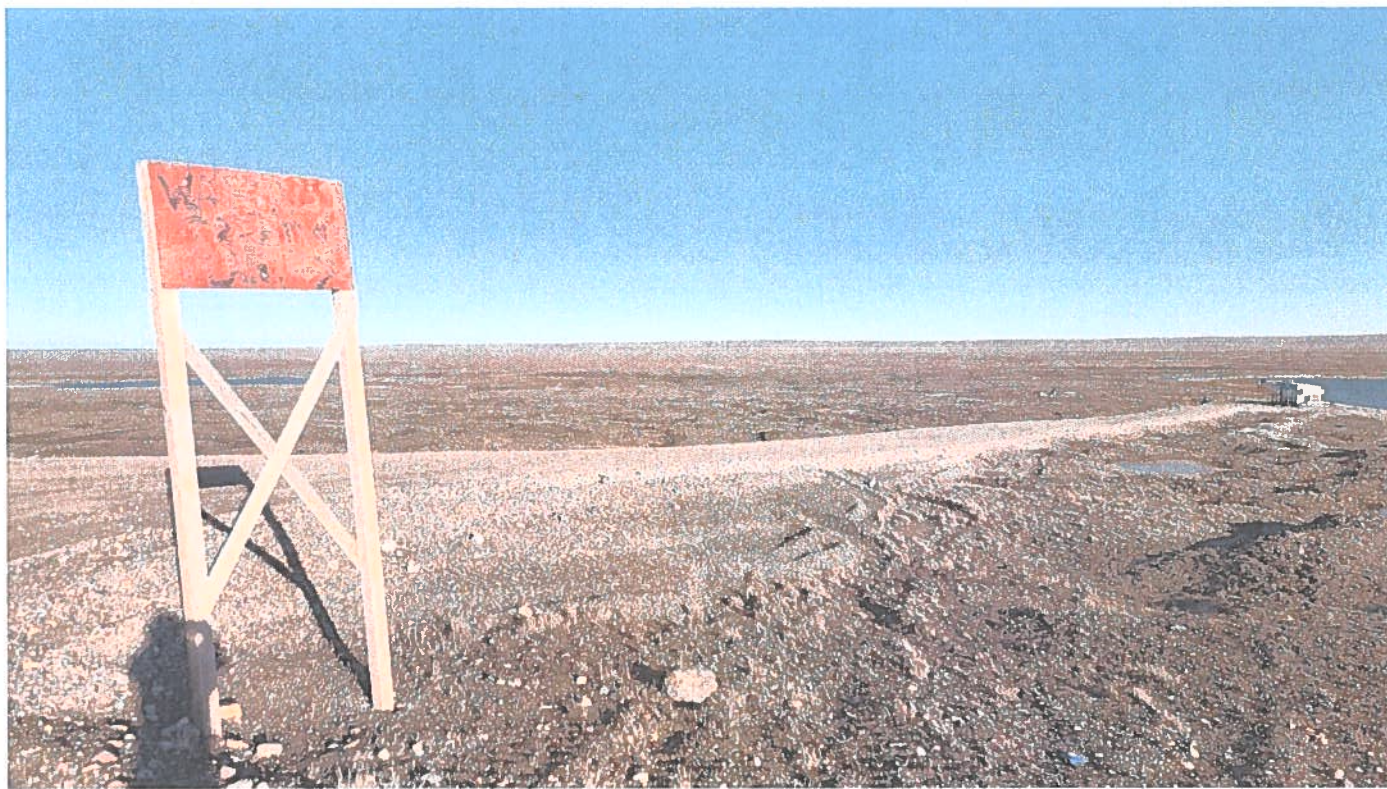
- The water treatment plant sign is a wooden sign with the words 'water treatment plant' painted on. This is acceptable, but the sign should be repainted to be more visible as the paint has started to weather and fade.

Figure 14: Sign for the Water Treatment Plant requires maintenance.

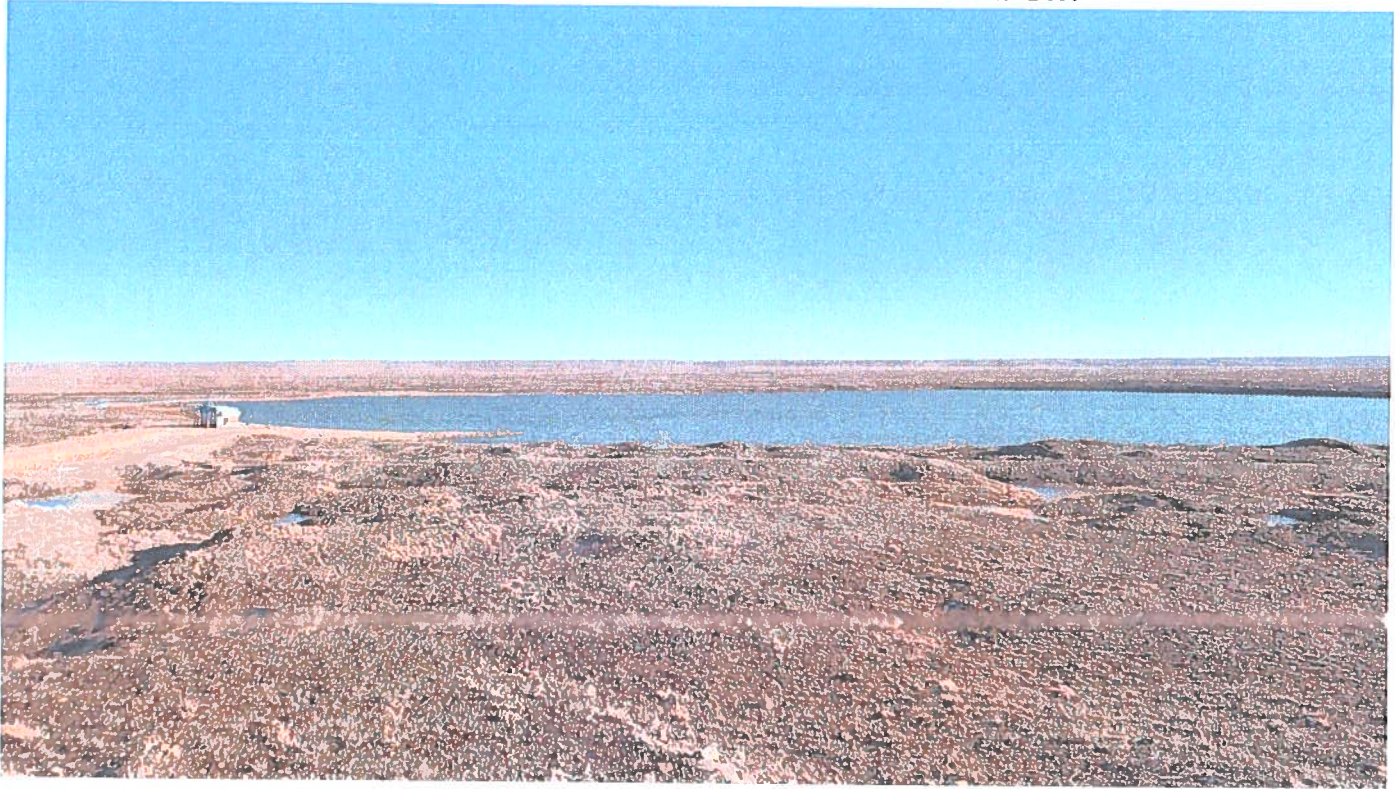
Figure 15: Water Treatment Plant and Water Lake.

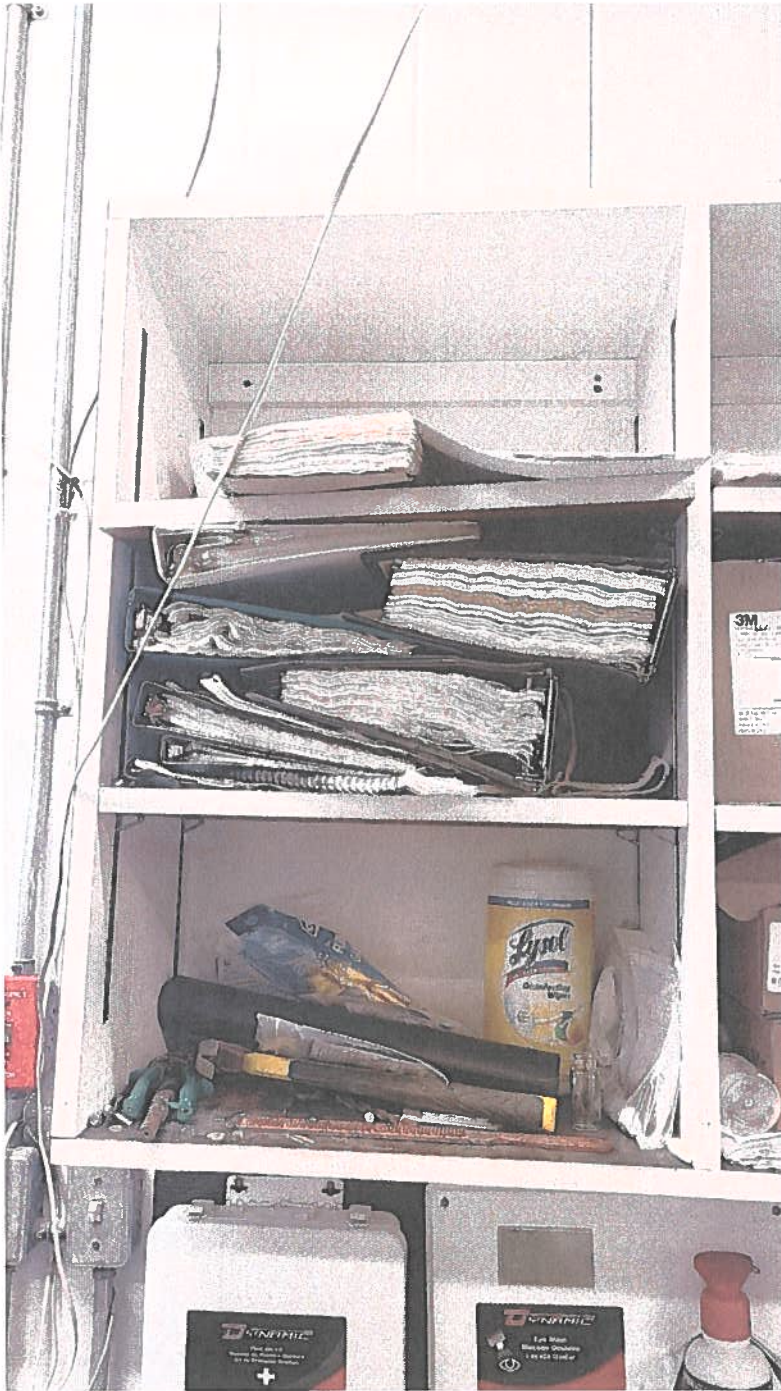
Figure 16: Water usage and tracking logs and documents ruined by water damage.

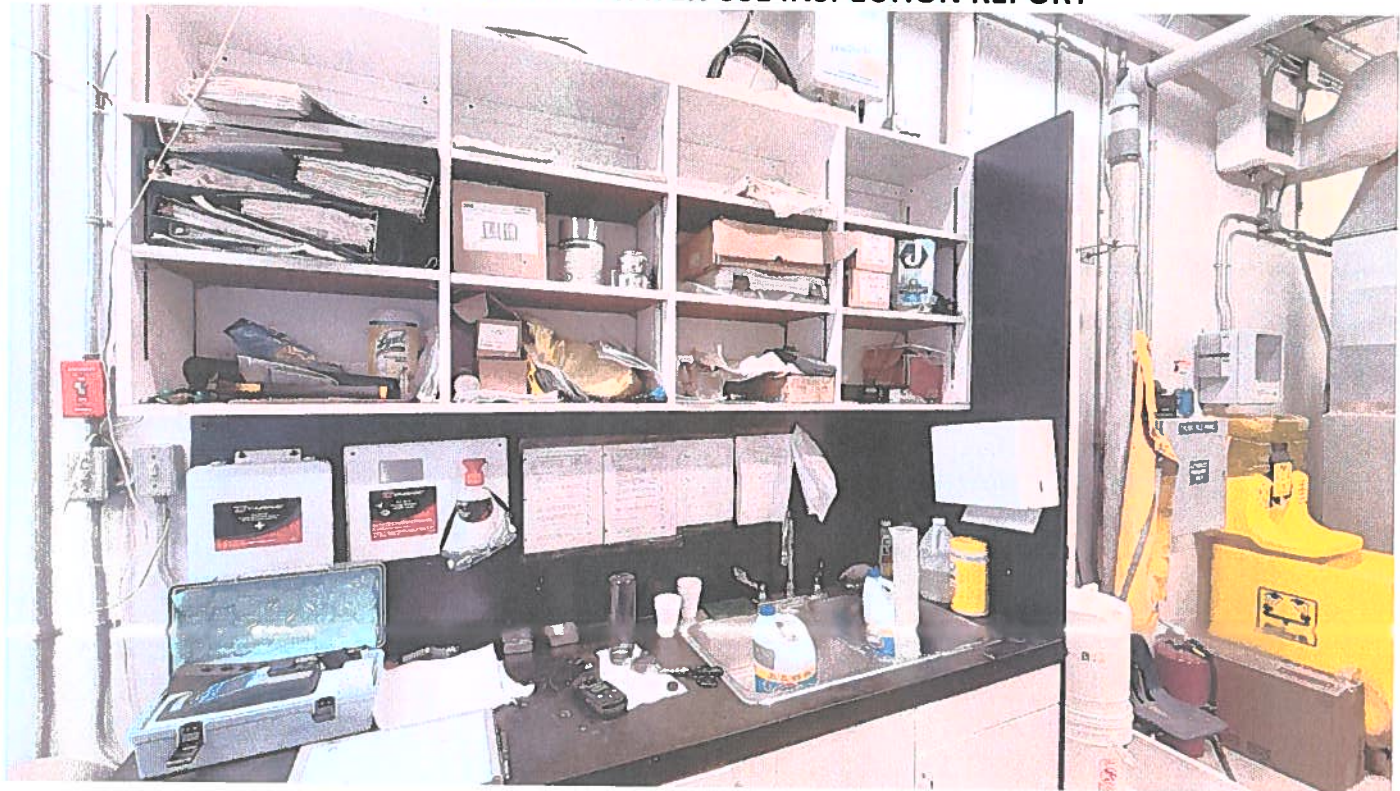
Figure 17: Condition of the working station at the water treatment plant at time of inspection.

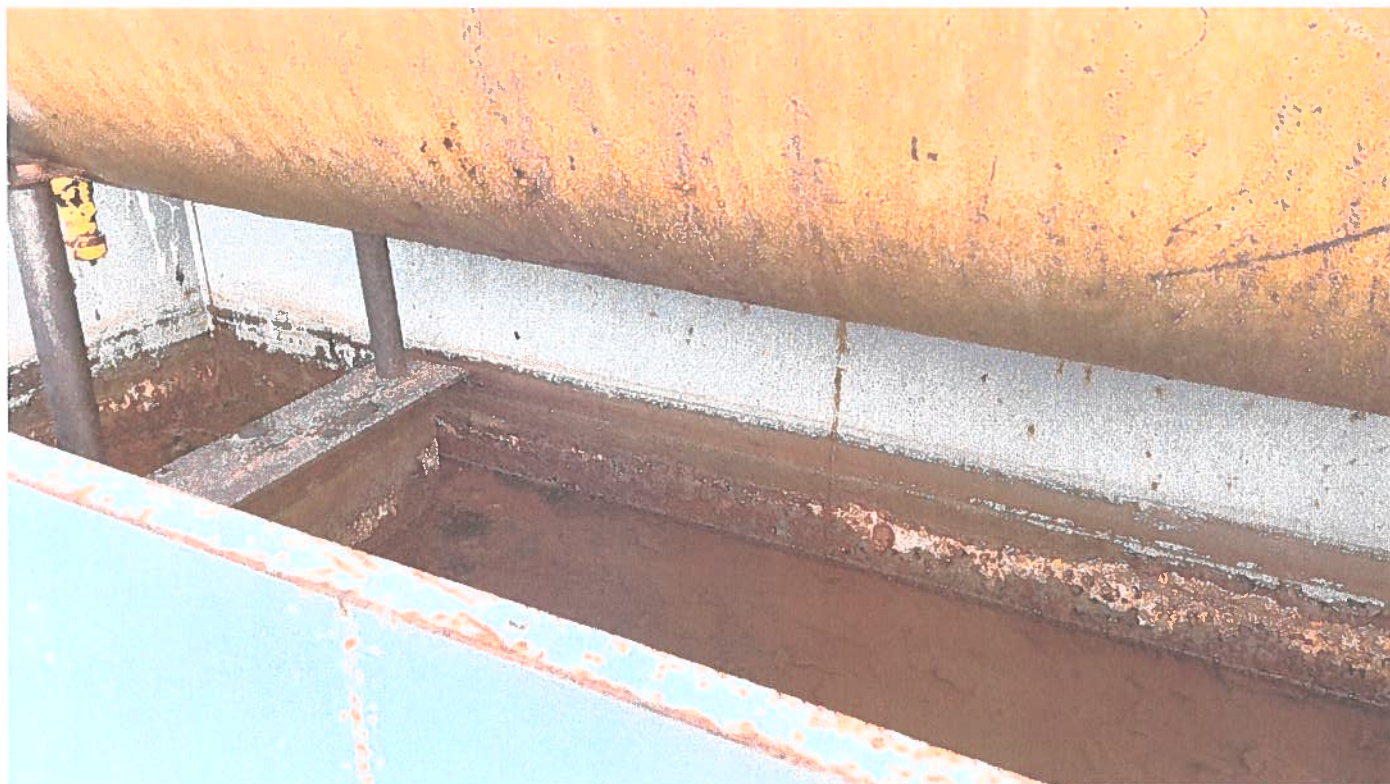
- The generator room was clean and well organized with a spill kit easily accessible. The spill kit's contents were full and complete.
- The secondary containment for the outside fuel tank was observed to be holding about 2 inches of water. This can displace the holding capacity in the event the fuel tank fails. The secondary containment needs to be clear of water, snow, and debris at all times. Water treatment plant operator, Mr. Wolki mentioned that they will have this water removed and will monitor it more frequently.

Figure 18: Water shown in the secondary containment for the water treatment plant's fuel tank.

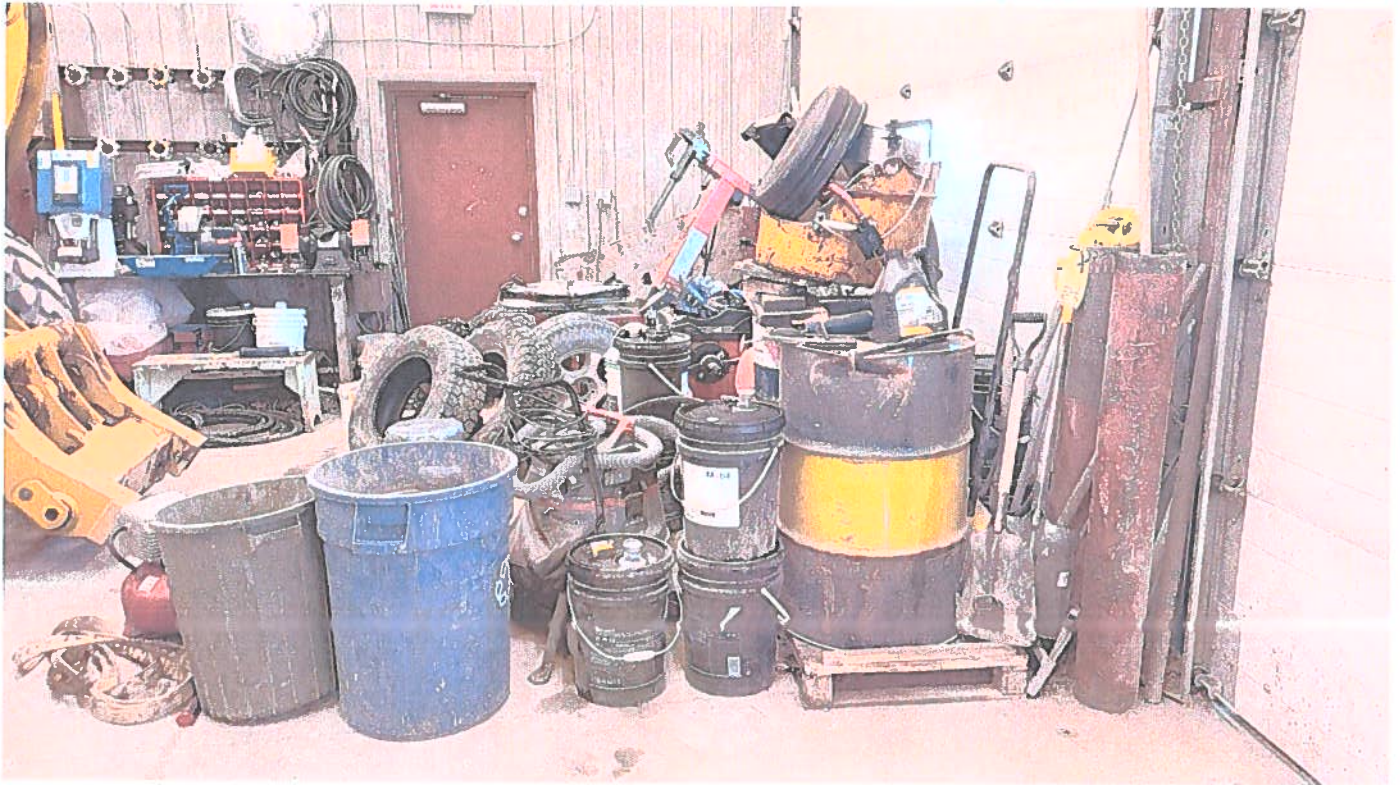
Figure 19: Storage of Hazardous Wastes at the Community Garage.
