File Number	N7L3-1531
Type of Operation	CLASS B - MUNICIPAL
Location	Sachs Harbour

An inspection of the above noted operation was conducted on September 15, 2021 by Regional Environmental Assessment Coordinator, Alicia McRae. Enclosed is a copy of the Municipal Water Use Inspection Report.

MUNICIPAL WATER USE INSPECTION REPORT

LICENCE #:	N7L3-1531	EXPIRY DATE:	November 20, 2022
LICENCEE:	Hamlet of Sachs Harbour	PREVIOUS INSPECTION:	October 17, 2019
COMPANY REP:	Betty Haogak, SAO	INSPECTION DATE:	September 15, 2021

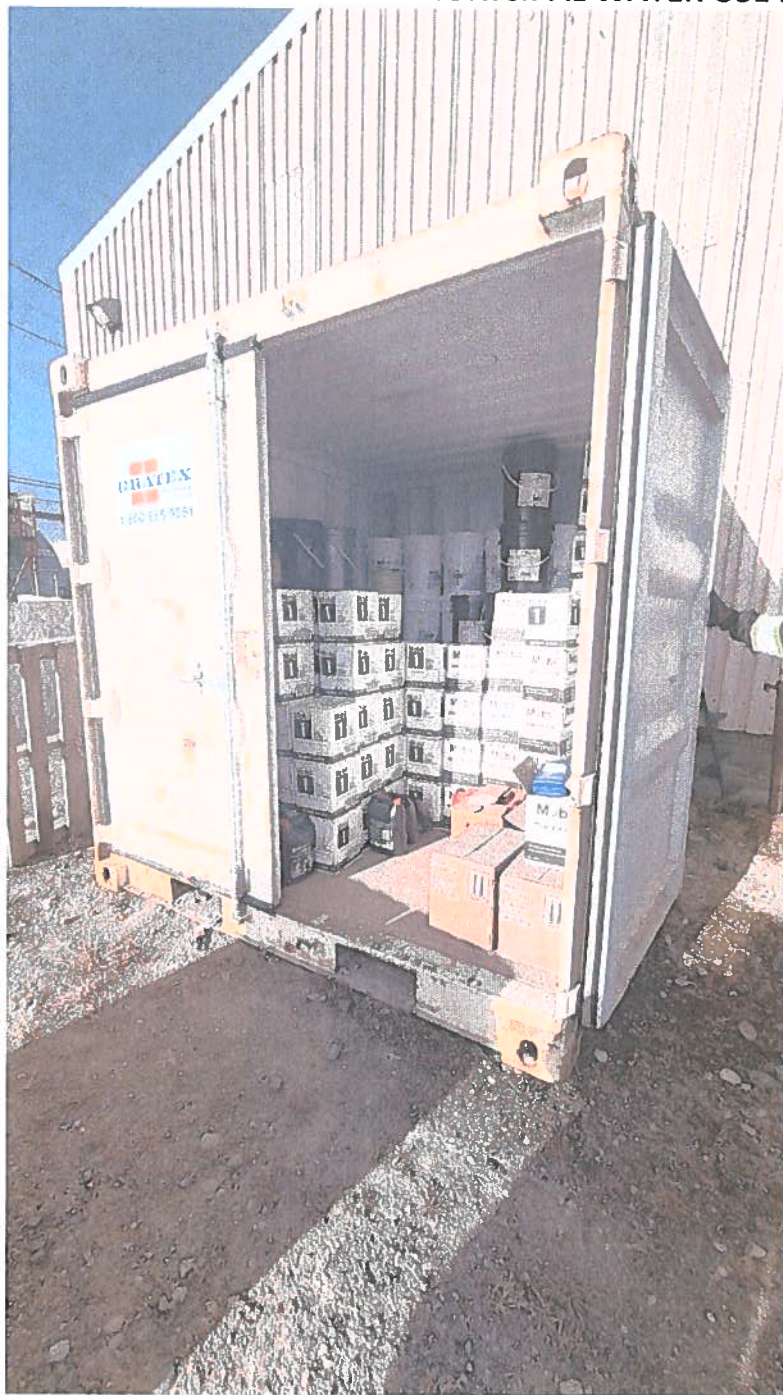
Figure 20: Storage of Hazardous Wastes at the Community Garage.
