**Hamlet of Paulatuk
Sewage and Solid Waste
Management Facility –
Abandonment and
Restoration Plan**

Draft

Abandonment and Restoration Plan

Hamlet of Paulatuk

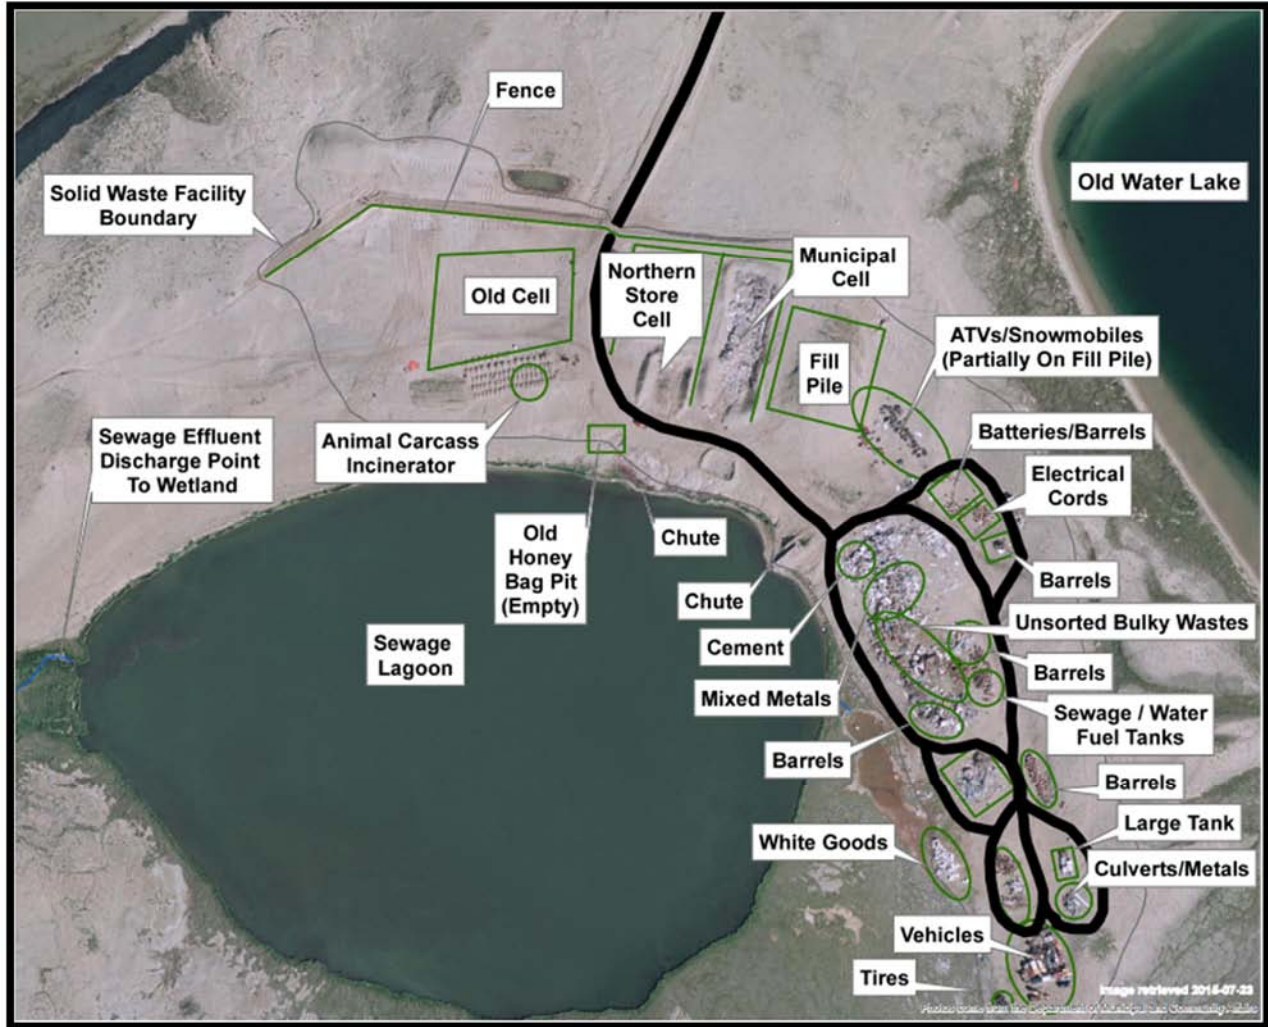
Figure 3: Active Sewage and Solid Waste Management Facility

All materials are currently being stored and sorted above ground as shown in Figure 3. Several landfill cells within the current facility boundaries have been developed for general household waste to the west of the access road and have been filled in and covered. The specific design for the cap and cover of these completed cells on site could not be determined. It is known that neither cell was constructed with an engineered leachate collection system. Based on May 27, 2015 site visit, the ground surface over these capped cells is flat to grade.

Historical site photos have shown the presence of standing water in the areas of old, capped cells. The same areas did not show any evidence of standing water during the May 27 site visit, however, it is not known if this is due to seasonal variations in surface water or if the standing water issue has been effectively addressed. If standing water remains an issue, it may infiltrate the landfill caps and get into the waste below causing leachate issues from the landfill cells into the wastewater lagoon. Since the site is very close to sea level and underlain by permafrost it is not expected that this leachate will contaminate groundwater supplies, but the potential to contaminate the sewage lagoon as it drains into the Darnley Bay is a concern. It is recommended that the old landfill cell areas to the west of the access road be monitored for standing water throughout the year. If water is detected, these areas should be tested, drained to an appropriate location (if contaminated, drained to a holding pond for further treatment) and the low lying areas filled and graded to ensure proper drainage away from the landfill cells and the sewage lagoon.

There is a chain link fence around part of the site perimeter to catch any windblown waste material. The fence has been damaged and is falling down in several areas. These sections should be rebuilt as soon as possible and the remaining perimeter of the solid waste facility should be fenced off to prevent access to wildlife which may become a nuisance or public safety risk, prevent illegal dumping, and stop the blowing away of loose waste material.

The existing chain link fence should be repaired as soon as possible and additional chain link fencing erected around the perimeter of the site. Proper fencing fulfils many roles at a site such as stopping any windblown material from leaving the property, preventing wildlife from getting into the solid waste and becoming a nuisance or safety hazard, and controlling access to the site to prevent illegal dumping and safety hazards.

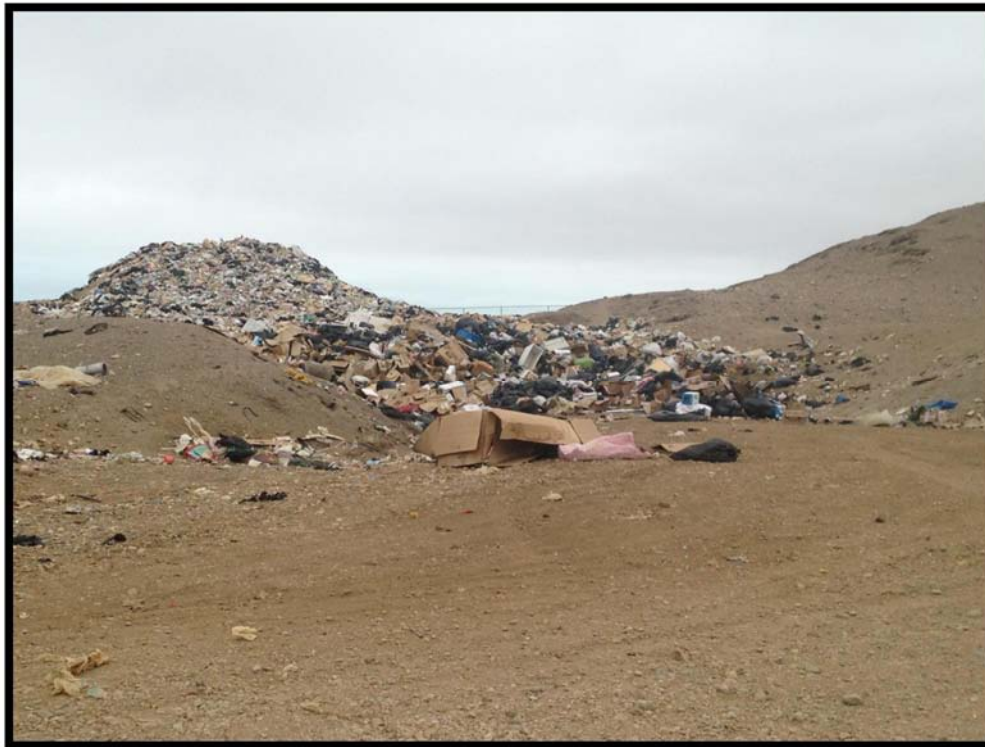
Figure 4: Active General Household Waste Disposal Area

This cell is covered by overburden periodically to prevent odour, wind, and pest issues. Overburden should be applied on a regular basis when waste is collected, delivered, and compacted into the cell as per the Paulatuk Solid Waste Operations and Maintenance Manual. The lack of regular overburden application presents many hazards including attracting nuisance animals. Current management practices

may also lead to a potential fire hazard. Allowing waste to pile up as per Figure 4 may lead to increased temperatures within the waste pile which can cause smoldering and burning of waste. If the general municipal waste were to catch fire, the fumes would be hazardous to community members downwind. Waste should be managed as per the Paulatuk Solid Waste Operations and Maintenance Manual to lessen the chance for fire.

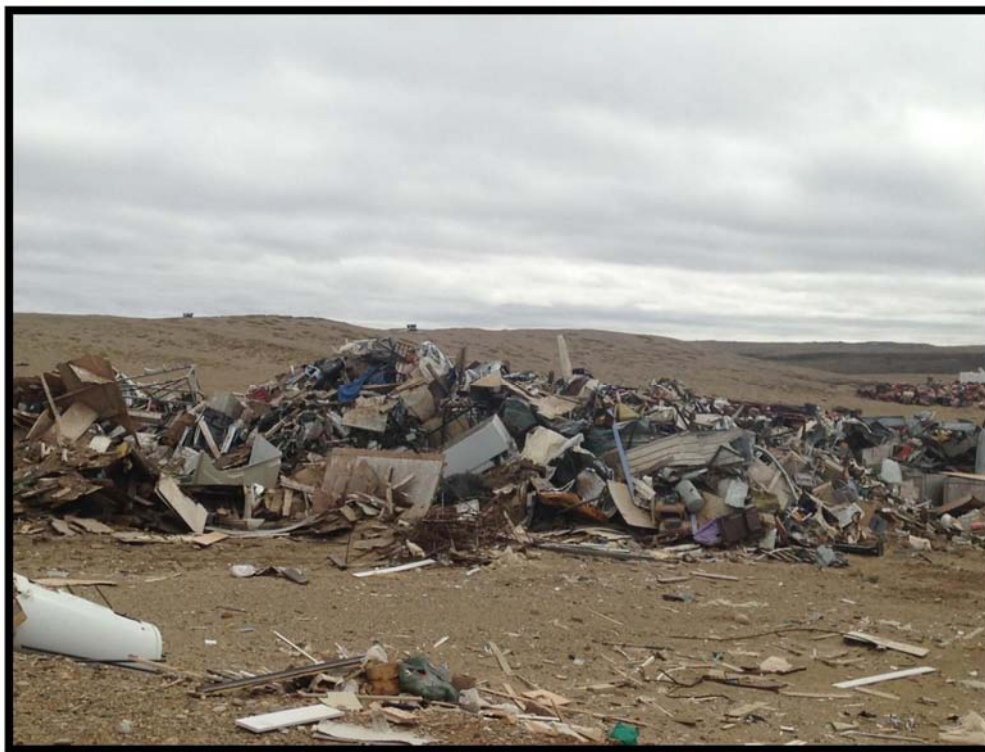
Figure 5: Unsorted Bulky Waste Area

The majority of the area to the northeast of the sewage lagoon is occupied by unsorted bulky waste that has not been properly processed into its component categories. This area contains white goods (fridges, freezers, washing machines, furnaces, hot water tanks, etc.), construction waste, mixed metal, household furniture, vehicle components, and other large waste items. Many of the white goods and other products have not been properly processed to remove hazardous components such as mercury temperature switches and hazardous refrigerants.

Construction waste products should be sorted by hamlet staff and recoverable materials made available for reuse by community residents. Particularly wood products and metal fixtures should be stored in a manner that protects them from further damage and avoids safety hazards to residents when combing through the materials.

The scrap metal content in the unsorted bulky waste area should be sorted and stockpiled with the construction scrap metal to ship south for recycling and recovery. Household furniture and other large, non-hazardous, non-recoverable items removed from the unsorted bulky waste area should be broken down to increase compaction and disposed of in the general household waste area.

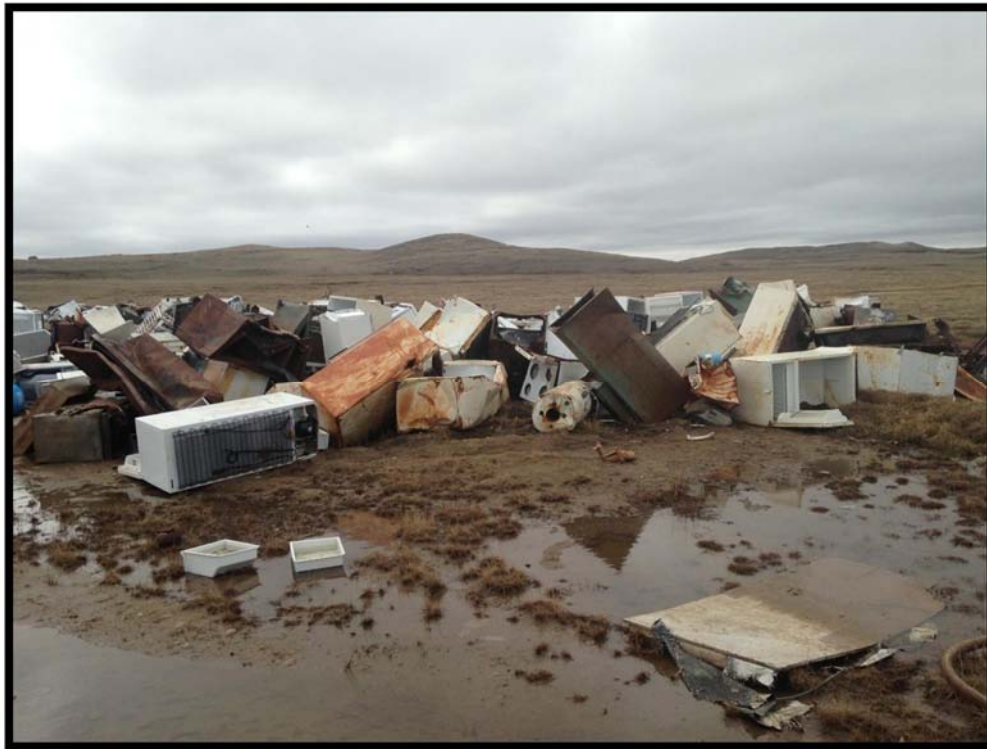
Figure 6: White Goods Storage and Sorting Area

The current white good storage area is bordering a pool of standing water as can be seen in Figure 6. This standing water impedes the proper storage and disposal of the white goods by causing corrosion and making it difficult to access and transport the materials. These standing water pools should be drained to a holding pond for treatment and the area backfilled and graded for water drainage to help provide safe access to the storage area.

Pools of standing water have been observed at the capped general municipal waste cells in historical satellite imagery in addition to the bulky waste storage areas during the site visit on May 27, 2015. This standing water presents several potential hazards including infiltrating the landfilled material causing leachate, making access to the site more difficult, making transportation of materials more difficult, and causing corrosion and degradation of potentially recoverable materials. This water should be tested by an approved laboratory to determine if it is contaminated by heavy metals or other contaminants of concern. If the standing water on site is found to be contaminated it should be pumped into a lined detention pond and treated according to the level and nature of the contaminants. If the water is safe to discharge, it should be pumped into the sewage lagoon for treatment of any organic or solids loading and discharge into Darnley Bay. Low spots where water previously pooled should be backfilled, compacted and graded to provide adequate drainage and avoid standing water in the future.

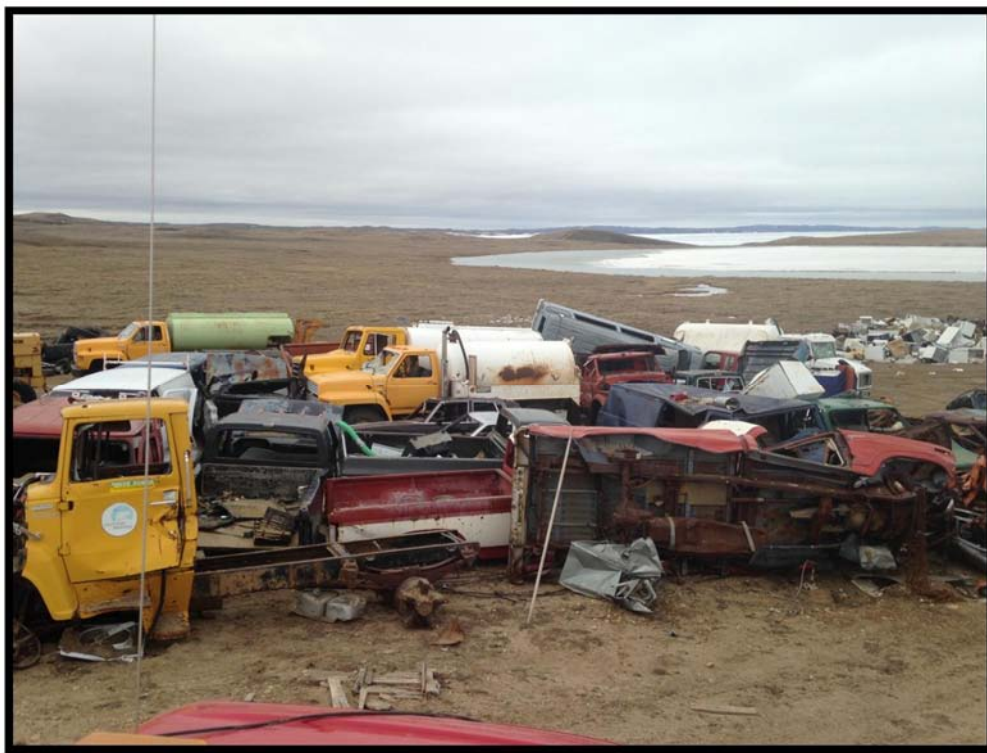
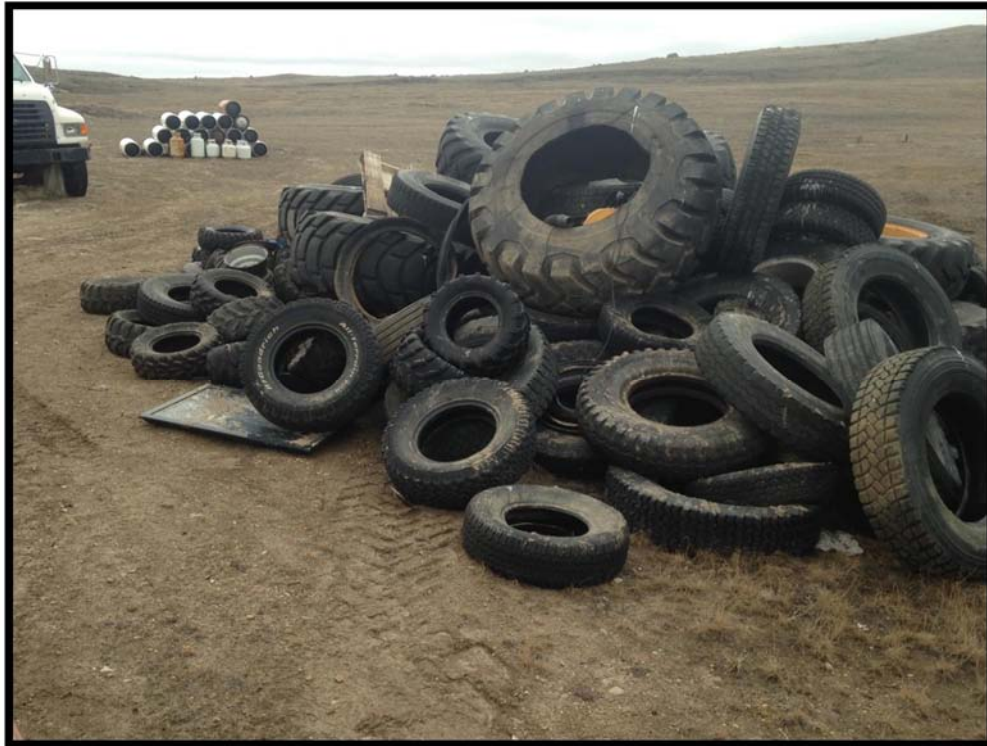
There are currently numerous end-of-life vehicles (ELVs) and used tires stored in a designated area to the west of the mixed bulky waste area. As discussed in the Solid Waste Operations and Maintenance Manual, the ELVs should have all hazardous components stripped including batteries, refrigerants, fuel, oils, antifreeze, windshield washer fluid, and other lubricants. Procedures for stockpiling and disposing of these hazardous materials are detailed in the Solid Waste Operations and Maintenance Manual. Once all hazardous materials are adequately recovered, ELVs should be stored in a manner that allows for parts recovery by community residents in order to reuse components as required and available. Once adequate storage space is no longer available for stockpiling ELVs, hamlet staff should arrange to have vehicles shipped to a proper recycling facility for further dismantling and disposal. In addition to passenger vehicles, there are several graders and tanker/vacuum trucks stored in the ELV area of the solid waste management facility. The hamlet should contact the manufacturer of the various vehicles or metal

As discussed in the Solid Waste Operations and Maintenance Manual, used vehicle tires are not considered hazardous and can be stored above ground in a manner allowing for recovery by community residents as required and available. However, tires are susceptible to fire, which produces hazardous fumes so care must be taken to store tires far from ignition sources. Tires should also be stored to limit the amount of water collected in the tires. Standing water in tires can provide a breeding ground for insects. Once the quantity of tires surpasses available storage space, arrangements should be made to ship stockpiled tires south for recycling at a properly equipped facility. Photographs of the ELV and tire storage areas are shown in Figure 7 and Figure 8.

recyclers that specialize in large equipment recycling to determine how best to dismantle them to ship south.

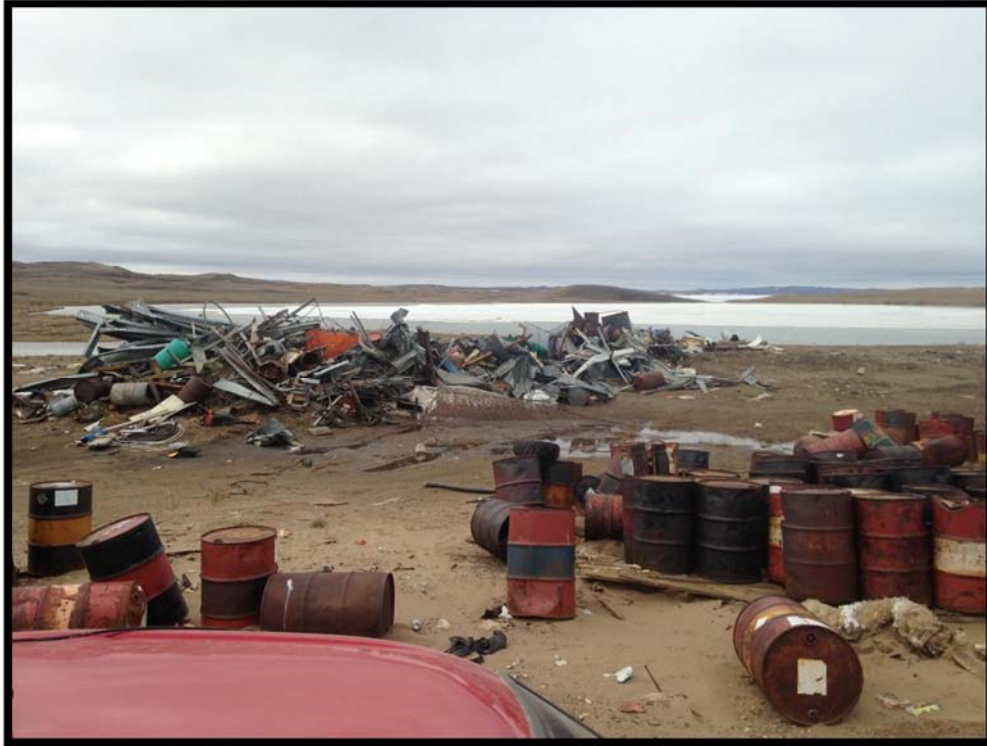
Figure 9: Mixed Metals Pile

In addition to the metal found in the unsorted bulky waste area, some metals have been sorted and stored separately in an area to the west of the bulky waste area. Materials stored in this area include scrap construction metal, old corrugated steel pipe culverts and old fuel tanks. There are also several locations throughout the bulky waste area where used metal barrels are stored. It is not known if all of these barrels have been properly cleaned or if they are still contaminated by hazardous waste. If they have not been properly cleaned out, the hamlet should make arrangements to have an environmental contractor clean them out, as described in the Solid Waste Operation and Maintenance Plan, so that they can be properly crushed and shipped south for material recovery. This should be completed promptly to prevent any residual fluids in the barrels from contaminating the surrounding site. Barrels that need to be cleaned should be stored upright in a lined area to prevent the migration of any leaking fluids into soils and water on site. Once cleaned, barrels should be crushed and transported off site promptly.

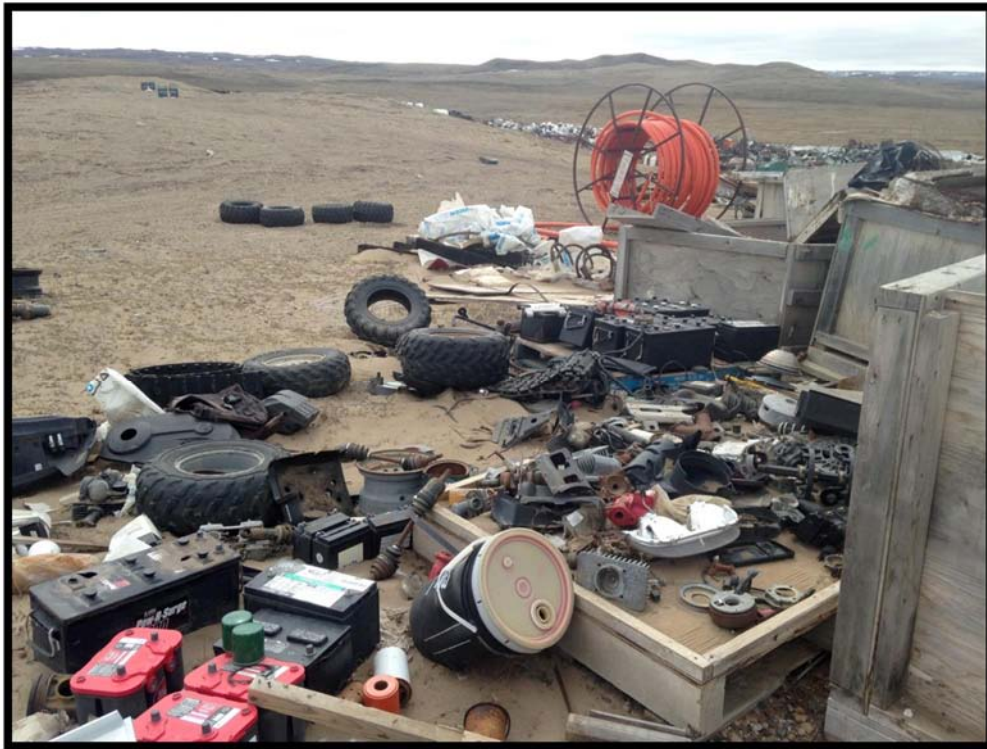
Figure 11: Mixed Hazardous Waste Including Batteries, and White Goods and Vehicle Components

There is not a significant quantity of hazardous wastes on site in the bulky storage area. The primary hazardous waste source on site consists of vehicle batteries, several buckets of waste oil and any residual substances in the barrels on site which are awaiting proper cleaning. Hazardous wastes should be stored in a way that prevents the potential for contamination of the surrounding soils, waterways, and air. They should be shipped out promptly on the annual barge to prevent contamination of the surrounding area. All materials should be stored as per the Solid Waste Operations and Maintenance Manual.

It is recommended that the hamlet develop a dedicated hazardous waste storage facility within the bulky waste area for storing these materials in addition to the uncleaned metal barrels, ELV fluids, and white good hazardous components. A hazardous waste storage area would need to be lined with a chemically stable, impermeable material overlain with a layer of backfill to prevent damage to the liner. It would also need to be surrounded by an impermeable berm to prevent the migration of any fluids out of the storage area. This hazardous waste storage area would not be intended for long term storage of materials and hazardous waste should still be shipped south promptly to avoid containment degradation and excess contamination.

A hazardous waste storage and processing area within the bulky waste sorting area of the solid waste management facility should be developed. This area should be lined with an impermeable liner and surrounded by a berm. Hazardous materials should be stored as per the Solid Waste Operations and Maintenance Manual until they can be shipped to a proper disposal facility.

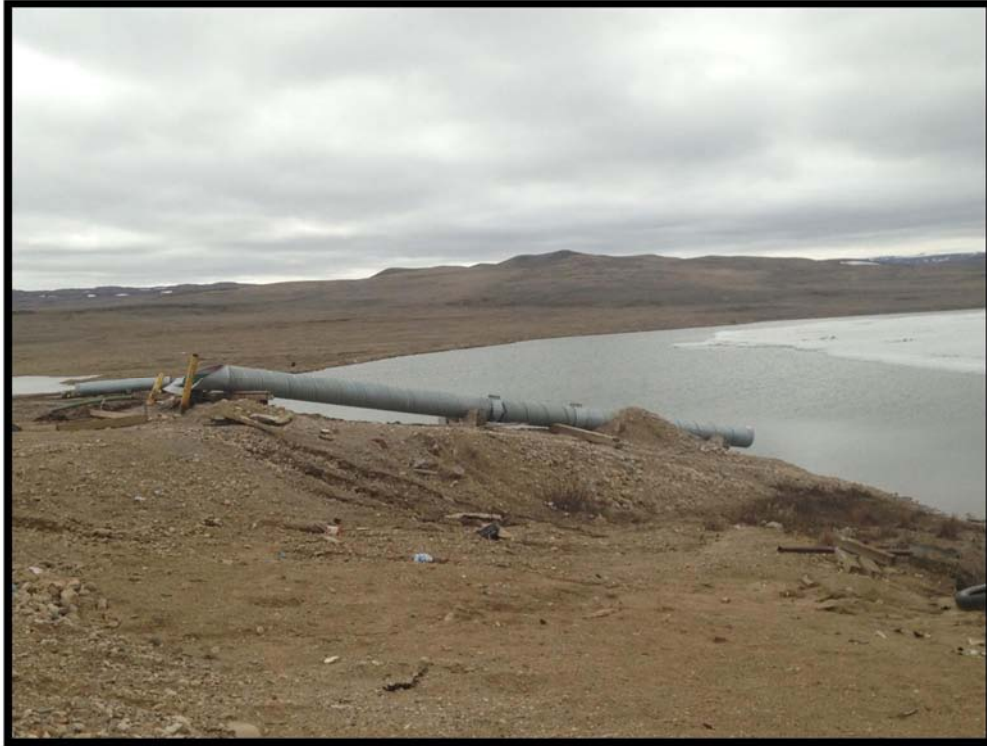
Figure 13: Sewage Discharge Pipe into the Sewage Lagoon

Sewage is discharged into the sewage lagoon, a natural lake that has been used for sewage disposal since the early 1990's. Solids are allowed to settle out and the sewage is naturally attenuated in the sewage lagoon. The sewage lagoon discharges to the west through a natural wetland approximately 300 m long which provides additional polishing before effluent discharges into Darnley Bay. The sewage lagoon continuously drains through the wetland during the summer months. Samples collected by INAC (now AANDC) in 2008 found that the pH, BOD₅, and total suspended solids measurements at both the lagoon discharge and wetland discharge were all within the limits set in the water licence. The most recent AANDC inspection report available from 2011 reported that sampling data was not available for the wastewater lagoon (AANDC, 2011). Routine sampling is not currently performed and more recent sampling data was not available for review. The hamlet has established plans and protocols to begin sampling the discharged water on a regular basis.

The 2009 water licence renewal application (Dillon Consulting, 2009) reported that the overflowing of the lagoon occurs periodically, particularly in the spring during runoff and periods of heavy precipitation. It was reported that there are holes/tunnels along the perimeter of the lagoon that cause particular overflowing issues. However during the site visit on May 27, 2015, it was reported that overflowing of the lagoon does not occur so it is assumed that the problem areas have been addressed. The lagoon is a natural lake and does not have an engineered berm surrounding the perimeter. The truck discharge area is built up upon a mound but it does not offer any overflow containment since the mound does not extend past the discharge.
